SAFETY ALERT

Safety Alert No. 446

Unsafe Working Practices Result in Crane Injury

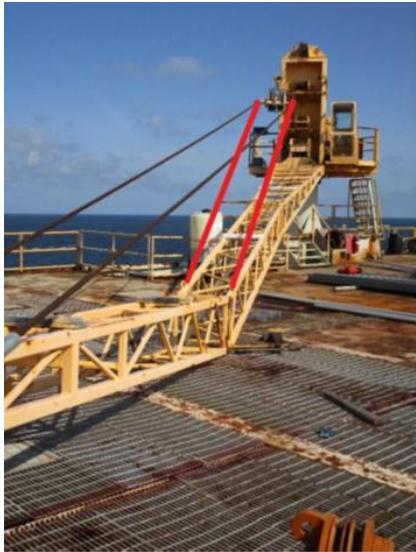
Figure 1 – Example of how mid-section should have been rigged

In May 2022, a lead mechanic suffered a severe leg injury while performing a boom tip changeout on an offshore pedestal crane. The injured person (IP) and his assistant deviated from the planned scope of work, failed to rig up the mid-section to the bridle (Figure 1) prior to removing the mid-section to boom tip connector pins (Figure 2), and failed to use boom connector safety pins (Figure 3). After removing the bottom right pin, both employees assumed the bottom left pin would be difficult to remove since it was bearing the weight of the boom section. When the IP struck the remaining connector pin, it unexpectedly ejected, causing the boom to drop and pinning the IP's leg against a sledgehammer and grating (Figure 4), and fracturing the IP's tibia.

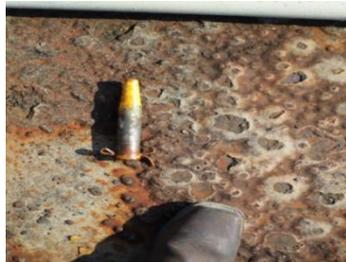
Figure 2 – Boom connector pin

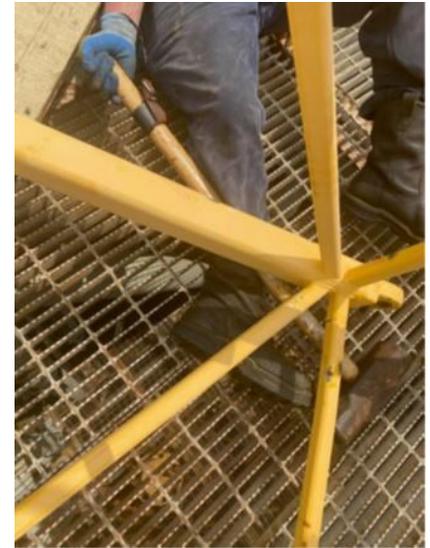
Figure 4 – Boom section on injured person's (IP) leg

- A. The Job Safety Analysis (JSA) was only completed by one employee and did not include rigging up the mid-section to the bridle prior to removing pins or the use of safety boom connector pins. In addition, the IP signed off on the JSA without reviewing it.
- B. There was no requirement for onshore management or the crew to review the JSA before commencing work.
