# SAFETY ALERT

**Safety Alert No. 340**  
**23 August 2018**

## Caisson Well Surface Safety Valve Actuator Explodes

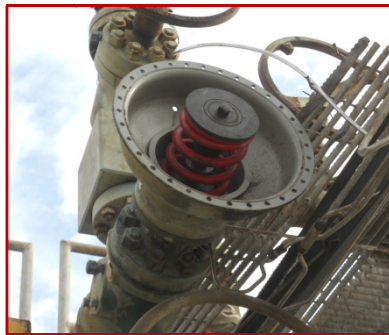
*Bottom of SSV Actuator*

overpressure. Therefore, the explosion occurred when the SSV opened upon actuator pressurization, which rapidly introduced 2,276 psi (recorded trend pressure) of non-regulated well gas through the tubing jumper and into the SSV actuator, which was designed for a maximum operating pressure of 150 psi. The overpressure caused the fastener bolts to fail, allowing explosive separation of the diaphragm case, top shaft, and diaphragm/diaphragm retainer plate from the lower diaphragm case. The operator reported that no injuries or pollution had occurred; however, nearby grating was damaged along with the SSV.

- Do not alter equipment from original design without fully understanding potential consequences.
- Institute operating procedures that account for start-up during all potential conditions.
- Initiate stop work for any deviation from safe operations.
- Follow Management of Change procedures when confronted with a situation for which there is no published Operating Procedure.
- Fully understand cause and effects during all operations.
- Safely supply instrument and fuel gas where applicable.

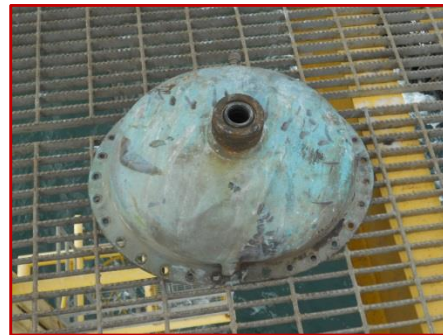
*Top Diaphragm Case*

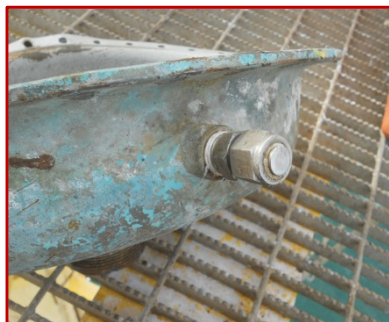
*Capped off fitting in place of pressure relief device*

Although the diaphragm actuator design included a ½-inch pressure relief device installed and sized for instrument gas regulator failure, it had been removed/replaced with a capped-off tubing fitting at some prior point in time.

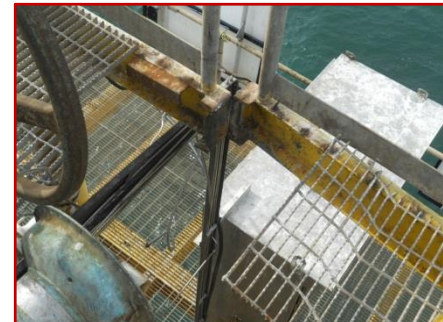
*Damaged Grating*
