# SAFETY ALERT

**Safety Alert No. 374**  
**December 11, 2019**

## Air Compressor Flaws Lead to Engine Fire

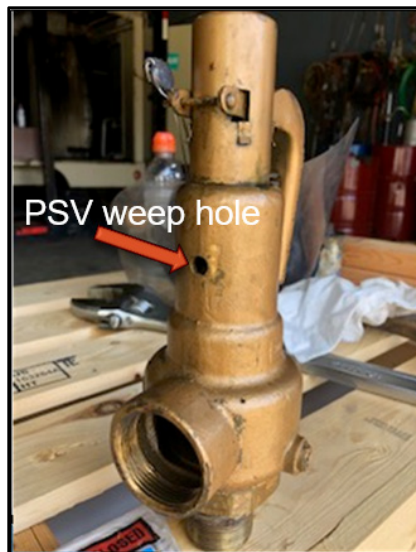
*Photo 1 – PSV Weep Hole*

The inadvertent release of hydraulic fluid and air throughout the engine housing caused the fire. Due to deterioration over time, the diaphragm in the regulator on the compressor's separator tank ruptured. As a result, the hydraulic fluid regulator seal failed, which rapidly increased the pressure in the unit and subsequently activated the Pressure Safety Valve (PSV). The fluids were released through two separate locations:

1. PSV weep hole (*Photo 1*) directly onto the air compressor engine; and,
2. PSV relief piping into the compressor skid (*Photo 2*), which was then drawn up by the compressor engine fan through louvers onto the engine.

- Align the drain piping to a secondary discharge containment pan below the unit to trap any potential hydraulic fluid leaking from the PSV;
- Cover the PSV body with a shroud in order to confine a hydraulic fluid release to a controlled discharge location;

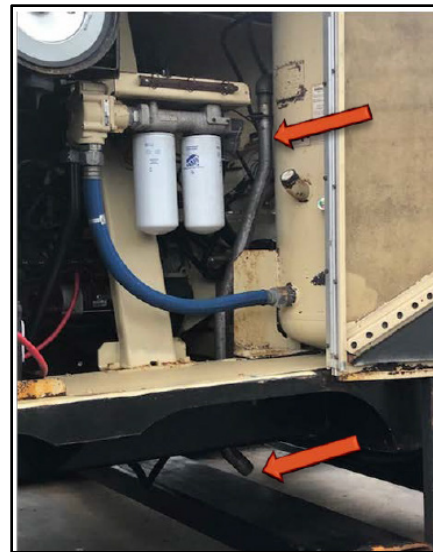
*Photo 2 – Relief Line Leading to Skid*

The fluids accumulated on the engine housing after the PSV was opened. Since the engine exhaust manifold remained hot after the unit was shut down, the fluids ignited.
