Safety Bulletin No. 013
3 December 2018

Severe Corrosion Found Under Insulation

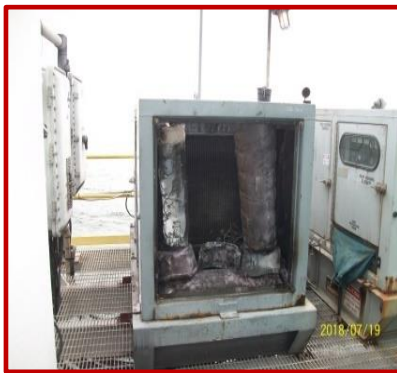
Exhaust Side

- Survey engine exhaust components (i.e., firewater pump drivers, cranes, compressors, generators, etc.) to identify exhaust leaks.
- Expand piping and vessel inspection programs to include routine inspections of all components covered with insulation or decals to identify corrosion issues that could result in process leaks. Such inspections may require removal of protective guards as well as the insulation.

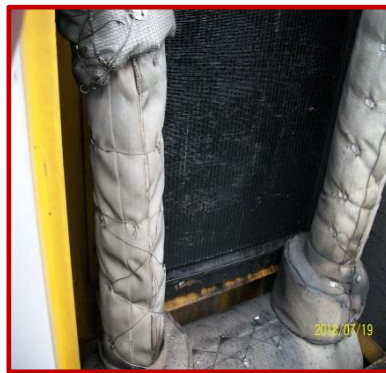
Exhaust with Insulation

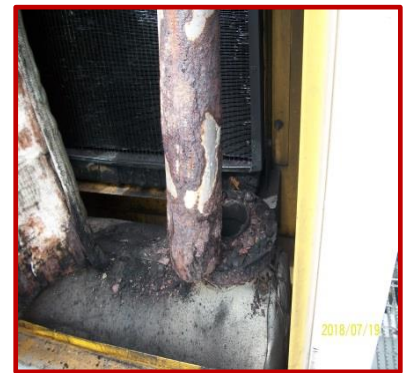
Corroded Exhaust

BSEE instructed the operator to shut-down an identical generator on the same facility for inspection; the same corrosion-related issues were identified. Corrosion beneath the insulation blankets was severe and affected the exhaust piping at the same points as the unit that experienced the fire.
