# SAFETY BULLETIN

**Safety Bulletin No. 014**  
**6 December 2018**

## Improper Procedures Result in Explosion and Evacuation

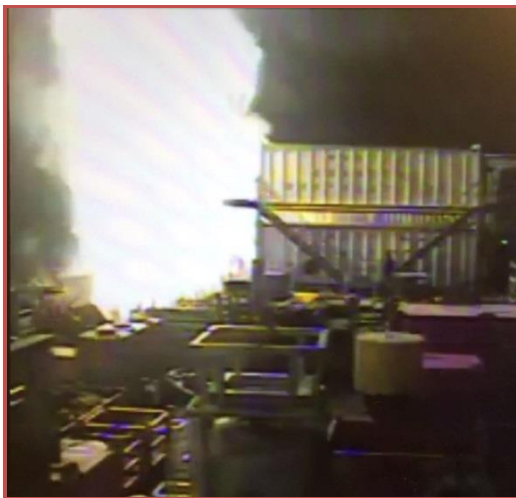
*Flame, as seen from the main deck*

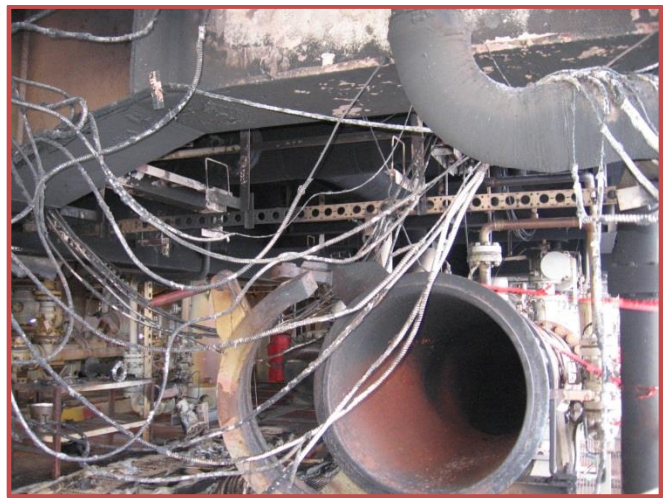
*Post-incident damage*

At the time of the incident, the crew was performing the 30-inch sales gas pig loading procedure. After loading the pig and closing the pig launcher door, the crew began to pressurize the pig launcher. At approximately 300 psi (MAWP of 1950 psi), an explosive gas release occurred, causing the pig launcher door to separate from the pig launcher. The resulting fire was likely ignited by metal-to-metal contact or electrical arcing from the blast damage. The fire continued to burn for nearly 27 hours after activation of the emergency shutdown system while the remaining gas volume in the sales gas pipeline vacated through the pig launcher door opening.

The BSEE investigation concluded that the crew did not secure the pig launcher door in accordance with Original Equipment Manufacturer (OEM) procedures, preventing the pig launcher door from properly sealing. Furthermore, the crew neglected to lock out and tag out (LOTO) some of the valves as outlined in their job procedure.

**Therefore, BSEE recommends that operators:**

- Consider incorporating established OEM procedures into operator-approved job procedures.
- Emphasize the importance of adhering to established OEM and operator procedures, even during routine tasks.
- Consider implementing visual or other verification methods for proper pig launcher door seal as a procedural step in pig loading/launching procedures.
- Emphasize the importance of adhering to LOTO procedures.
