EVALUATION OF CAPACITIES OF TEMPLATE-TYPE GULF OF MEXICO PLATFORMS

R. G. Bea, K. J. Loch, and P. L. Young

Department of Civil Engineering and
Department of Naval Architecture & Offshore Engineering
University of California
Berkeley, California

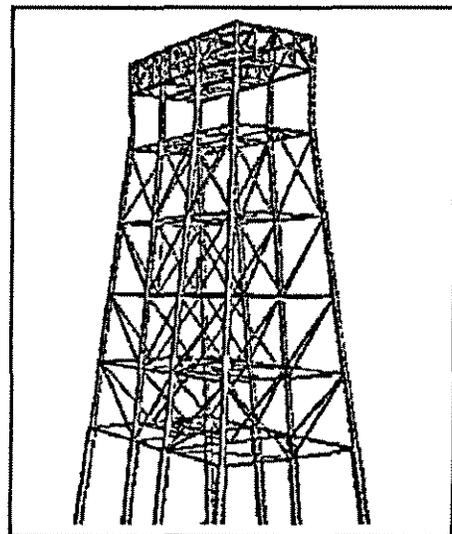
FIGURE 1: PLATFORM 'B'

Platform 'B' (PB) is a self-contained, 8-leg, drilling and production platform with 12 well slots and 9 drilled wells (Figure 1). The platform was installed in 118 ft of water in the South Timbalier region in 1964. The platform was designed according to conventional 1963 criteria based on "25-year" return period design conditions (wave height of 55 feet).

Cellar and main deck elevations were located at + 34 ft. and + 47 ft. respectively. The major deck framing is 43 ft. by 93 ft. in plan, and the jacket legs are battered at one to eight in both broadside and end-on framing. The deck legs are 36 in. in diameter with a wall thickness of 0.625 in. and are connected to the tops of the piles with welded shim connections. The 39 in. diameter legs have an average wall thickness of 0.50 in. and have no joint cans. However, gusset plates are used with the jacket leg K-joints. The broadside braces vary from 14 in. in the first of four jacket bays to 20 in. in the lowest jacket bay, while the end-on bracing varies from 14 in. to 16 in.

Based on coupon tests performed after the platform was installed [Imm, et al., 1994], the jacket bracing and horizontal framing are made of nominal 50 ksi steel with an average yield strength of 58 ksi. The jacket legs and piles are composed of nominal 36 ksi steel with an average yield strength of

The 36 in. piles extend 190 ft. below the mudline through 165 ft. of soft to stiff gray clay and 25 ft. of fine dense sand. At the time of design, anticipated pile loads were 770 tons in compression and 350 tons in tension. PB's piles were grouted inside its 39 in. jacket legs in 1973.

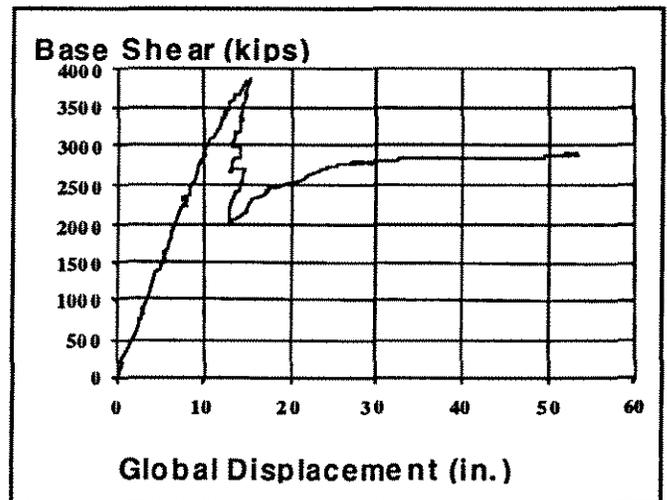
FIGURE 2: BROADSIDE FORCE-DISPLACEMENT RELATIONSHIP

The force-displacement curve for broadside loading is shown in Figure 2. This curve indicates that platform fails at 0.907 of the reference load pattern or a total base shear of 3,860 kips. This lateral loading capacity is less than the 4,900 kips reported by Imm et al. [1993]. This difference is due to the differences in the loading patterns utilized in the two analyses. The analyses reported in this paper have larger wave forces acting on the platform lower deck.

Figure 2 indicates that the platform has no reserve strength after the first brace - joint failure. However, it is important to note that the platform can experience large inelastic displacement before a failure mechanism is formed. If the force-displacement curve were extended it would show that eventually, the jacket legs develop sufficient resistance in bending to cause buckling of the braces in the third jacket bay.

The hurricane hindcast data [Cardone, Cox (1992)] and observed platform performance indicate that PB survived 60 - 64 ft waves 15 degrees off of broadside during hurricane Andrew. Approximately 96 percent the peak loading developed during the storm was resisted by the broadside framing. The USFOS analysis indicates that the platform experiences first significant member failure, brace - joint failure, at 91 percent of the load from a 64 ft direct broadside wave.

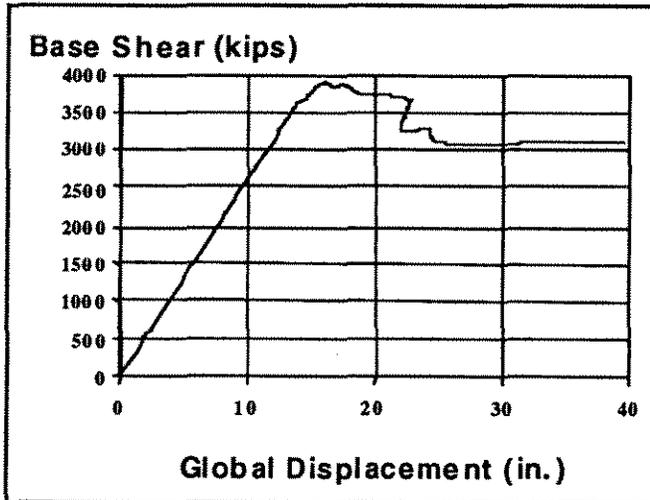
FIGURE 3: END-ON FORCE-DISPLACEMENT RELATIONSHIP

The force-displacement curve for end-on loading is shown in Figure 3. This curve indicates that the uppermost compression braces buckle at 1.12 of the reference load pattern or a total base shear of 3,900 kips. Figure 4 shows that after the compression braces - joints in the fourth jacket bay fail the platform has a small increase in resistance capacity until the compression braces in the third jacket bay and the horizontal framing between these two levels almost simultaneously fail, at which point the platform is at imminent collapse.

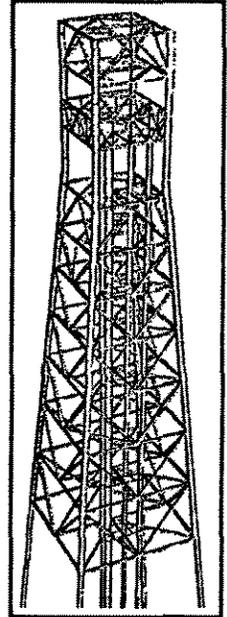
FIGURE 4: PLATFORM 'C'

Platform 'C' (PC) (Figure 4) was installed in the GOM Ship Shoal region in 1970. This platform is a self contained four pile drilling and production platform located in 157 ft. of water. PC survived hurricane Andrew without significant damage.

The platform has four conductors and eight risers. The PC decks are located at elevations of +33 ft., +43 ft., +56 ft. and +71 ft. The deck legs form a 30 ft. by 30 ft. square in plan and the jacket legs are battered at 1:11 in both primary directions.

The piles for PC run through the jacket legs, but unlike PB the pile-jacket leg annulus is not grouted. The 36 in. diameter piles extend 355 ft. below the mudline through 328 ft. of soft to stiff gray clay and 27 ft. of fine dense sand. The sand layer starts at 197 ft. below mudline. The clay above the sand is generally soft and silty, while the clay below the sand is stiff.

While the pile-leg annulus is not grouted, the jacket legs and most other intersecting members have joint cans. The 39.5 in. diameter jacket legs are 0.5 in. thick while the joint cans are 1.25 in. thick. The deck legs are 36 in. in diameter with a wall thickness of 1.25 in. and are connected to the tops of the

piles. The vertical braces vary from 16 in. in the top or seventh jacket bay to 20 in. in the first jacket bay. All members reportedly are constructed of nominal 36 ksi steel with an average yield stress of 43 ksi.

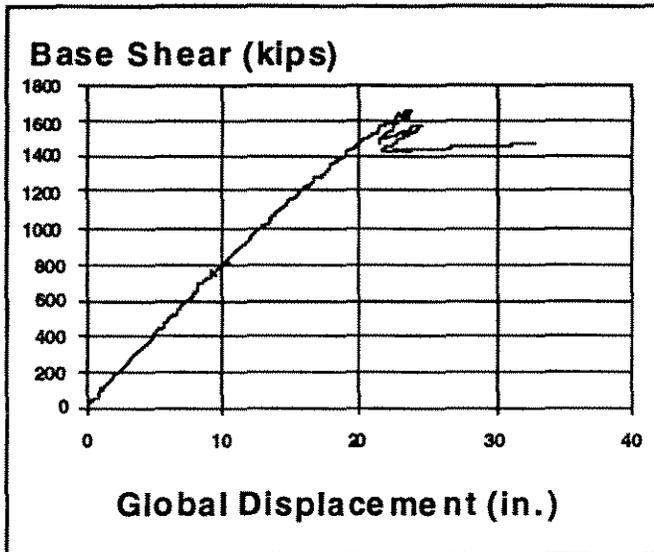
FIGURE 5 - FORCE - DISPLACEMENT RELATIONSHIP BASED ON STATIC PILE CHARACTERISTICS

The initiating failure mode for PC based on the static pile characterization is pile plunging. The force-displacement history for broadside loading is shown in Figure 5. This curve indicates that platform fails at 0.628 of the reference load pattern or a total base shear of 1,700 kips at a displacement of about 24 in. From Figure 5 it can be seen that the platform has a constant stiffness after all the T-Z and Q-Z springs of the compression piles have reached their final plateaus

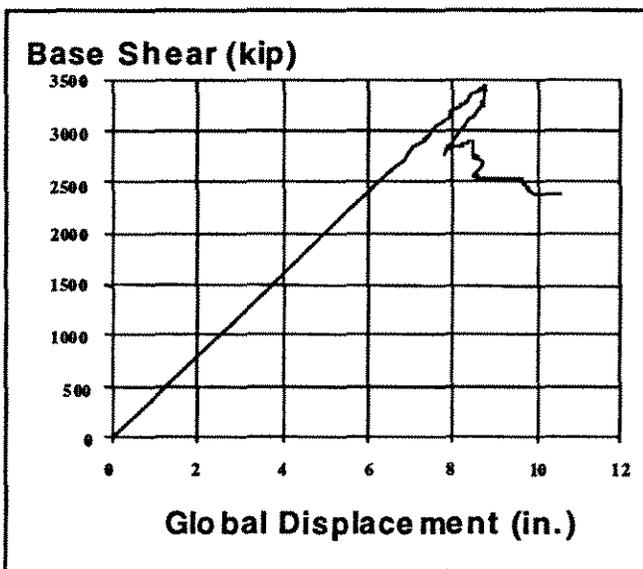
FIGURE 6: FORCE - DISPLACEMENT RELATIONSHIP FOR DYNAMIC PILE CHARACTERIZATION

The lateral force - displacement characteristics for the analyses based on the dynamic pile characterization is given in Figure 6. The peak lateral load capacity is now 3,500 kips and it is reached at a lateral displacement of about 9 in. Based on the dynamic pile characterization, the lateral load capacity of the platform is about doubled.

Since the foundation was shown to be the weak link in the platform, an analysis based on a dynamic pile characterization was also performed. Results from the USFOS analyses showed that if the foundation was characterized based on consideration of dynamic effects, the braces in the second jacket bay became the weak link. The second bay compression braces buckled at 1.30 of the reference load pattern or a total base shear of 3,440 kips. After the compression braces in the second jacket bay buckled, the braces in the third jacket bay buckled and the jacket began to "unzip".

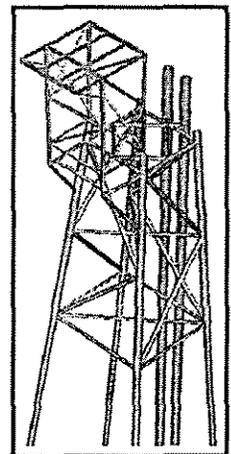
FIGURE 7: WELLHEAD PROTECTOR 1

The eye of hurricane Andrew passed within a few miles to the west of Wellhead Protectors 1 (WP1) and 2 (WP2) (Figures 7 and 8). Hurricane Andrew produced extreme storm loadings which caused WP1 to collapse. Diver surveys made after the storm indicated WP1 failed by pull out of the piles on the south side of the platform. The seemingly identical WP2 did not collapse; there was no significant damage to this structure. The goal of this study was to determine how the forces developed by hurricane Andrew could have caused the collapse of WP1 and not the collapse of WP2.

The two structures evaluated herein were both located in the South Timbalier area. The two wellhead protectors were designed and installed early in the 1980's by the same firm. The two wellhead protectors were designed according to the same API RP 2A guideline. The slightly older WP1 is located in 52 ft. of water and is oriented 45° counterclockwise from true north. WP2 is located in slightly shallower water (49 ft.) and is oriented parallel to true north. Both structures are two bay, four pile template structures designed to provide limited facilities for 36 in. diameter caisson well risers (Figures 7 and 8). Both protectors have offset braced heliports and boat landings for easy access.

The jacket framing of the two structures is almost identical, with WP2 having slightly smaller diameter jacket legs and piles; 28 and 24 in., as opposed to 30 and 26 in. Diagonal vertical bracing is made up of 18 in. tubulars, while plan bracing is composed of 12.75 in. tubulars on all three levels. All members were fabricated using A36 grade steel.

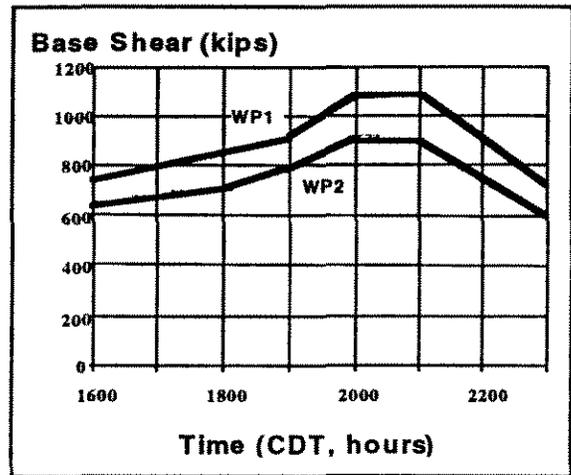
FIGURE 9: TIME HISTORY OF MAXIMUM BASE SHEARS ON WP1 AND WP2 DURING HURRICANE ANDREW

The two structures were loaded only along their principal axes to provide consistency between the various approaches employed to analyze structural response. Wave loads for USFOS were generated by the seastate program WAJAC [DNV 1993] which determines peak loads using phase angle intervals of 1° . The global base shears developed on WP1 and WP2 during the passage of Andrew are summarized in Figure 9. The results indicate WP1 experienced peak lateral loadings that were about 20 % larger than those on WP2. The peak lateral loading on WP1 was 1,100 kips and on WP2 was 850 kips.

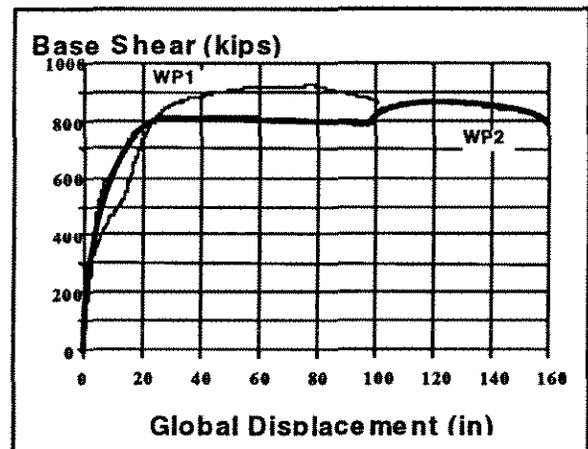
FIGURE 10: LOAD - DISPLACEMENT CHARACTERISTICS FOR WP1 AND WP2

The static push-over results for WP1 and WP2 based on the USFOS results are summarized in Figure 10. The "double humps" found in both analyses result from the increased stiffness of the structures when contact between the jacket and caissons occur. The negative stiffness found at the end of all analyses represents pile pullout. The large lateral deformations produce plastic hinges in the piles which produce a near mechanism. It is the additional strength and rigidity of the caissons which prevents the structures from soft story collapse. This added stiffness allows the full axial capacity of the soils to be exceeded to produce pile pullout. The maximum lateral load capacity of WP1 is 910 kips and WP2 880 kips.

The USFOS result that both structures fail due to pile yielding and pullout was confirmed by results from the StruCad*3D and ULSLEA analyses. The ratio of the peak lateral loading during hurricane Andrew to the maximum lateral loading capacity is 1.2 and 0.95 for WP1 and WP2, respectively. The analyses indicate that WP1 should have failed due to pile pullout and WP2 should have survived. The paradox of why these two seemingly identical structures behaved differently was due to the differences in the appurtenances (well conductors), the manner in which the wells were tied into the structures, and the under-driven piles. The effects of these differences only
