## DRILL STRING SAFETY VALVE TEST PROGRAM

Adam T. Bourgoyne, Jr.  
Elliot D. Coleman  
Thomas T. Core  
*Petroleum Engineering Department  
Louisiana State University  
Baton Rouge, Louisiana 70803-6417*

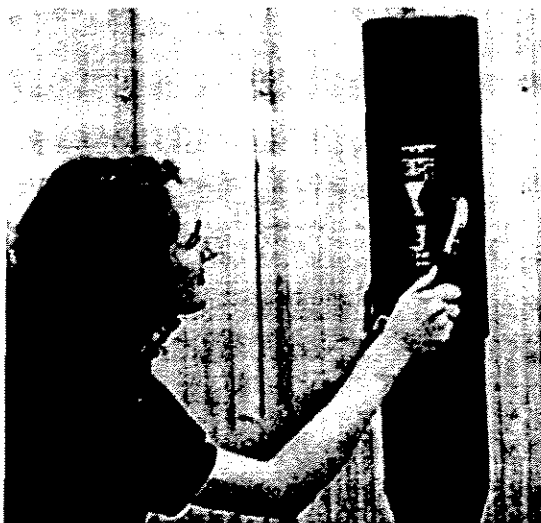
Displayed in Figure 3 is a photograph of a safety valve made-up on top of a section of drillpipe. The valve has been cutaway so that the ball and seats may be observed. This particular safety valve is a one piece valve design that eliminates the need for threads in the valve body area. This not only decreases the number of possible leak paths, but also eliminates the problem of the ball locking due to excessive make-up torque. The basic design remains with a floating ball in a cage which houses the fixed upper and lower seats.

Figure 3: Photograph of a safety valve which has been cutaway and made-up on top of a section of drillpipe.

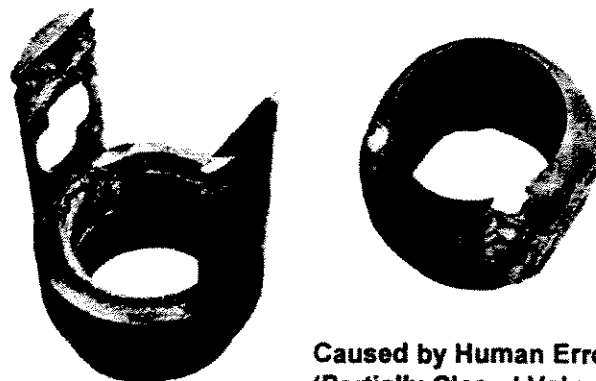
Figure 6: Photograph of ball and seat that has been eroded by mud flowing through a partially closed lower kelly valve.

Shown in **Figure 6** is a photograph of a ball and seat that has been eroded by mud flowing through a partially closed lower kelly valve. The valve was erroneously left in this position during drilling operations and would not seal during a well control event.

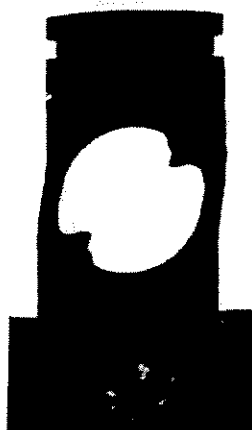
**Figure 10:** Ball cage deformed around stem opening by excessive torque.

**Figure 10** shows a valve component that has been subject to excessive torque, which caused permanent deformation in the ball cage and valve stem stops. The resulting deformation allowed over rotation of the ball which caused seal erosion (shown in **Figure 11**) and metal to metal contact between the ball cage and the valve stem. This contact is apparent from the wear shown in **Figure 12** on the valve stem.

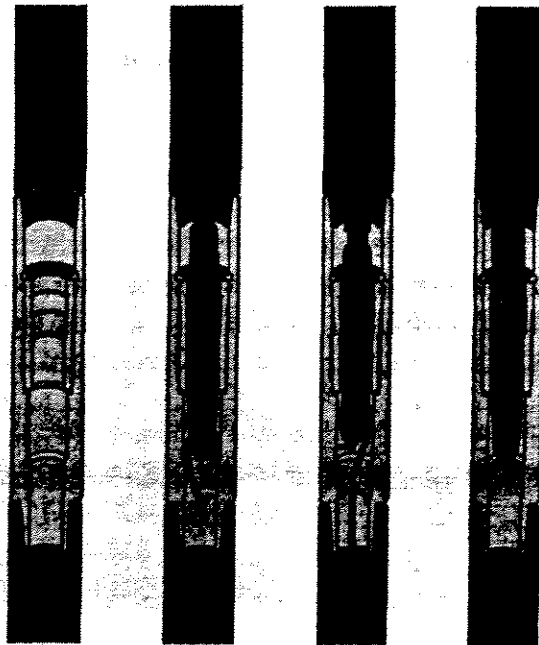
The drop-in check valve overcomes many of the objections to a float in the drill collars. **Figure 13** is a schematic of a drop-in check valve. A sub that will accept a check valve is run in the drill string near bottom. Just before it becomes necessary to pull the drill string from the well, the check valve assembly is dropped into an open drillpipe connection and pumped to bottom where it latches into the sub. If the well tries to blowout during tripping operations, the check valve will stop the flow and make it easy to stab and close the

**Figure 13:** Schematic of a drop-in check valve.

surface safety valve as part of the shut-in procedure. In the event wireline work below the check valve becomes necessary, the drop-in check valve is wireline retrievable.
