Structural Integrity Assessment of Corrosion-Damaged Offshore Tubular Braces Subjected to Inelastic Cyclic Loading

**Duncan Paterson
James M. Ricles**

**ATLSS Report No. 01-09
May, 2001**

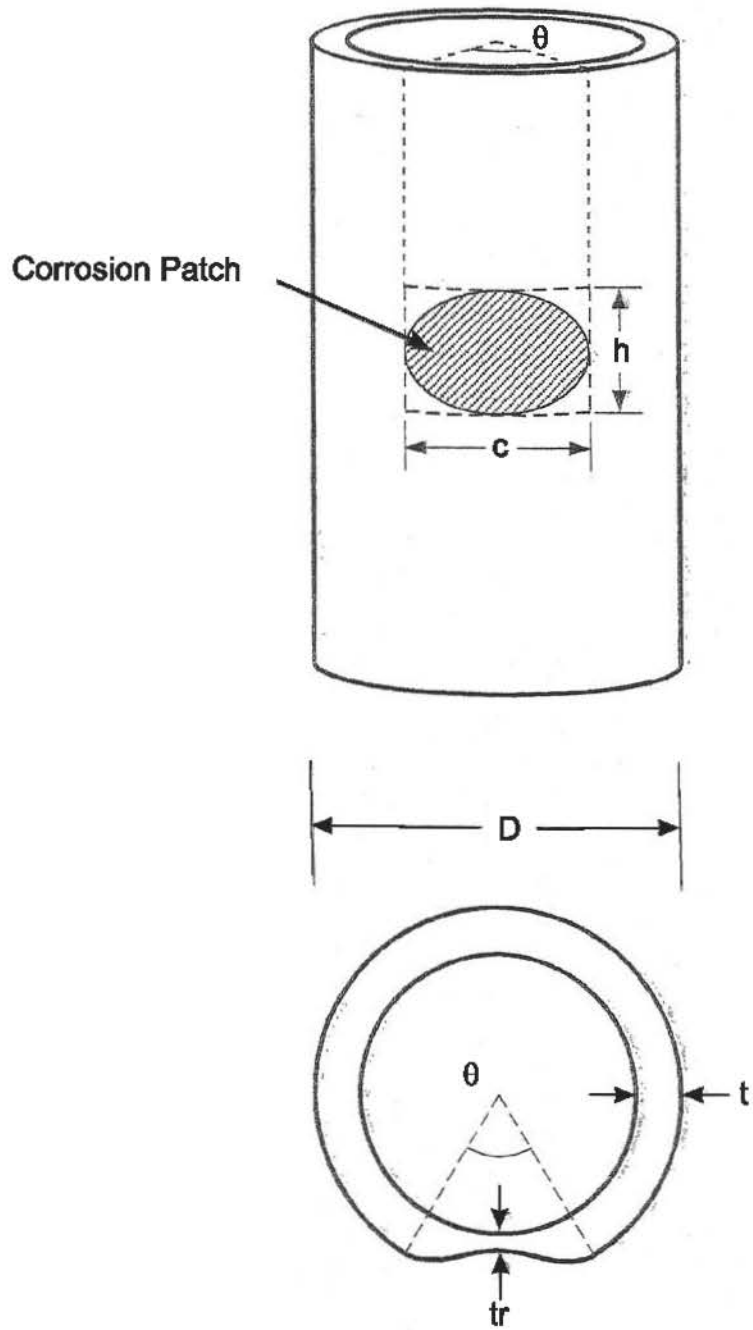
Figure 3.2 Patch Corrosion Parameters (Hebor and Ricles 1994)

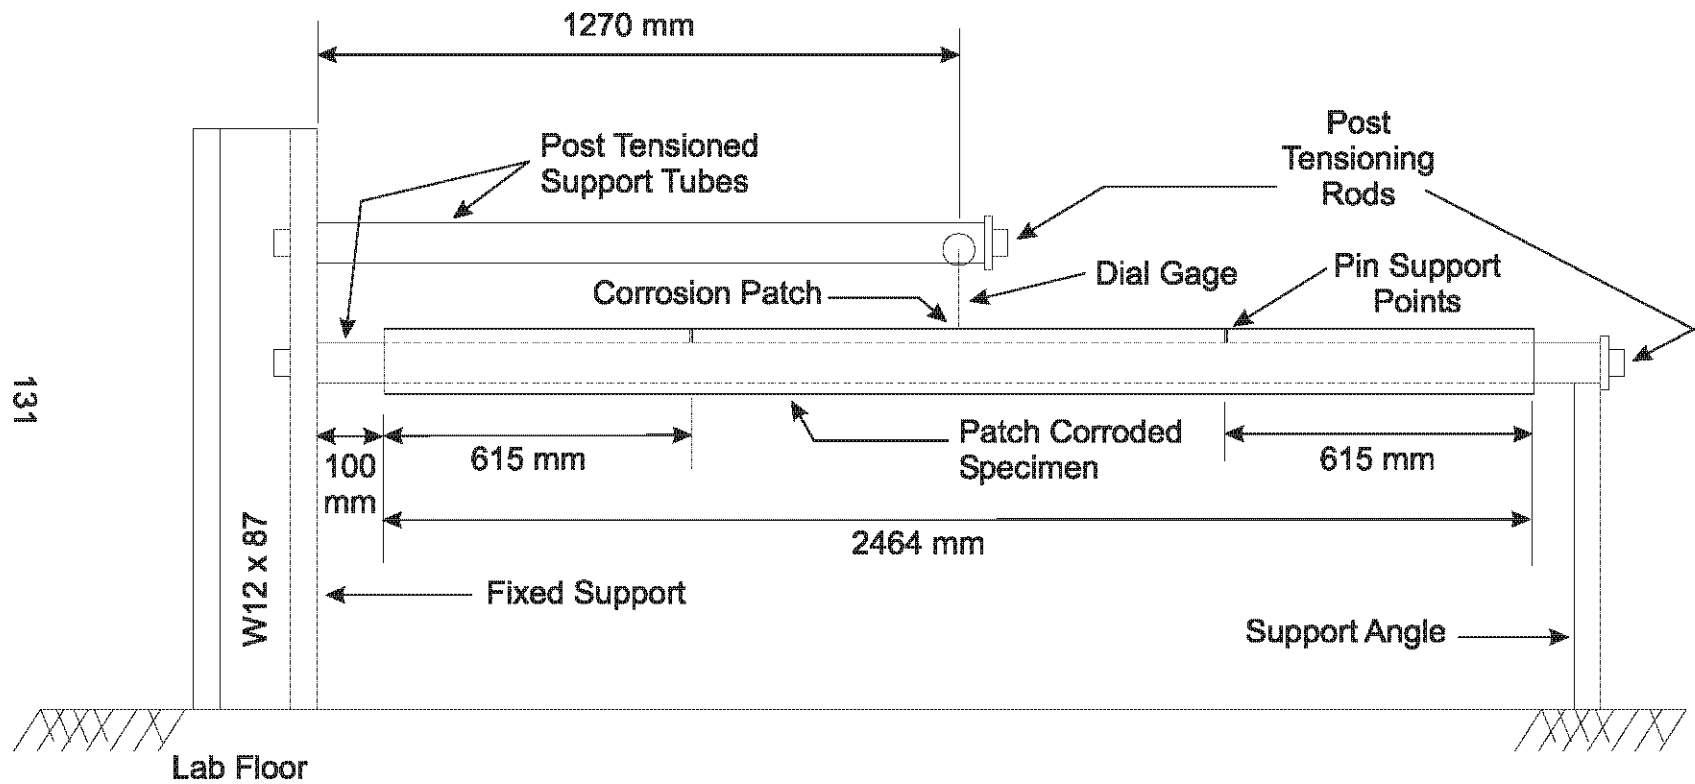
Figure 4.3 Setup for Measuring Corrosion Patch

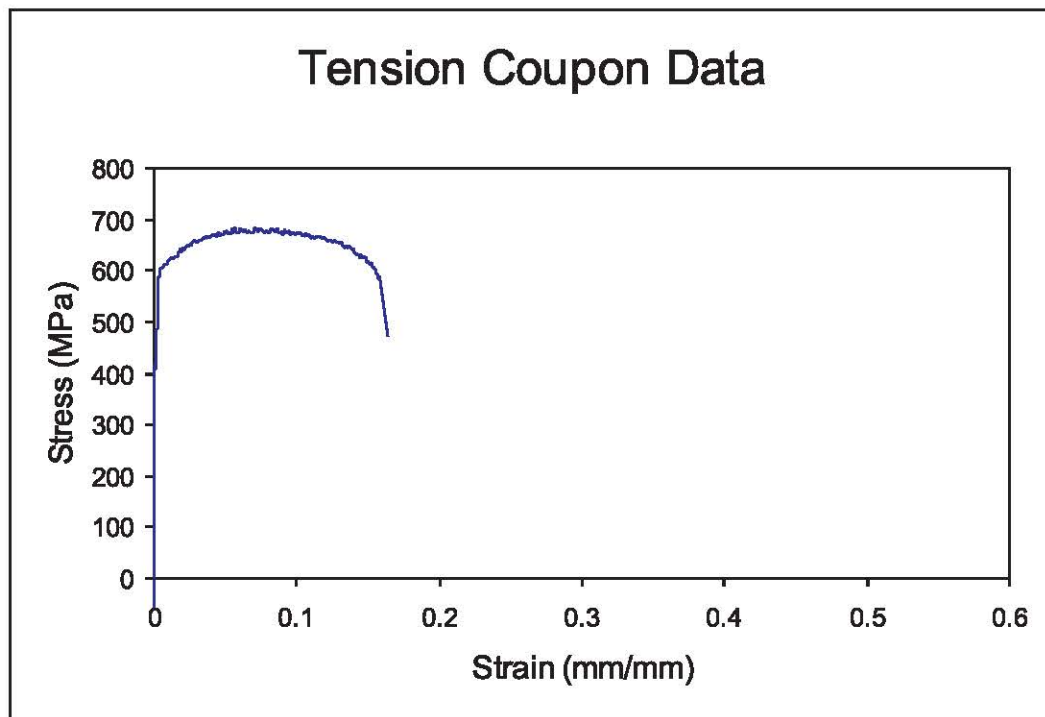
Figure 4.25 Stress-Strain Plot for Steel Repair Sleeve

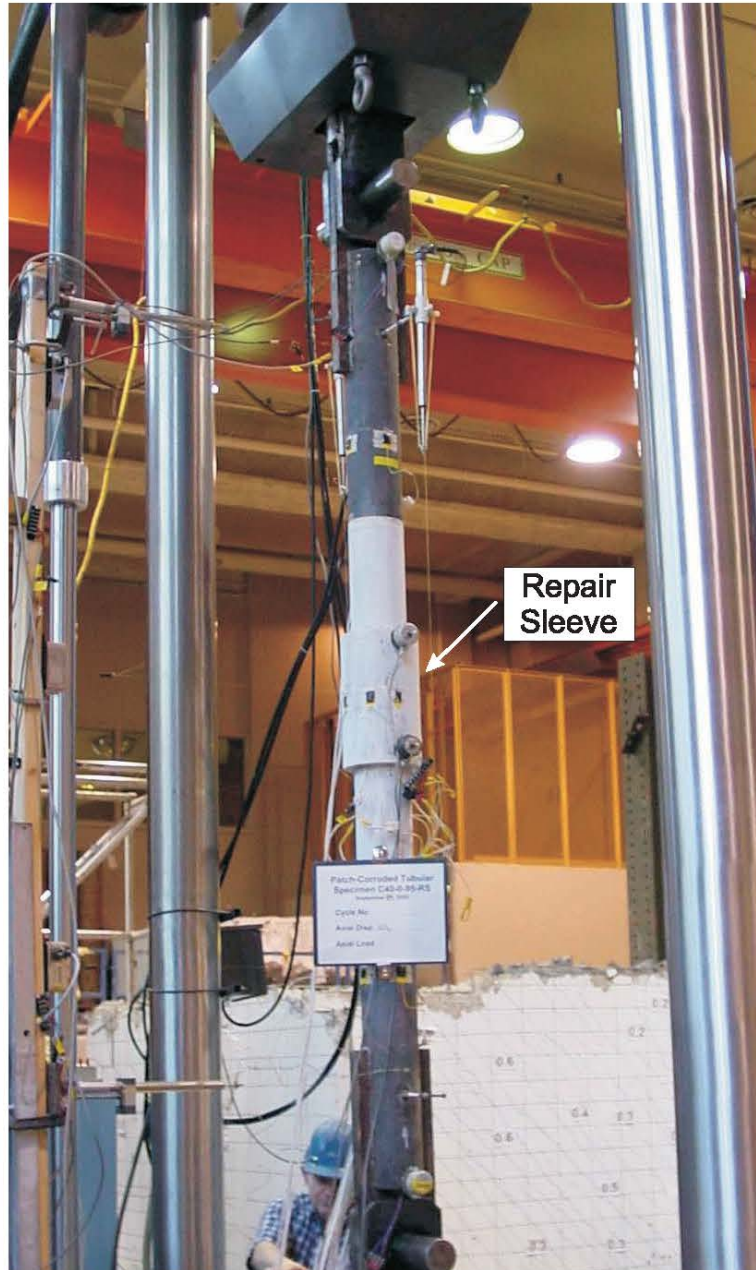
Figure 4.29 Typical Repaired Specimen

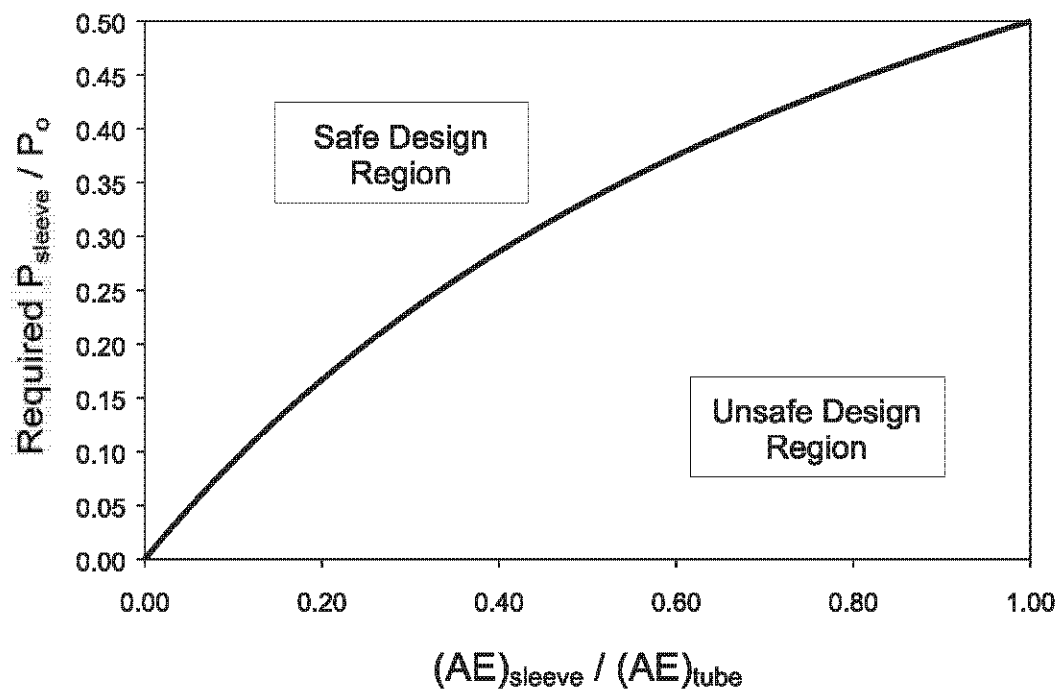
Figure 4.30 Graphical Representation of Sleeve Design Equation

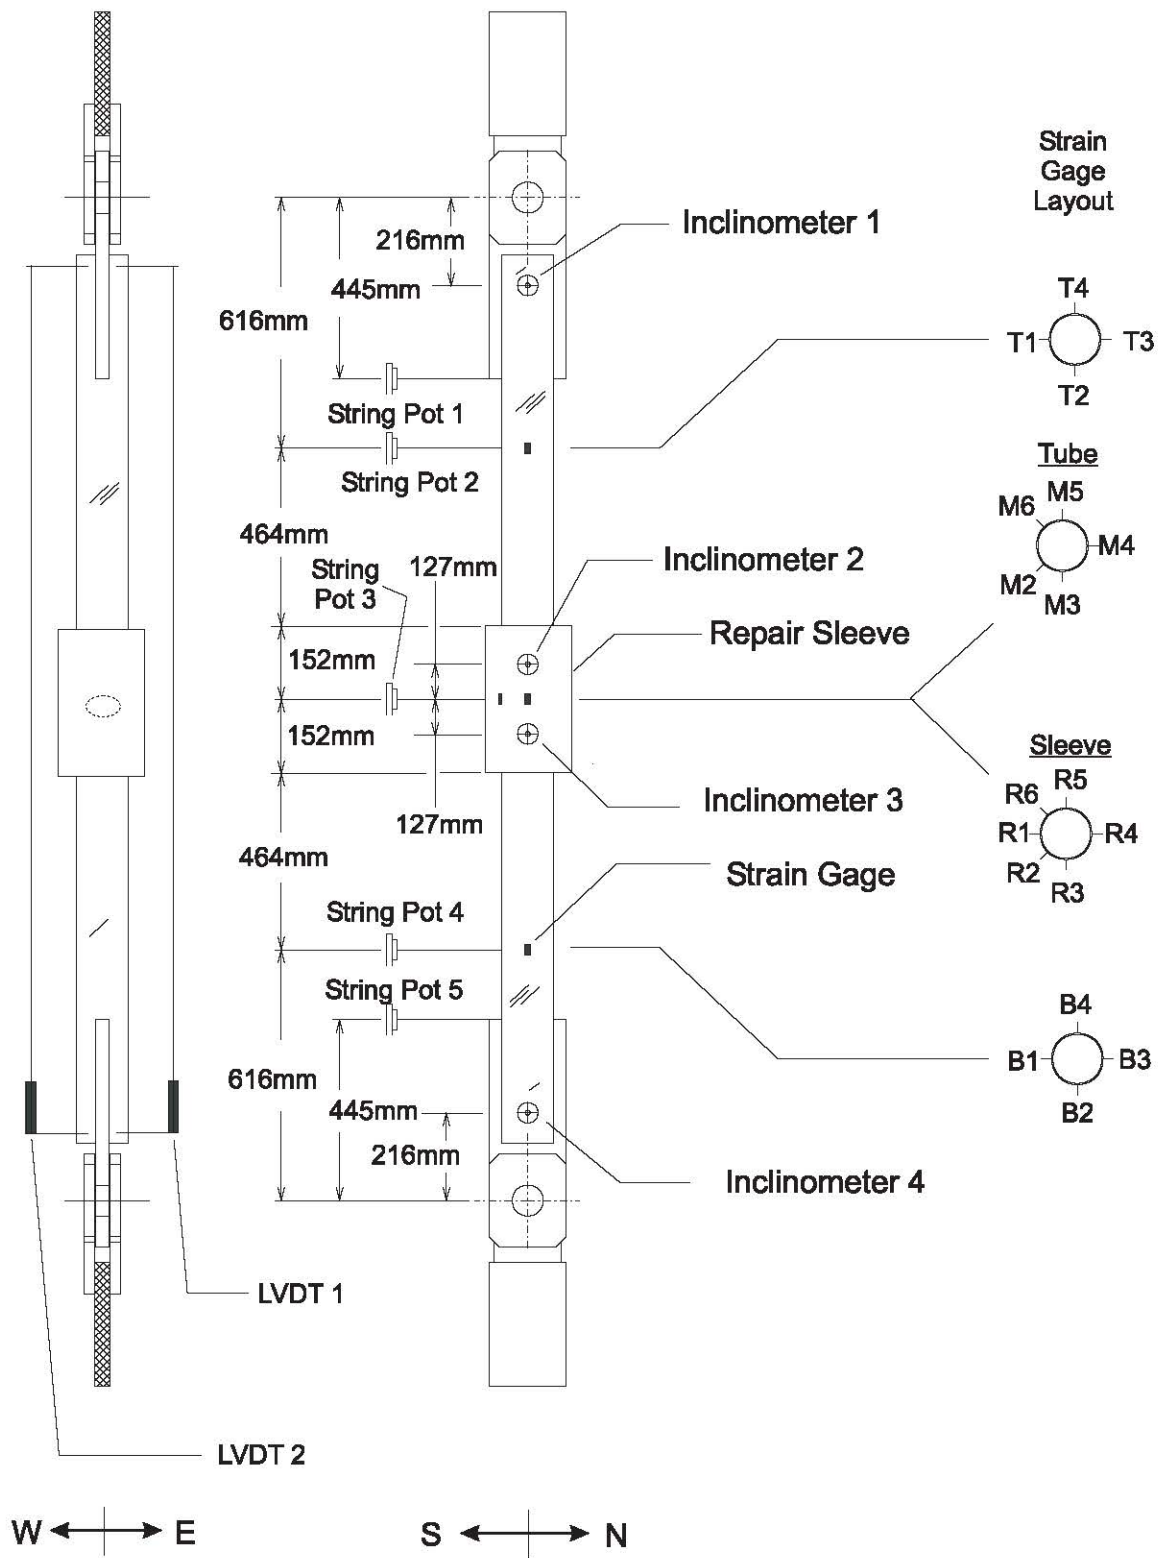
Figure 4.36 Adjusted Instrumentation for Repaired Specimens

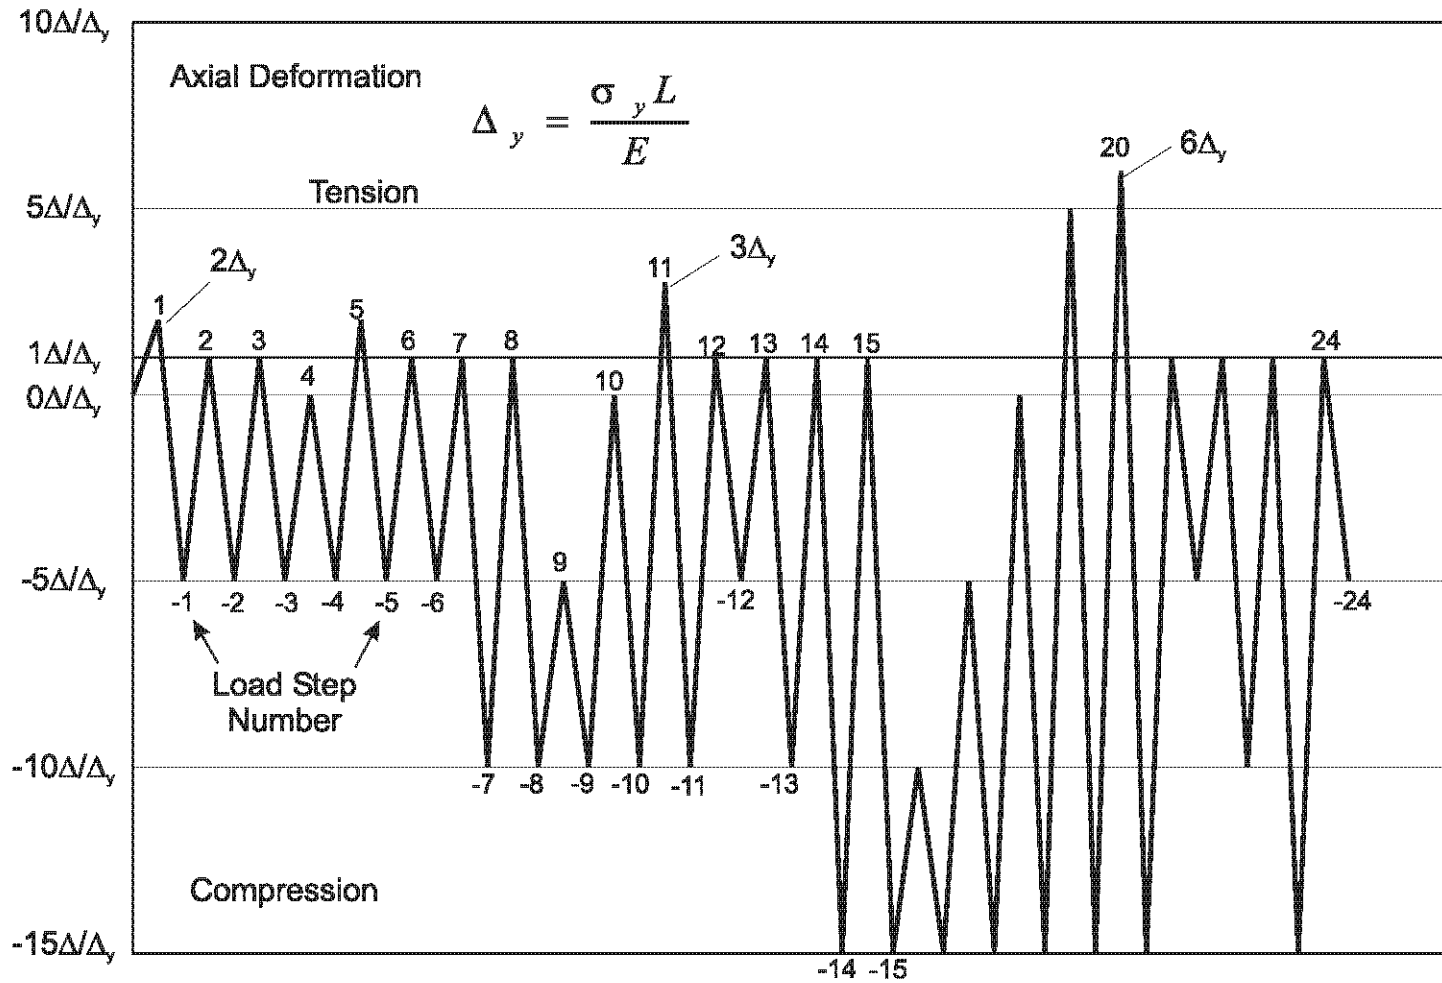
Figure 4.37 Load History

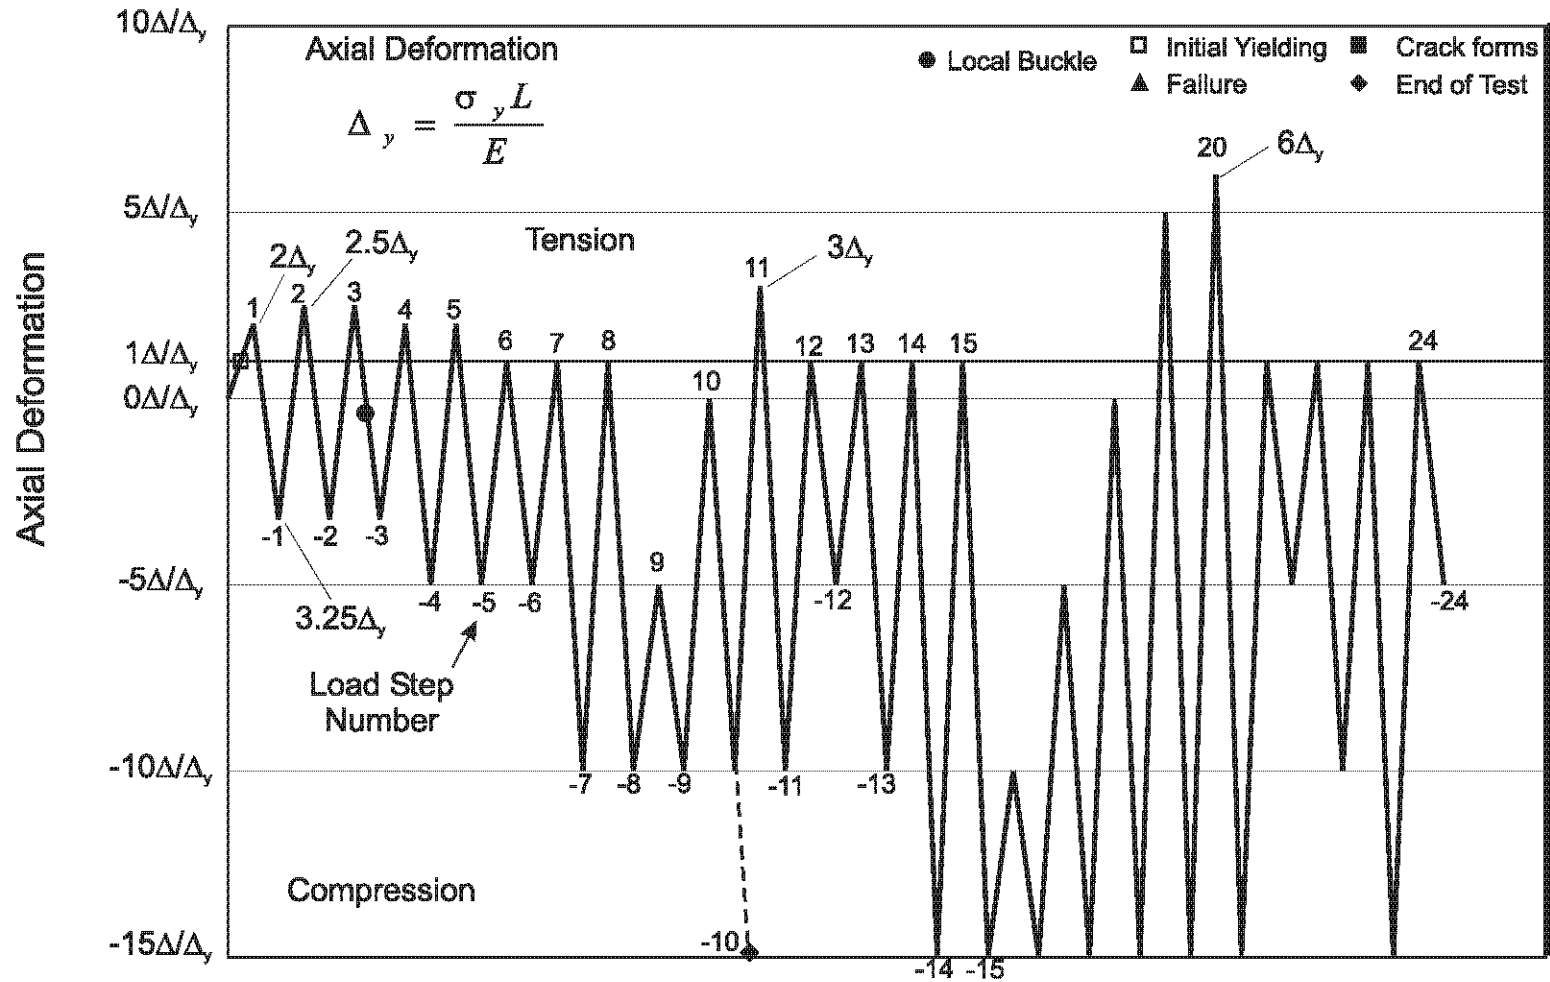
Figure 5.14 Displacement History with Events of Interest Noted,
Specimen C27-100-0

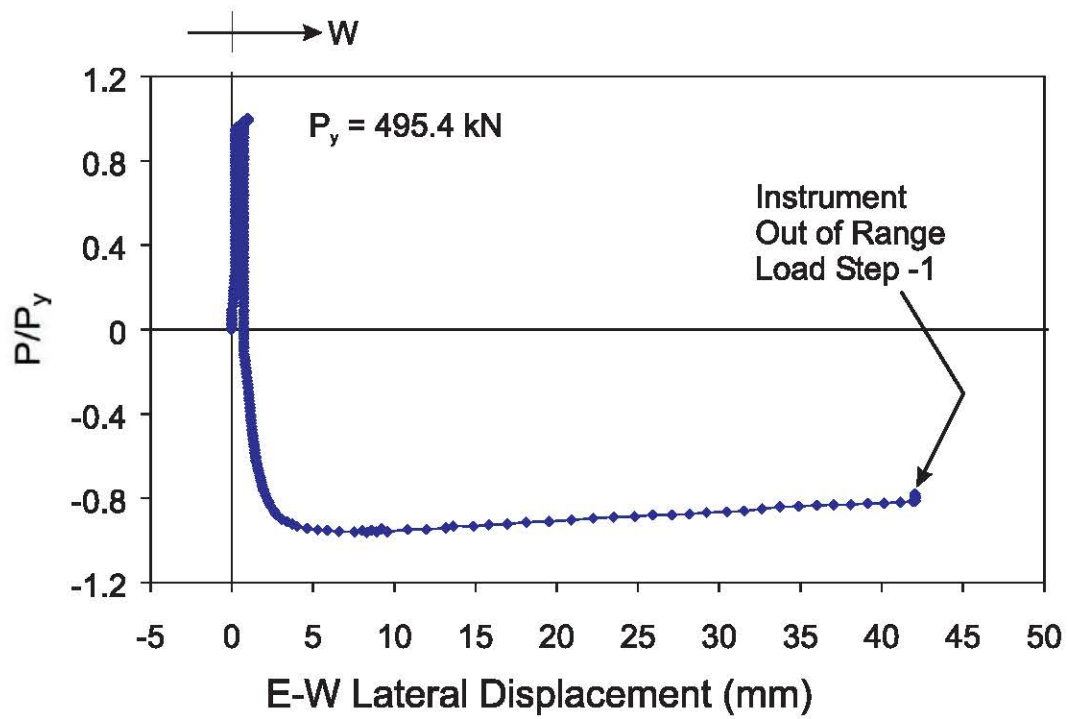
Figure 5.15 Measured Lateral displacement in the East-West Direction, Specimen C27-100-0

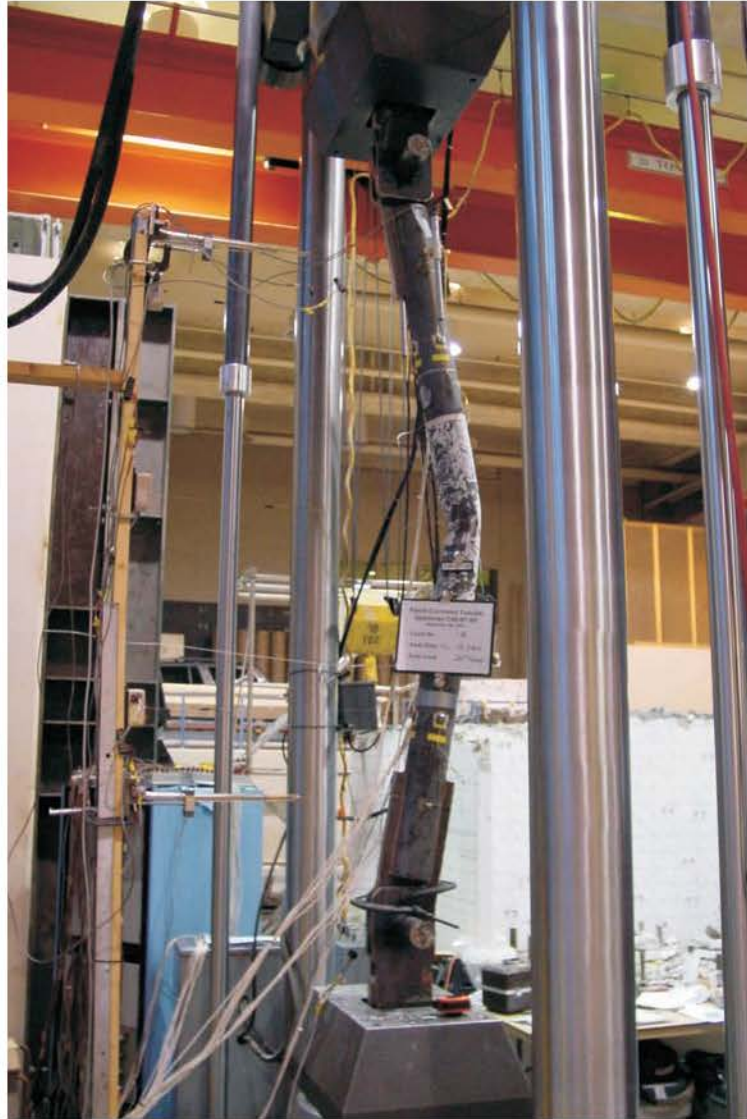
Figure 5.44 Final State of Specimen C40-67-95

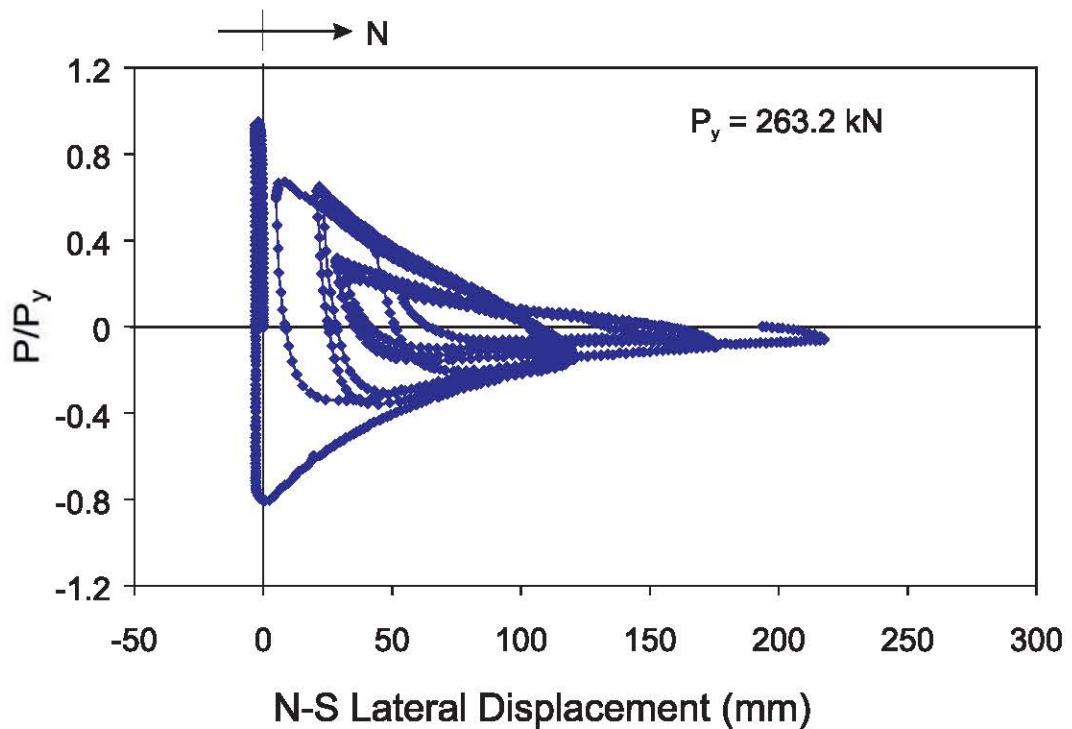
Figure 5.53 Measured Lateral Displacement in the North-South Direction, Specimen C40-33-95

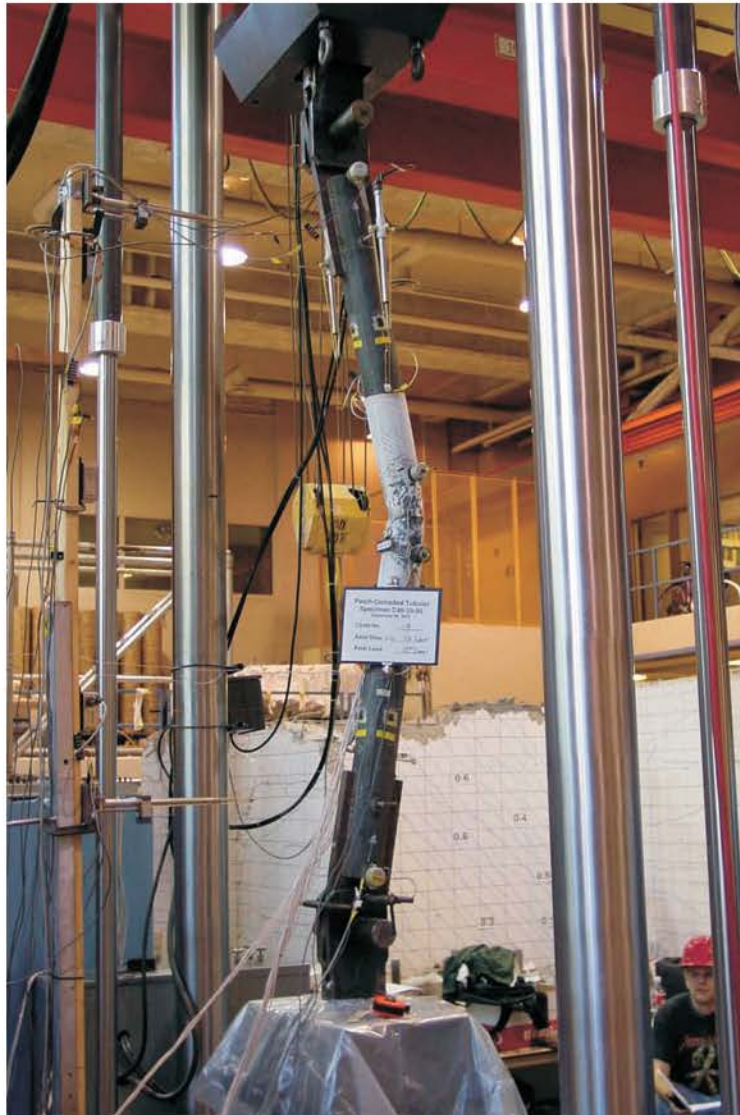
Figure 5.56 Final State of Specimen C40-33-95

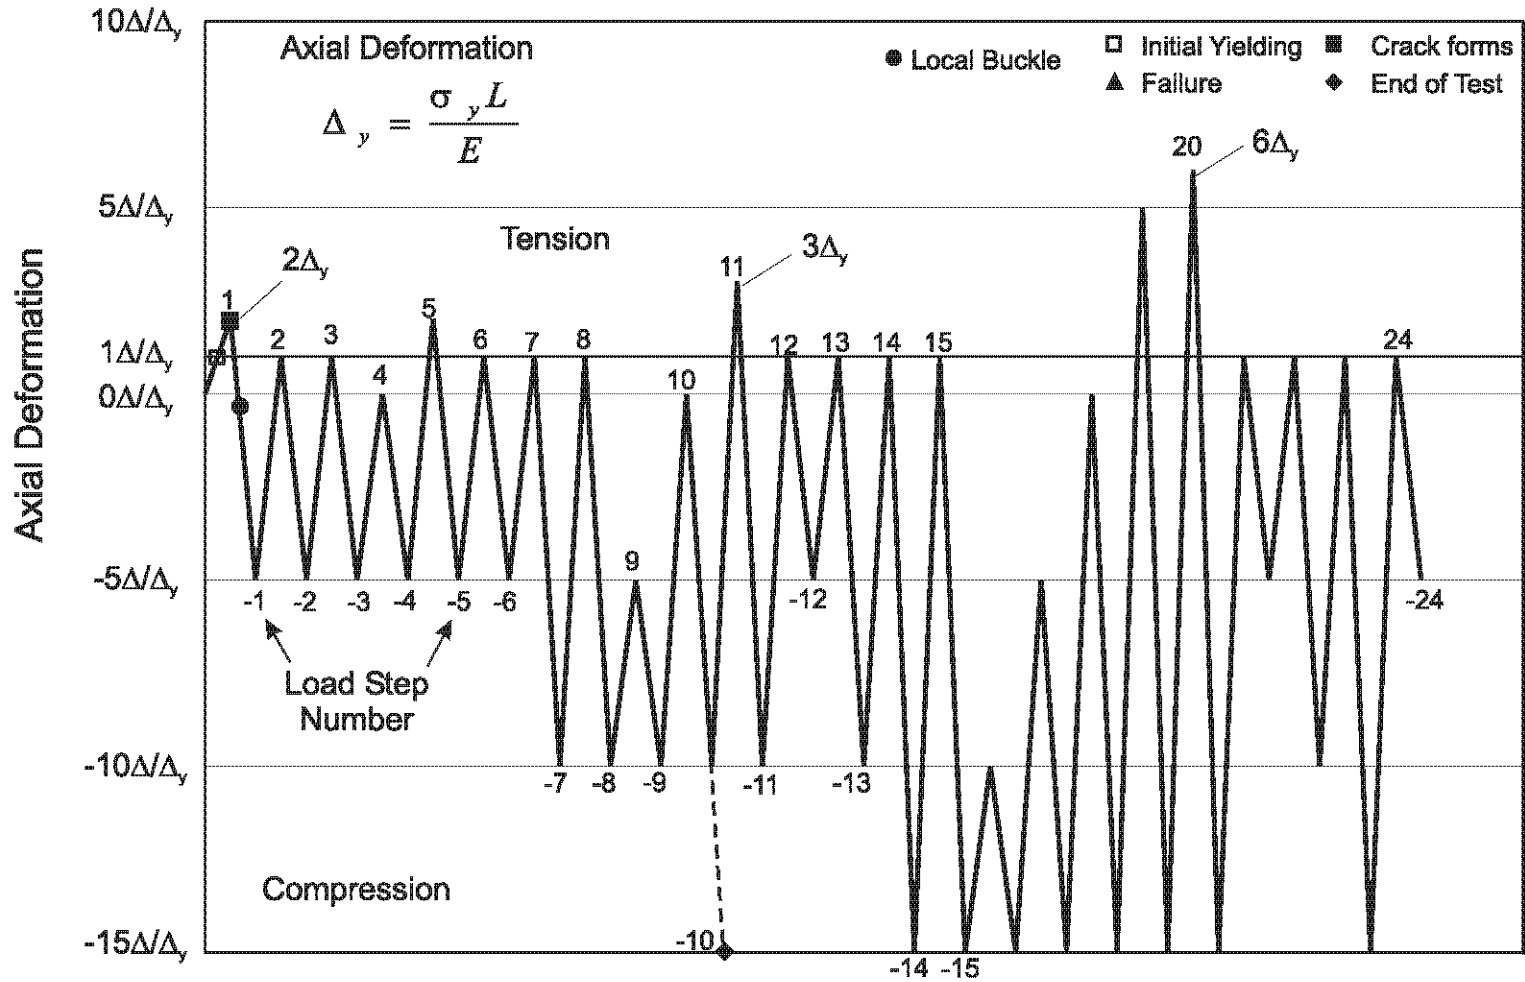
Figure 5.61 Displacement History with Events of Interest Noted, Specimen C40-00-95

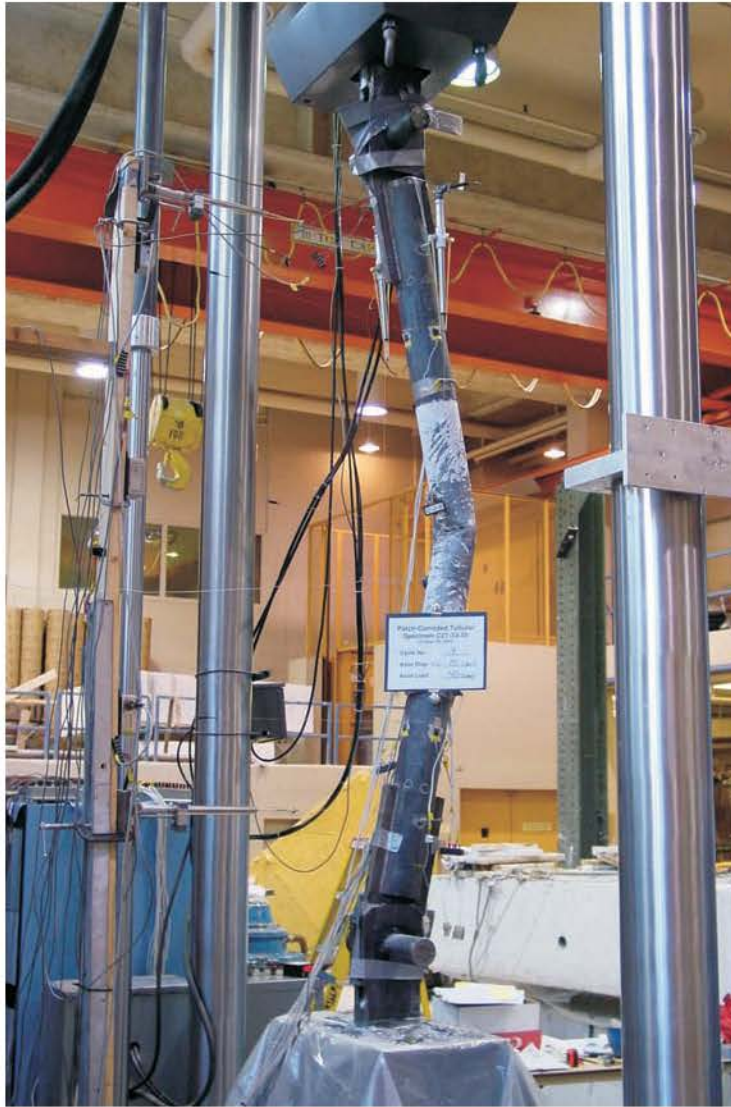
Figure 5.77 Final State of Specimen C27-33-58

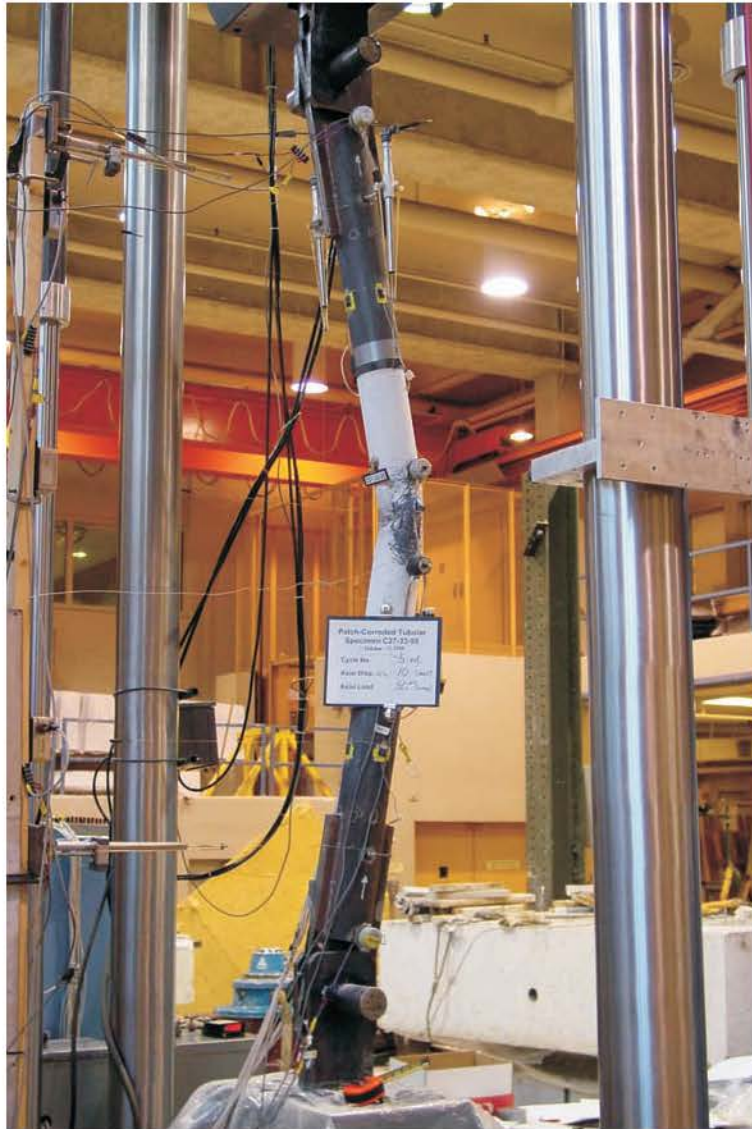
Figure 5.88 Final State of Specimen C27-33-95

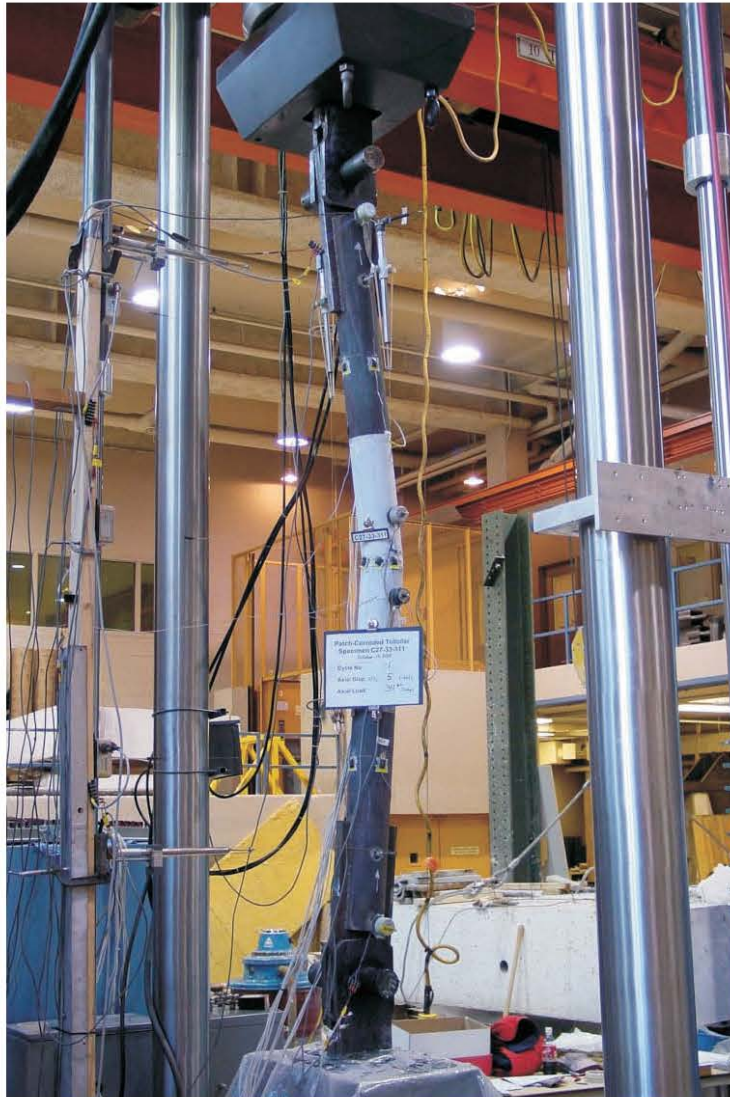
Figure 5.95 Final State of Specimen C27-33-311

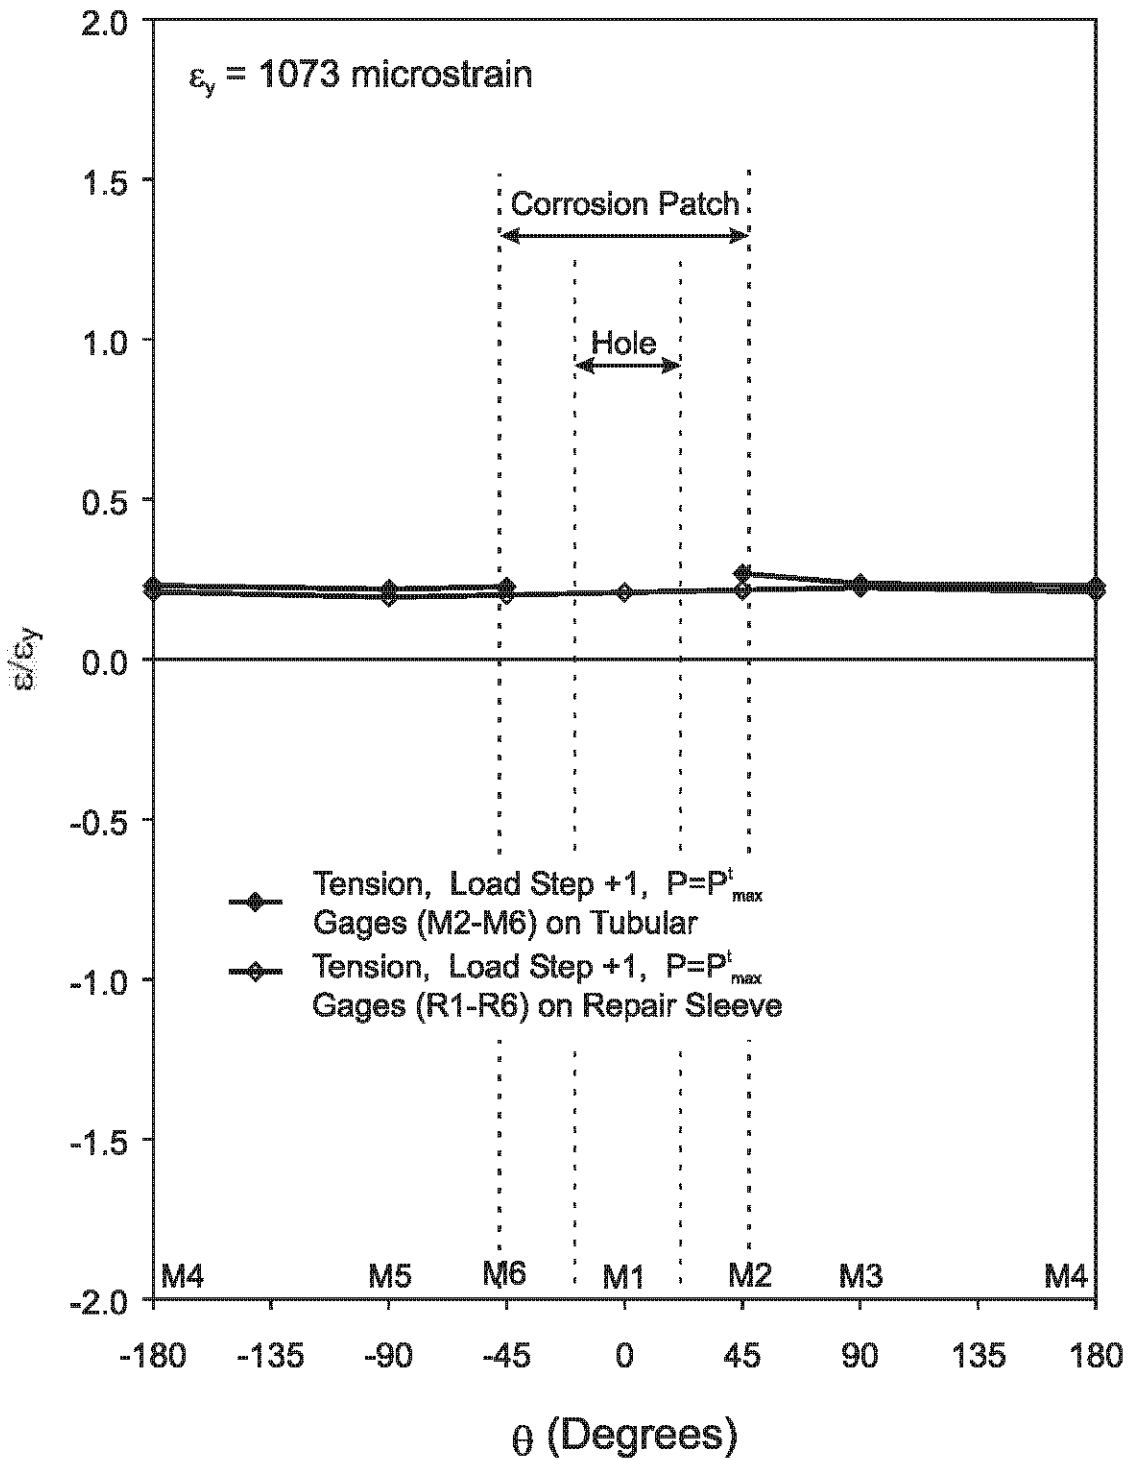
Figure 5.105 Strain Distribution of Cross Section at Mid-height on Tubular and Repair Sleeve at Peak Tension Load (P_{max}^i), Specimen C40-00-95-RS

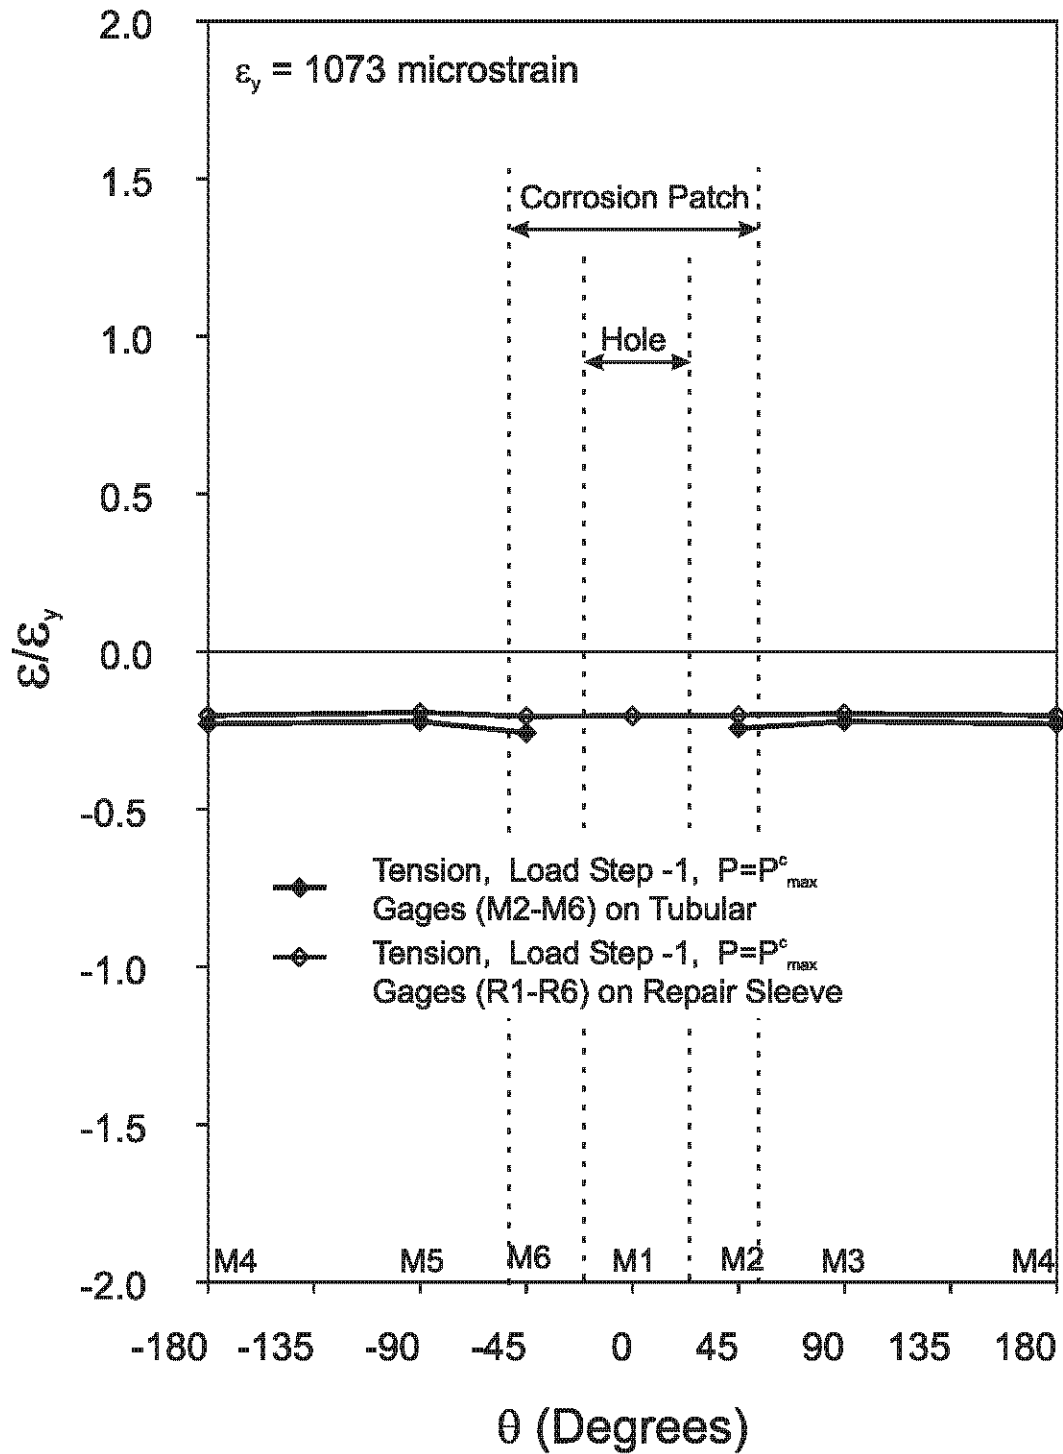
Figure 5.106 Strain Distribution of Cross Section at Mid-height on Tubular and Repair Sleeve at Peak Compression Load (P_{max}^c), Specimen C40-00-95-RS

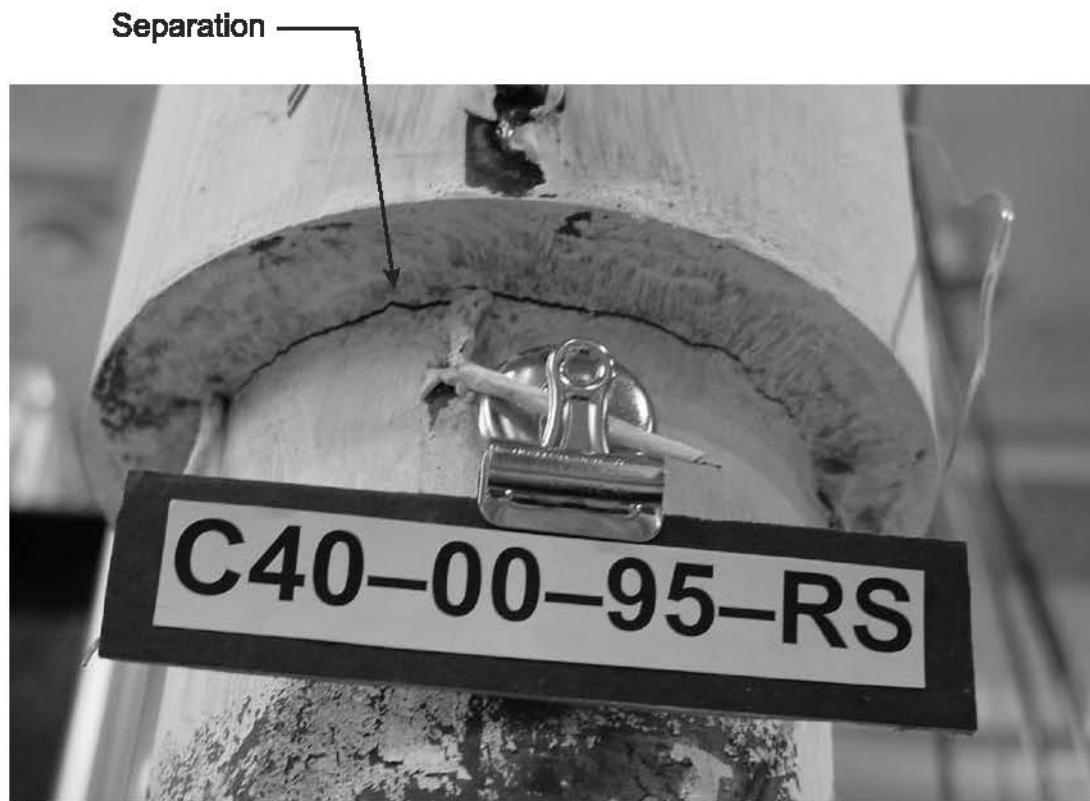
Figure 5.109 View of Top End of Sleeve Repair after Testing,
Specimen C40-00-95-RS

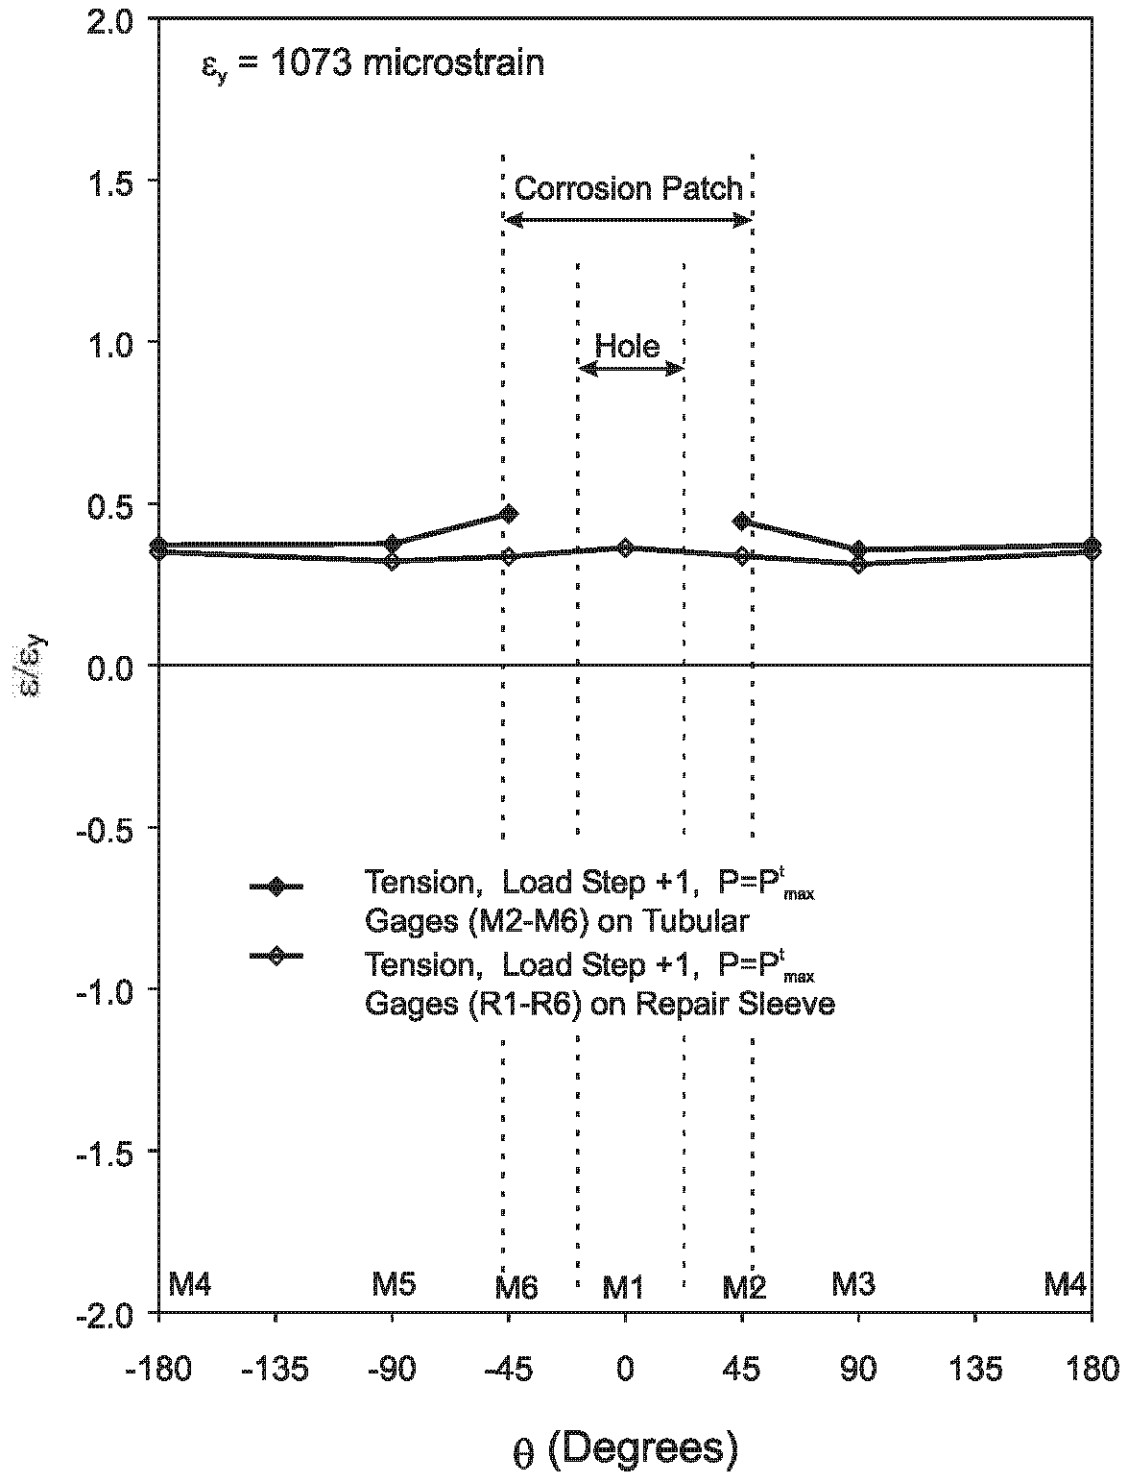
Figure 5.116 Strain Distribution of Cross Section at Mid-height on Tubular and Repair Sleeve at Peak Tension Load (P_{max}^t), Specimen C40-00-95-RC
