Structural Integrity Assessment of Corrosion-Damaged Offshore Tubular Braces Subjected to Inelastic Cyclic Loading

**Duncan Paterson
James M. Ricles**

**ATLSS Report No. 01-09
May, 2001**

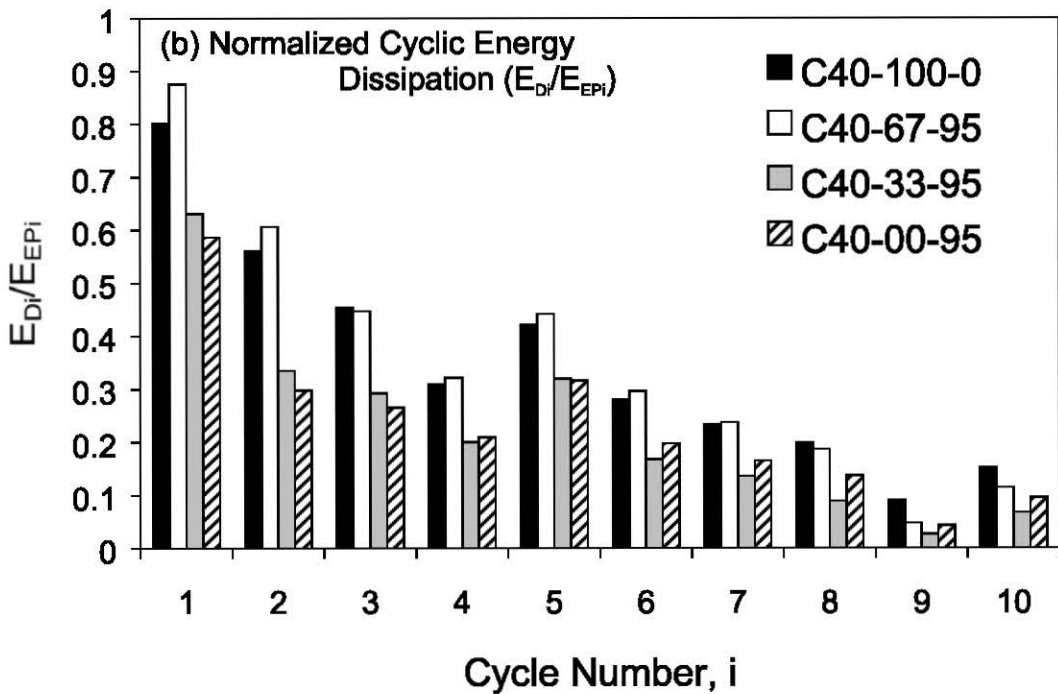
Figure 6.11 Effect of Reduced Thickness (t_r) on Deterioration of Energy Dissipation per Cycle

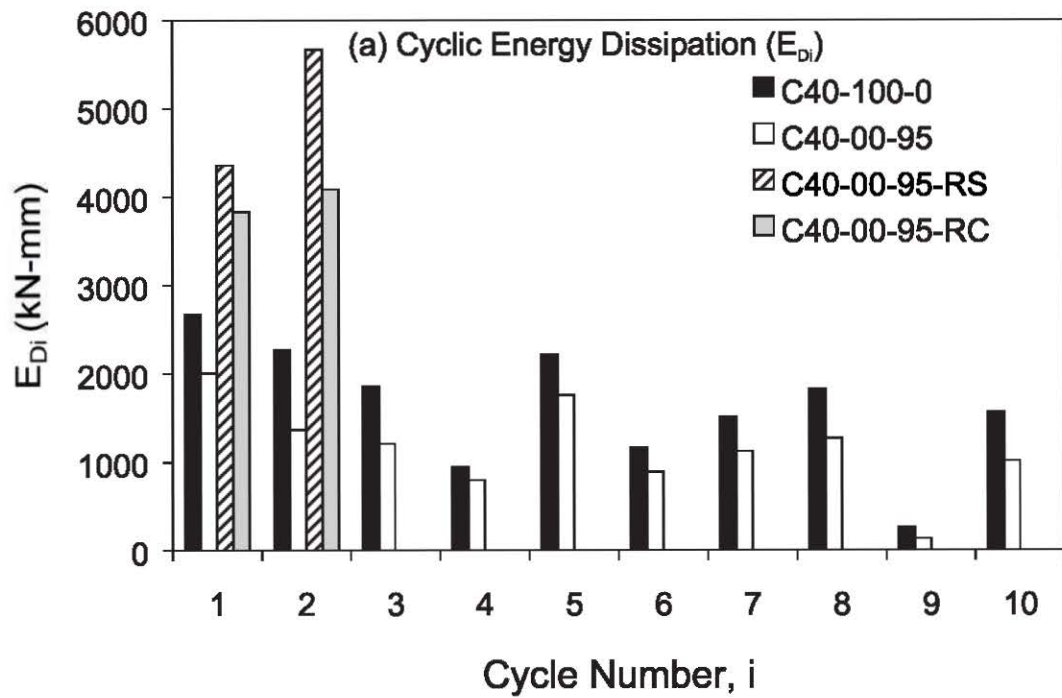
Figure 6.43 Effect of Repair on Energy Dissipation
