Case Study of Emergency Disconnect Sequence in the Gulf of Mexico

Trent Fleece

Subsea BOP Operations Team Lead

May 8, 2015

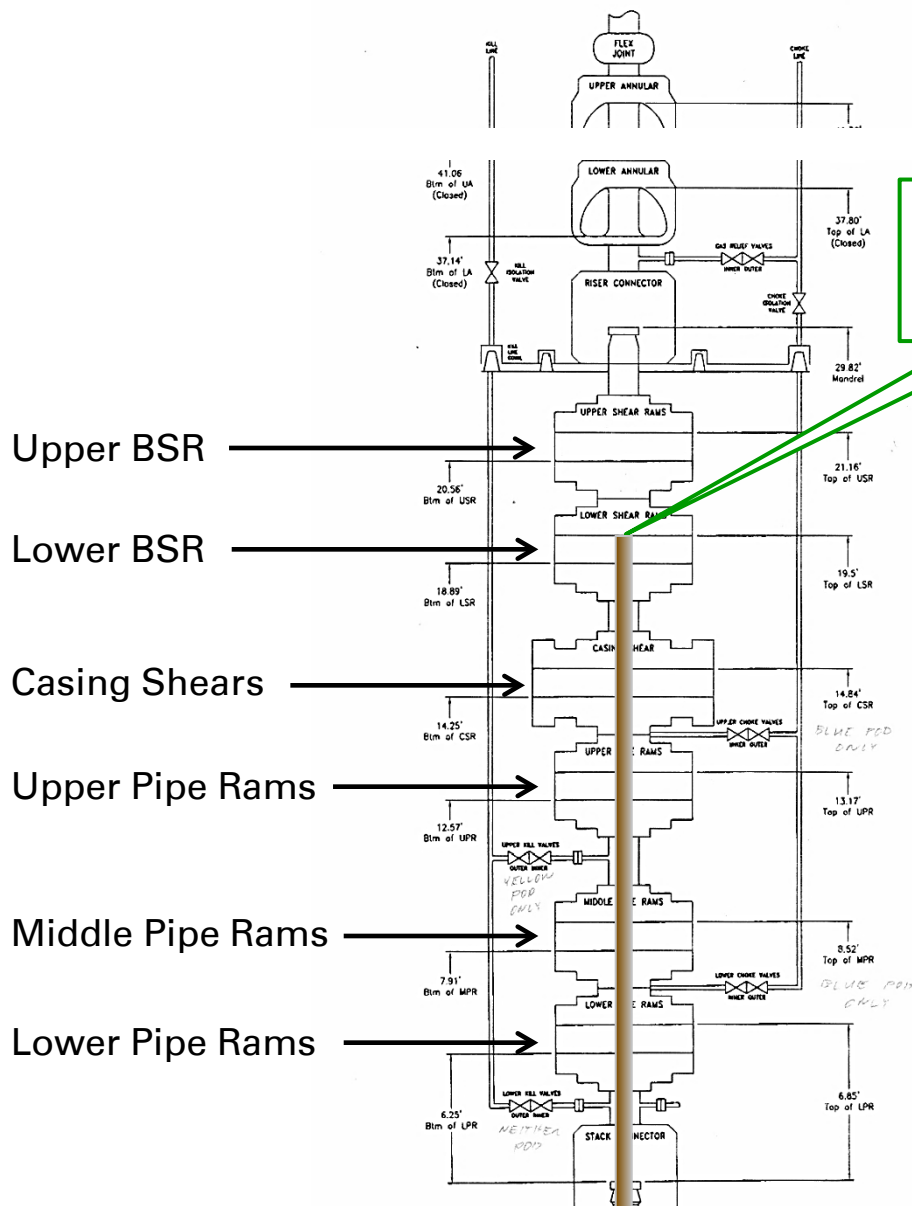
Well Status

6-5/8" 27.7# drill pipe cut at lower blind shear rams

Upper BSR

Lower BSR

Casing Shears

Upper Pipe Rams

Middle Pipe Rams

Lower Pipe Rams

- EDS Sequence – Casing shear closed, LBSR closed, LMRP disconnects

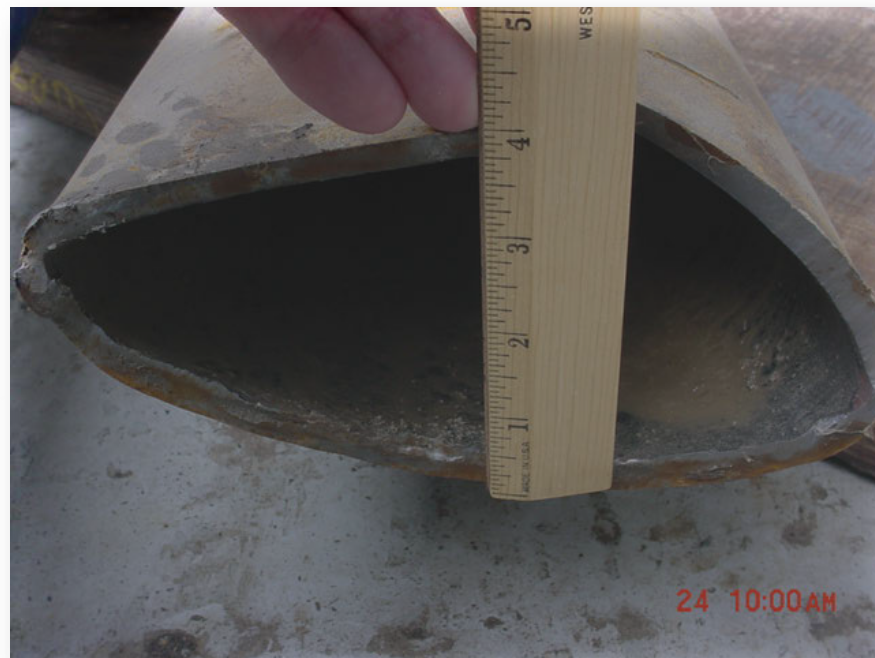
Picture of sheared 6-5/8" drill pipe pulled to the surface

- Pull bottom hole assembly (BHA) into shoe; hang off; begin seawater displacement of riser
- Environmental loads continue to increase: yellow alert declared per rig contractor policy; 6-5/8" 27.7 ppf drill pipe is sheared on lower blind shear ram (LBSR)
