TEST AND EVALUATION OF A NEW AND UNIQUE
FIRE CONTAINMENT BOOM

Alan A. Allen
Spiltec
Anchorage, Alaska

E.M. Fischer
3M
St. Paul, Minnesota

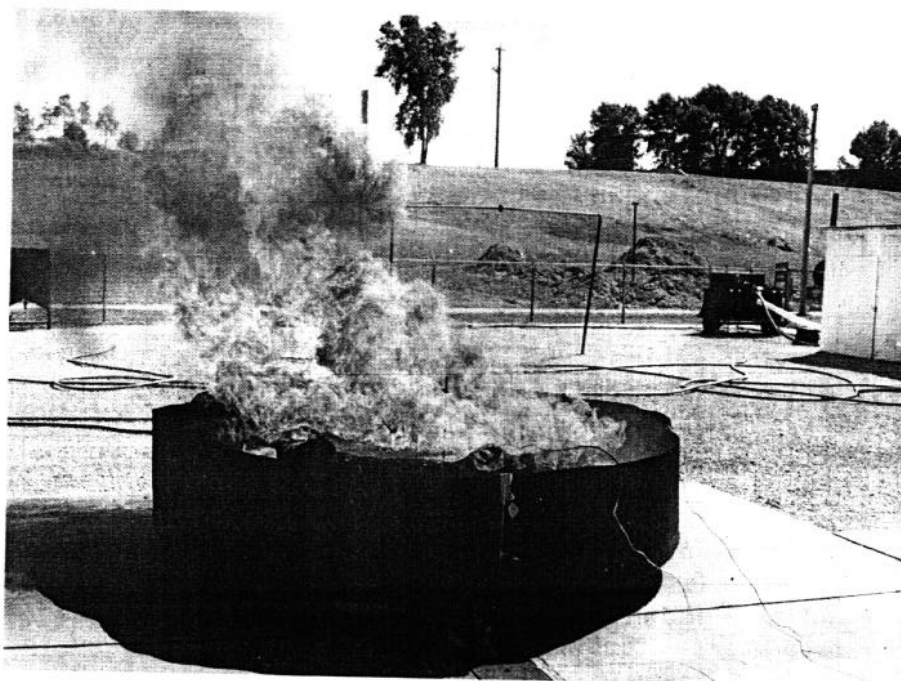
FIGURE 3 FIRE BOOM AFTER IGNITION OF HEPTANE IN 6-HOUR BURN TEST

components revealed no sign of thermal stress, and lab testing of the fabrics showed very little loss of original strengths.

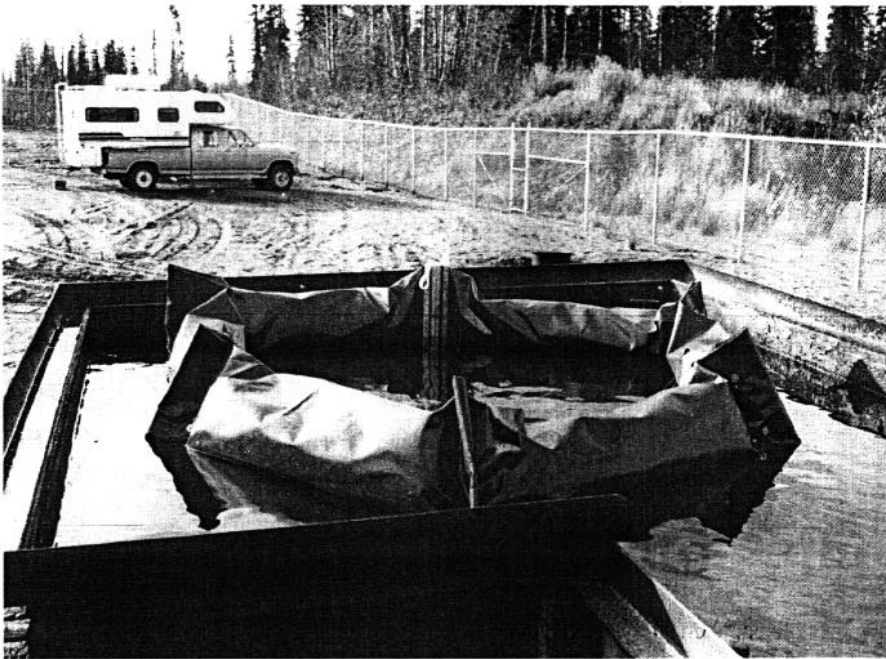
FIGURE 5 FIRE BOOM IN POSITION PRIOR TO IGNITION OF CRUDE OIL

Test Procedures: The 3M Fire Boom used during this test had a flotation diameter of 10 inches (25.4 centimeters) and a total length of approximately 24 feet (7.3 meters). The boom was closed into a hexagonal shape within the 10-foot (3-meter) square portion of the test tank (Figure 5). The sacrificial layer used during this test was made of Urethane (23 ounces per square yard, or 780 grams per square meter); however, a second test was conducted later in the week using a PVC layer of the same weight. The tests included both materials in response to requests from potential Fire Boom users regarding their own preferences for an outer covering.

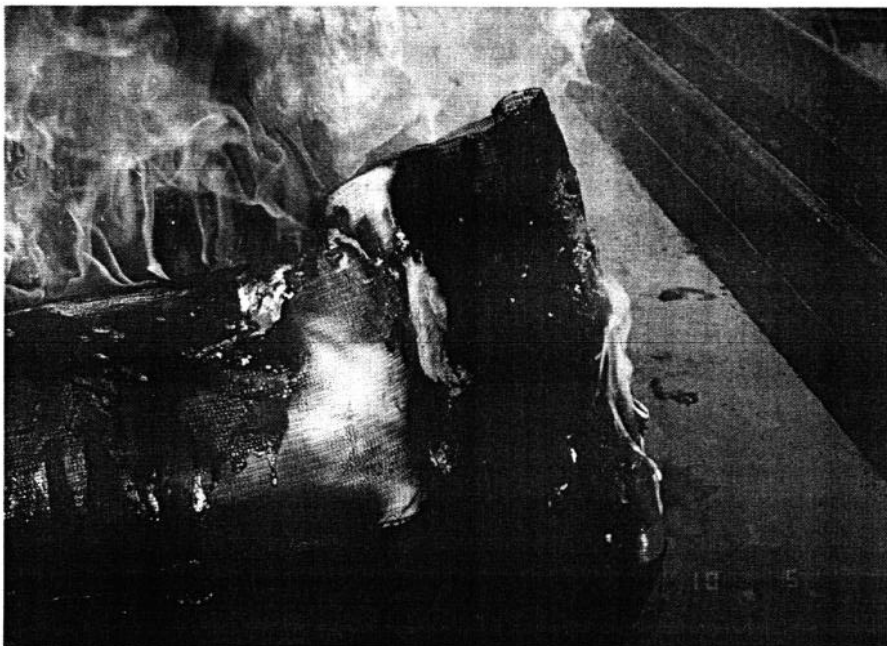
FIGURE 7 CLOSEUP VIEW OF THE FIRE BOOM AS THE LAST PORTION OF THE SACRIFICIAL LAYER IS BURNED OFF

Burn Test Results: Figure 6 shows the nature of the fire approximately one minute following ignition. Much of the outer, sacrificial (Urethane) layer is still in place on the side of the boom facing away from the fire. In Figure 7, several minutes later, the last portion of the sacrificial layer can be seen burning down to the water line.

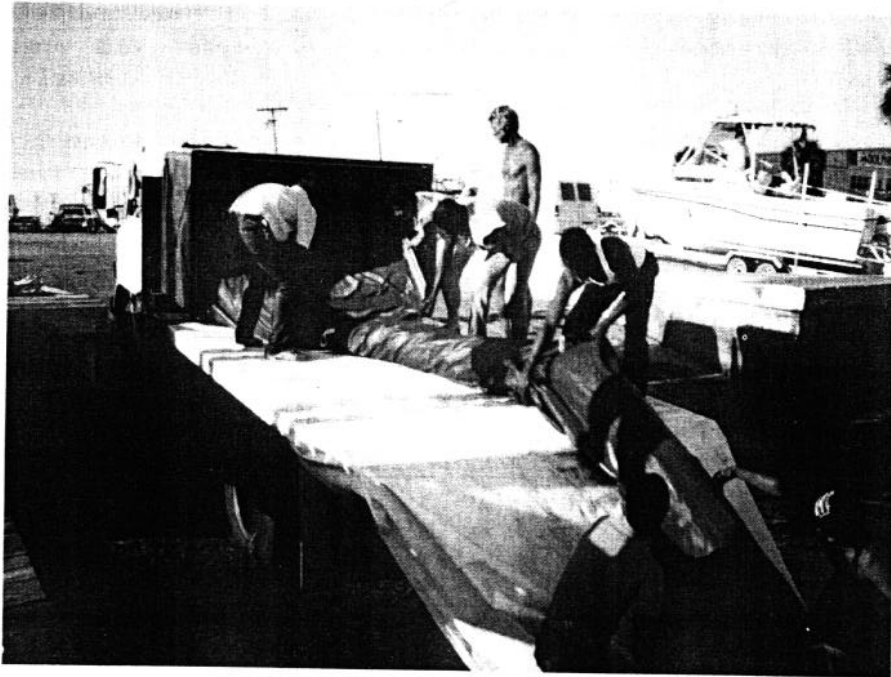
FIGURE 9 WORKERS DEPLOYING FIRE BOOM FROM FLATBED TRUCK INTO THE HARBOR

Six workers and a single tow boat easily completed the deployment of 500 feet (152 meters) of Fire Boom from the storage containers and flatbed truck

(Figure 9). The entire length was deployed within 5 minutes, including the time required to complete the attachment of several connectors.
