# SAFETY BULLETIN

Safety Bulletin No. XXX  
10 November 2016

## Electrostatic Heater Treater Explosion with Resulting Fatality

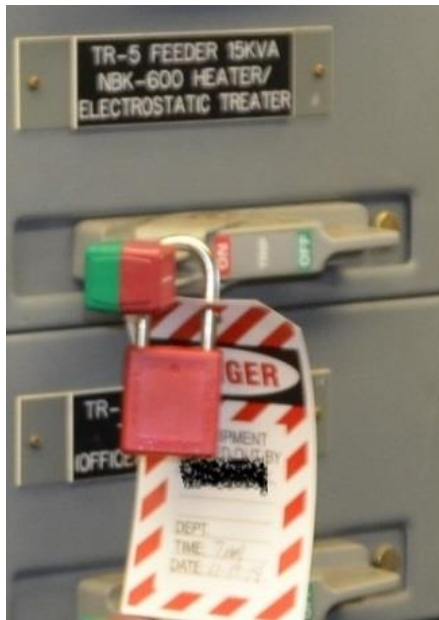
An explosion occurred offshore in the U.S. Gulf of Mexico while a contracted cleaning crew was cleaning an electrostatic heater treater. The explosion resulted in the death of the supervisor of the cleaning crew and injured three others in the vicinity of the vessel.

A BSEE investigation found that the partially drained heater treater had not been effectively ventilated to remove flammable vapors. When the manway hatch was opened, introducing outside air, the mixture of flammable vapors and oxygen created an environment inside the vessel where an ignition source could trigger an explosion.

BSEE determined that a potential ignition source was not mitigated during the preparation for cleaning of the heater treater. During the initial onsite investigation, BSEE investigators observed that the circuit breaker in the Motor Control Center that regulated the electrical energy to the heater treater transformer and coalescing section of the vessel had been clasped with a lock and tagged for energy isolation, but it was in the “On” position and was not de-energized or isolated.

A BSEE Panel investigation identified other factors that may have caused or contributed to the incident. These included the following: inadequate verification of isolation, lack of effective ventilation, and the absence of an automatic function to remove energy from the electrical components when the fluid level in the coalescing section of the vessel dropped below and exposed those components.

- Ensure that pre-job isolations and verification of isolations are completed for all available isolation locations and by at least one authorized and qualified electrician or technician with knowledge of how to perform isolation on the equipment, using group lockout/tagout when appropriate. Ensure and document that employees working with this equipment, i.e., “affected employees”, also verify that the isolations are completed.
- After product removal (without opening manways or hatches), use approved and appropriate ventilation methods to safely displace or dilute potentially hazardous

residual liquids, gas and vapors in the tank or vessel. Have a qualified person test and document the applicable atmospheric conditions and ensure levels are safe prior to permitting work inside or around the outside of the tank or vessel (API Standard 2015 7<sup>th</sup> edition, Requirements for Safe Entry and Cleaning of Petroleum Storage Tanks).

- Use procedures or safety devices to ensure protection against electrostatic grids as a source of ignition, through de-energization when liquid levels drop and expose the grid components.
- Ensure that authorized personnel confirm that job safety analyses align with approved procedures, address hazards specific to the job and represent an orderly completion of job steps.
- Ensure contractors are aware of the functions and all potential hazards of the equipment on which they are working.
