DET NORSKE VERITAS

FORENSIC EXAMINATION OF DEEPWATER HORIZON BLOWOUT PREVENTER

VOLUME II APPENDICES

Report No. EP030842
20 March 2011

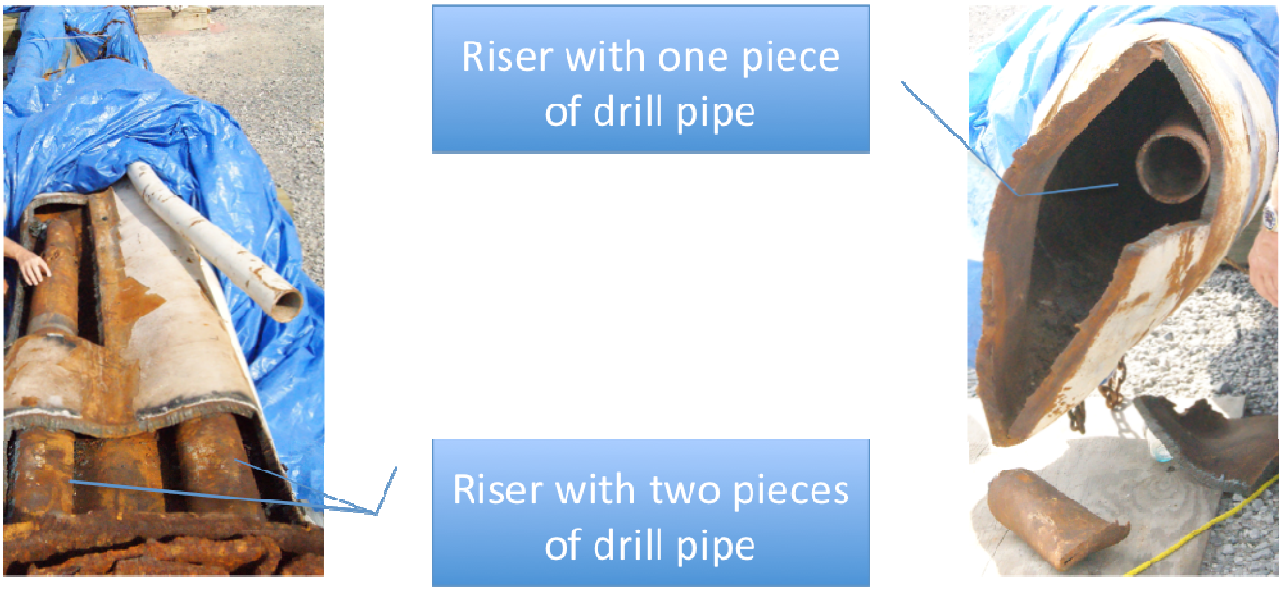
Figure 1 - Photograph of Riser showing two pieces of drill pipe at downstream end of riser and only one piece of drill pipe at upstream end of riser.

A 'window' has already been cut into the side of the Riser to expose the pipe trapped inside. To complete the investigations there is a need to remove the sections of pipe within the Riser and to examine the various failure surfaces on that drill pipe as a means to determine if they match to failure surfaces seen in the drill pipe removed from the LMRP and BOP.

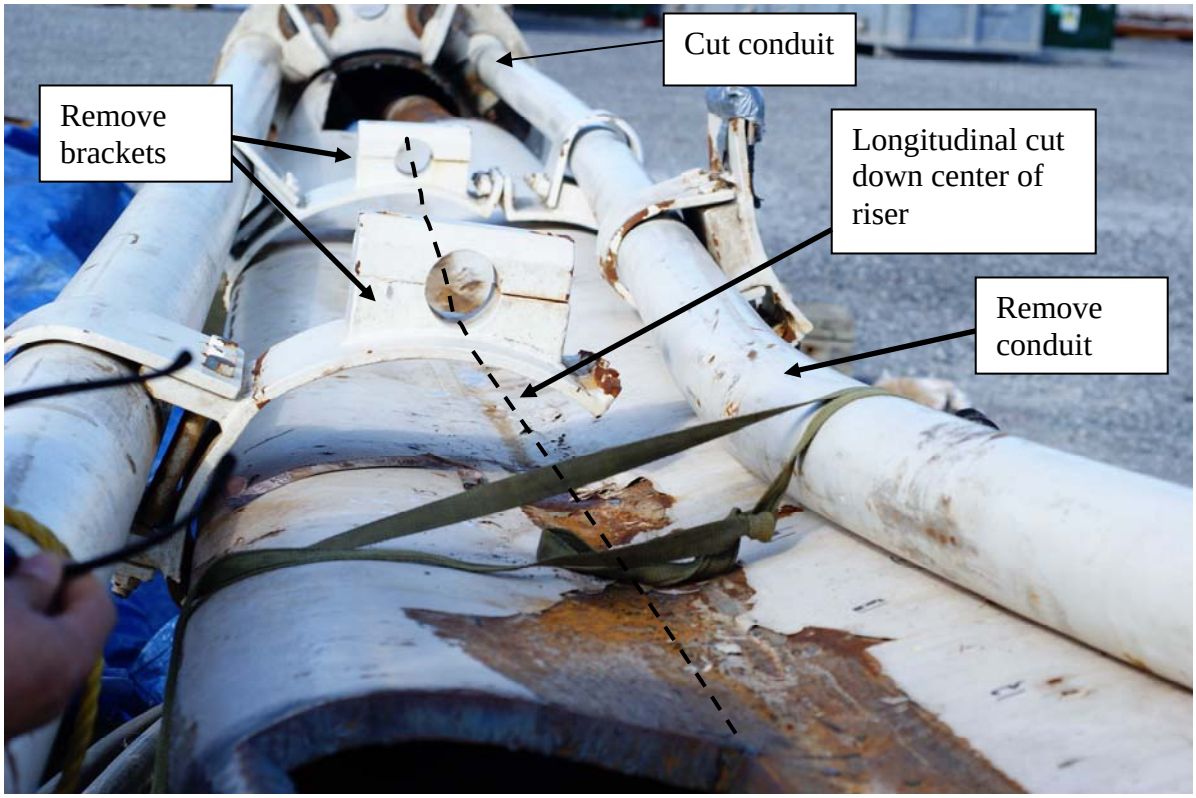
Figure 2 – Longitudinal cut on the edge of the riser.

6. Eyelets will be welded to the top piece of the riser to permit attachment for lifting.
7. The second longitudinal cut will be down the edge of the riser the length of the drill pipe from the cut-out nearest the buckle end of the riser down to the flange (see Figure 2). This cut must be performed carefully to produce a vertical angle directing any metal splatter from the cutting operation to the far side of the internal riser surface and away from the drill pipe.

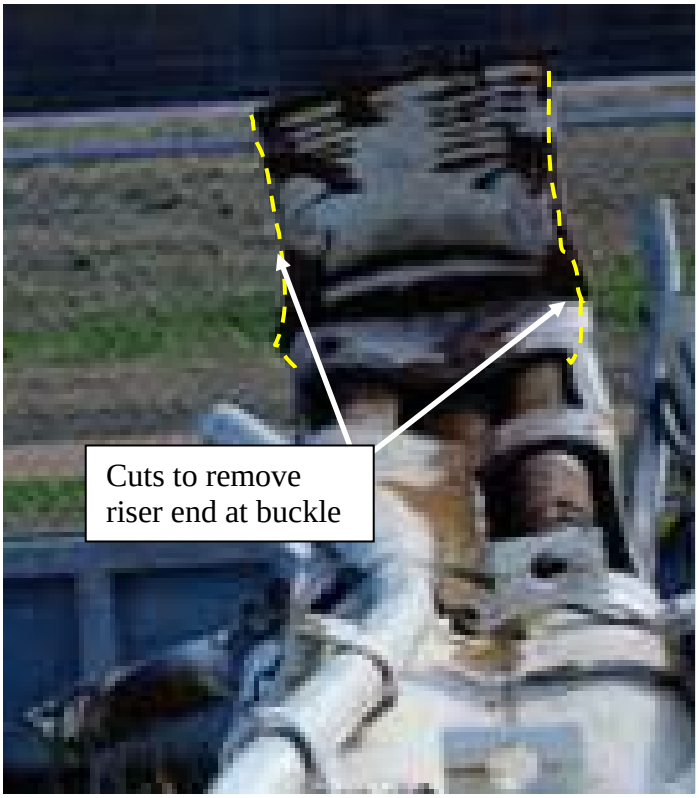
Figure 3 – Longitudinal cut down center of riser.

3. Clearly mark the riser as to the cuts to be made (see Figure 2, Figure 3, and Figure 4)
4. All cuts will be made with a plasma torch.
5. The first longitudinal cut will be down the middle on the riser top surface from the cut-out nearest the buckle end of the riser down to the flange (see Figure 3).

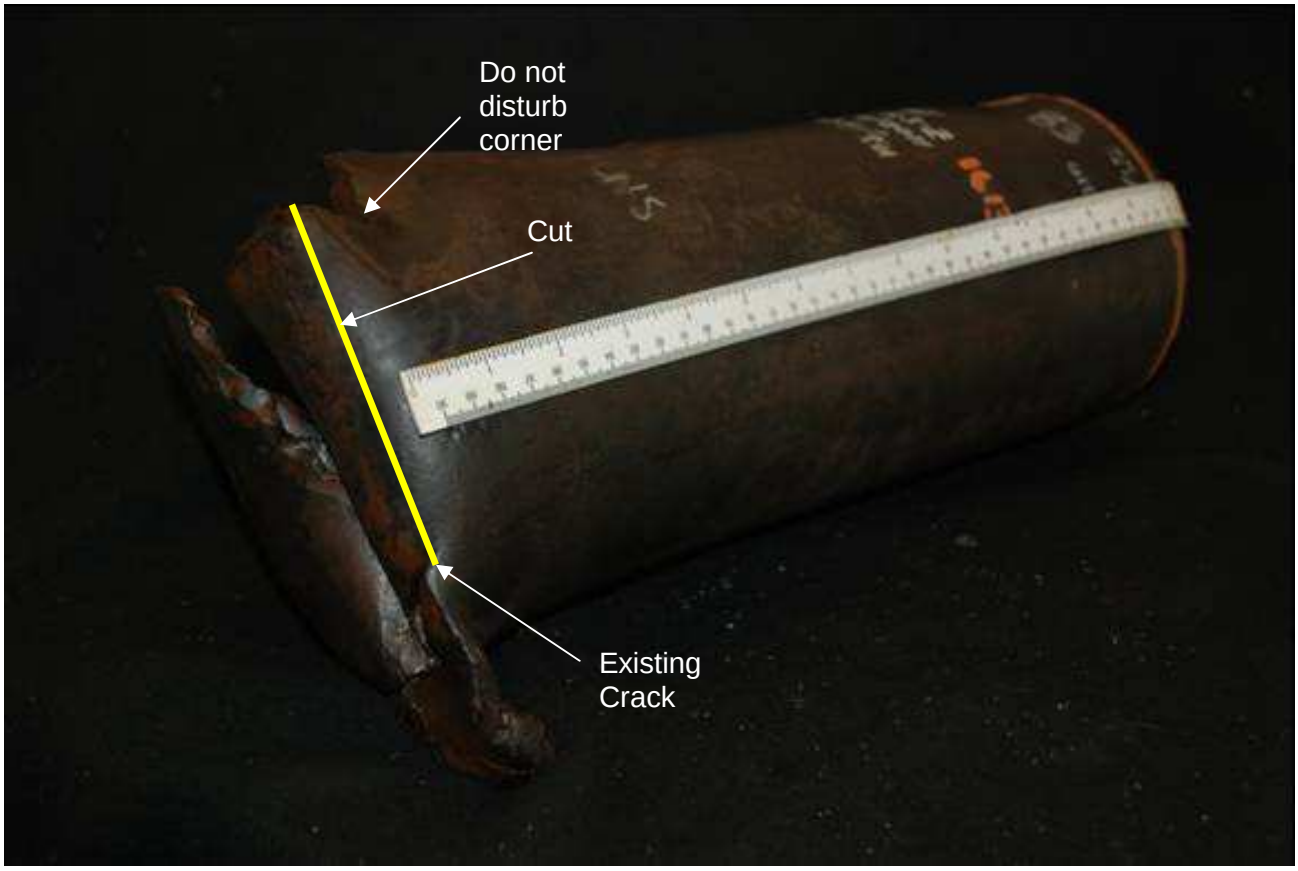
Figure 1 – Documentation of the proposed cut on Item 83 on the side without the "flat"

3. Cut Item 83-Z to reveal the surfaces that are curled into the ID of the pipe (see Figure 1 and **Error! Not a valid bookmark self-reference.**).

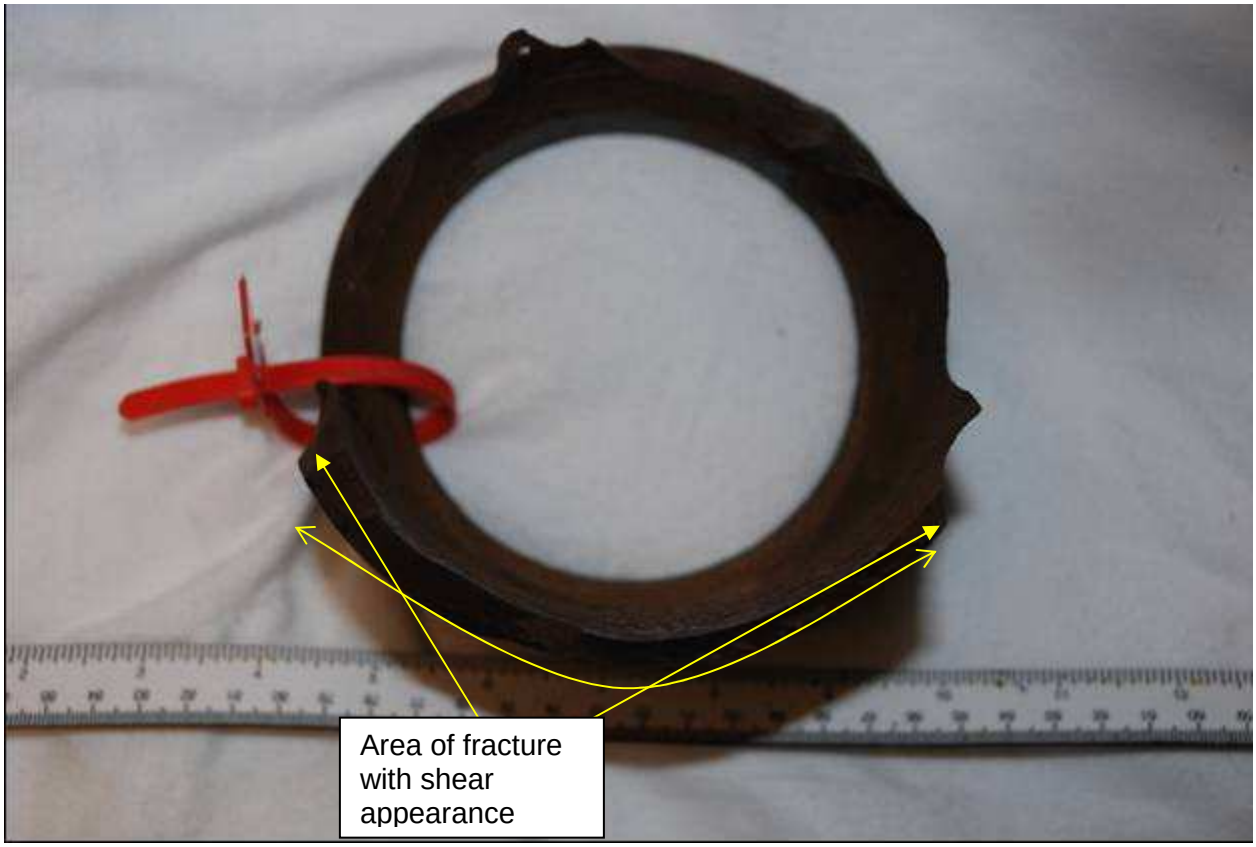
Figure 3 – Top view of Item 1-B-1-Z

5. Cut fracture surface area from Item 1-B-1-Z (see Figure 3 and Figure 4).

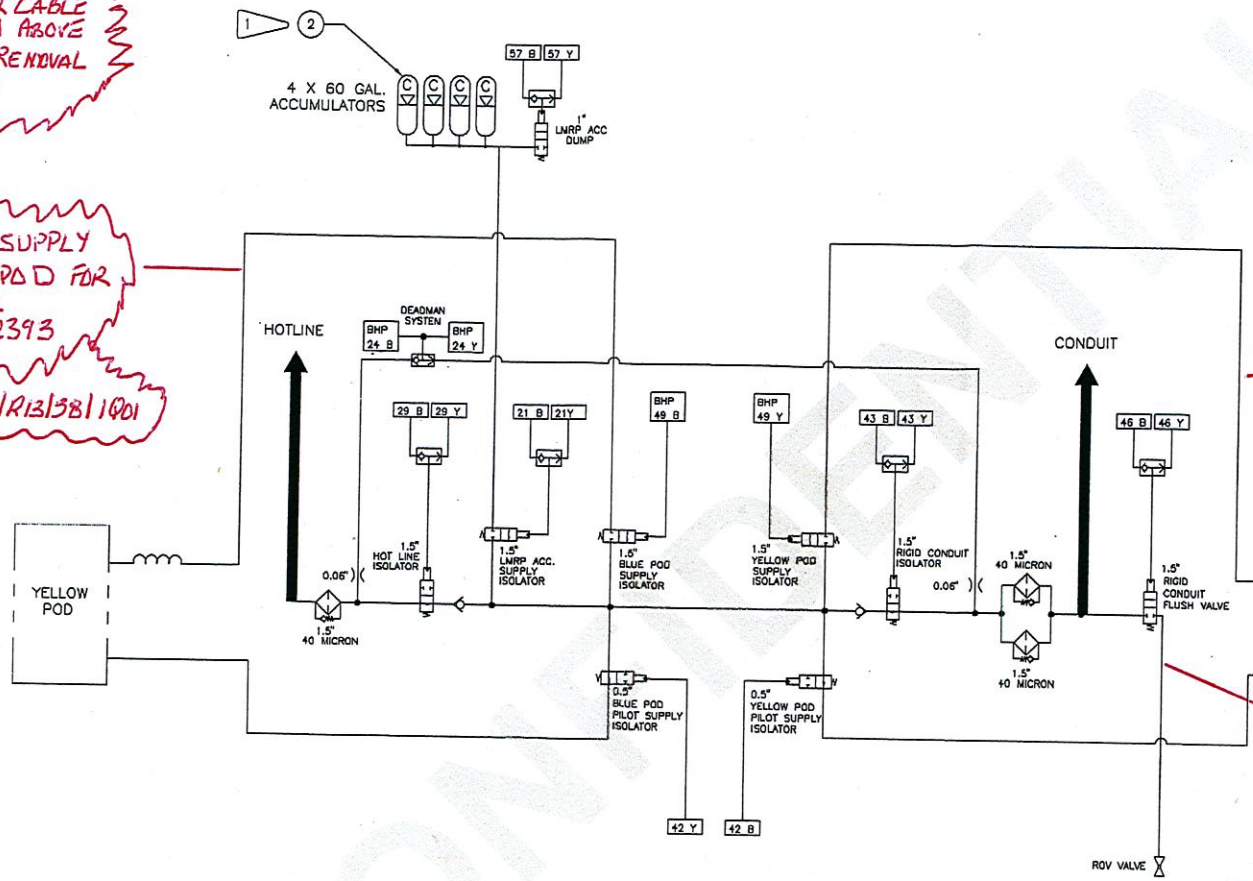
1/4" SHUTTLE VALVE ARRANGEMENT TUBING CUT FROM DEADMAN, ACCUM. DUMP, RIGID CONDUIT FLUSH, RIGID CONDUIT ISOLATOR, LMRP ACCUM. CHARGE FOR ROV INERVENTION PICT 2508-2516

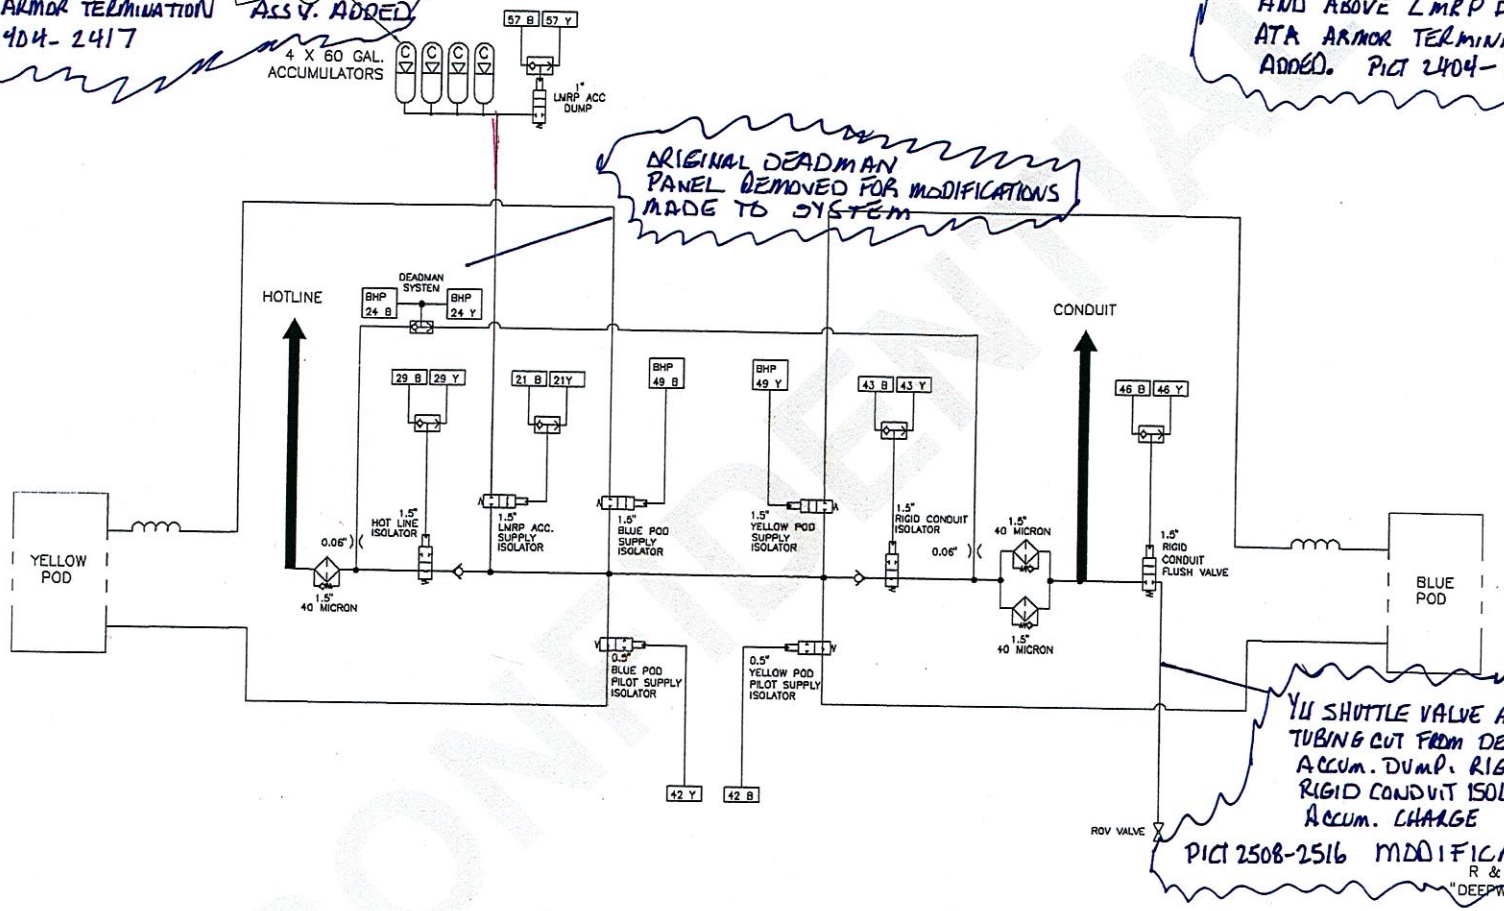
YU SHUTTLE VALVE ARRANGEMENT TUBING CUT FROM DEADMAN. ACCUM. DUMP. RIGID CONDUIT FLUSH. RIGID CONDUIT ISOLATOR. LMRP ACCUM. CHARGE

PICT 2508-2516 MODIFICATION

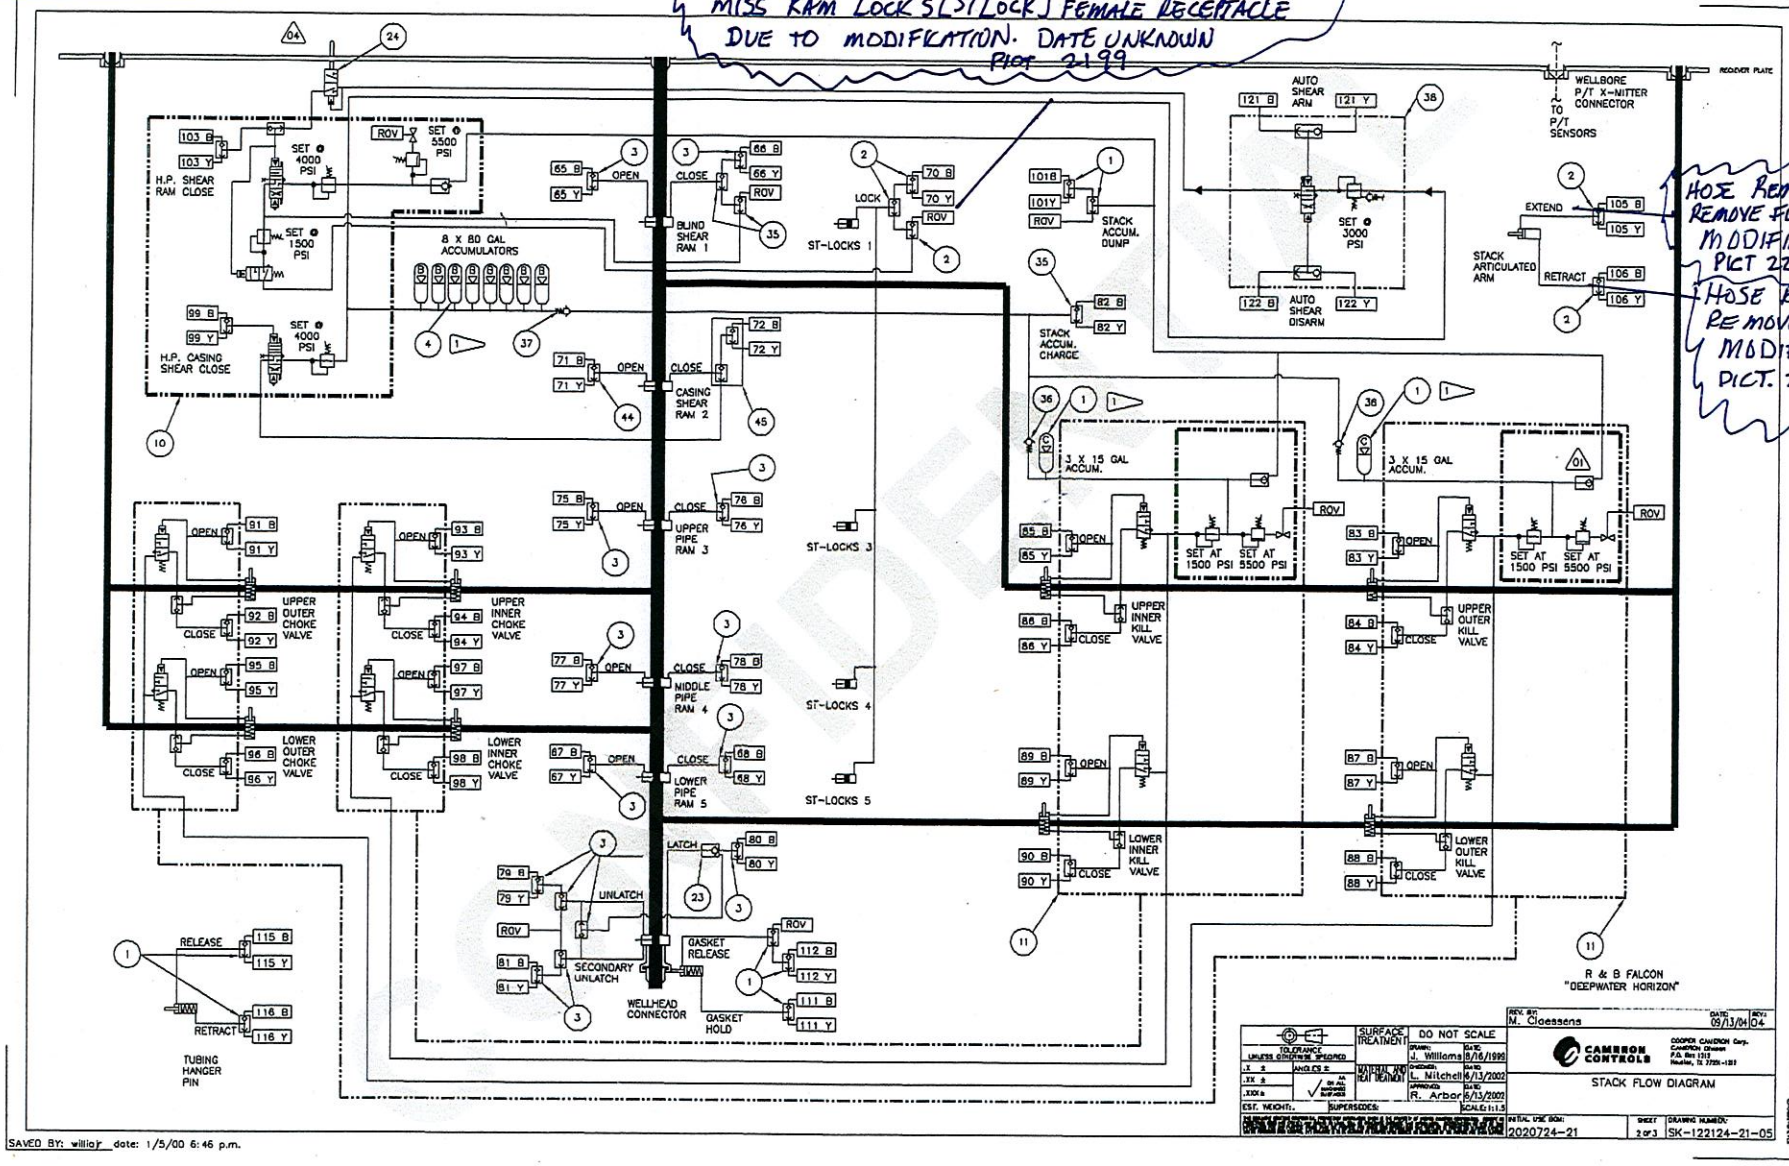
MISS RAM LOCKS (ST LOCK) FEMALE RECEPTACLE DUE TO MODIFICATION. DATE UNKNOWN PICT 2199

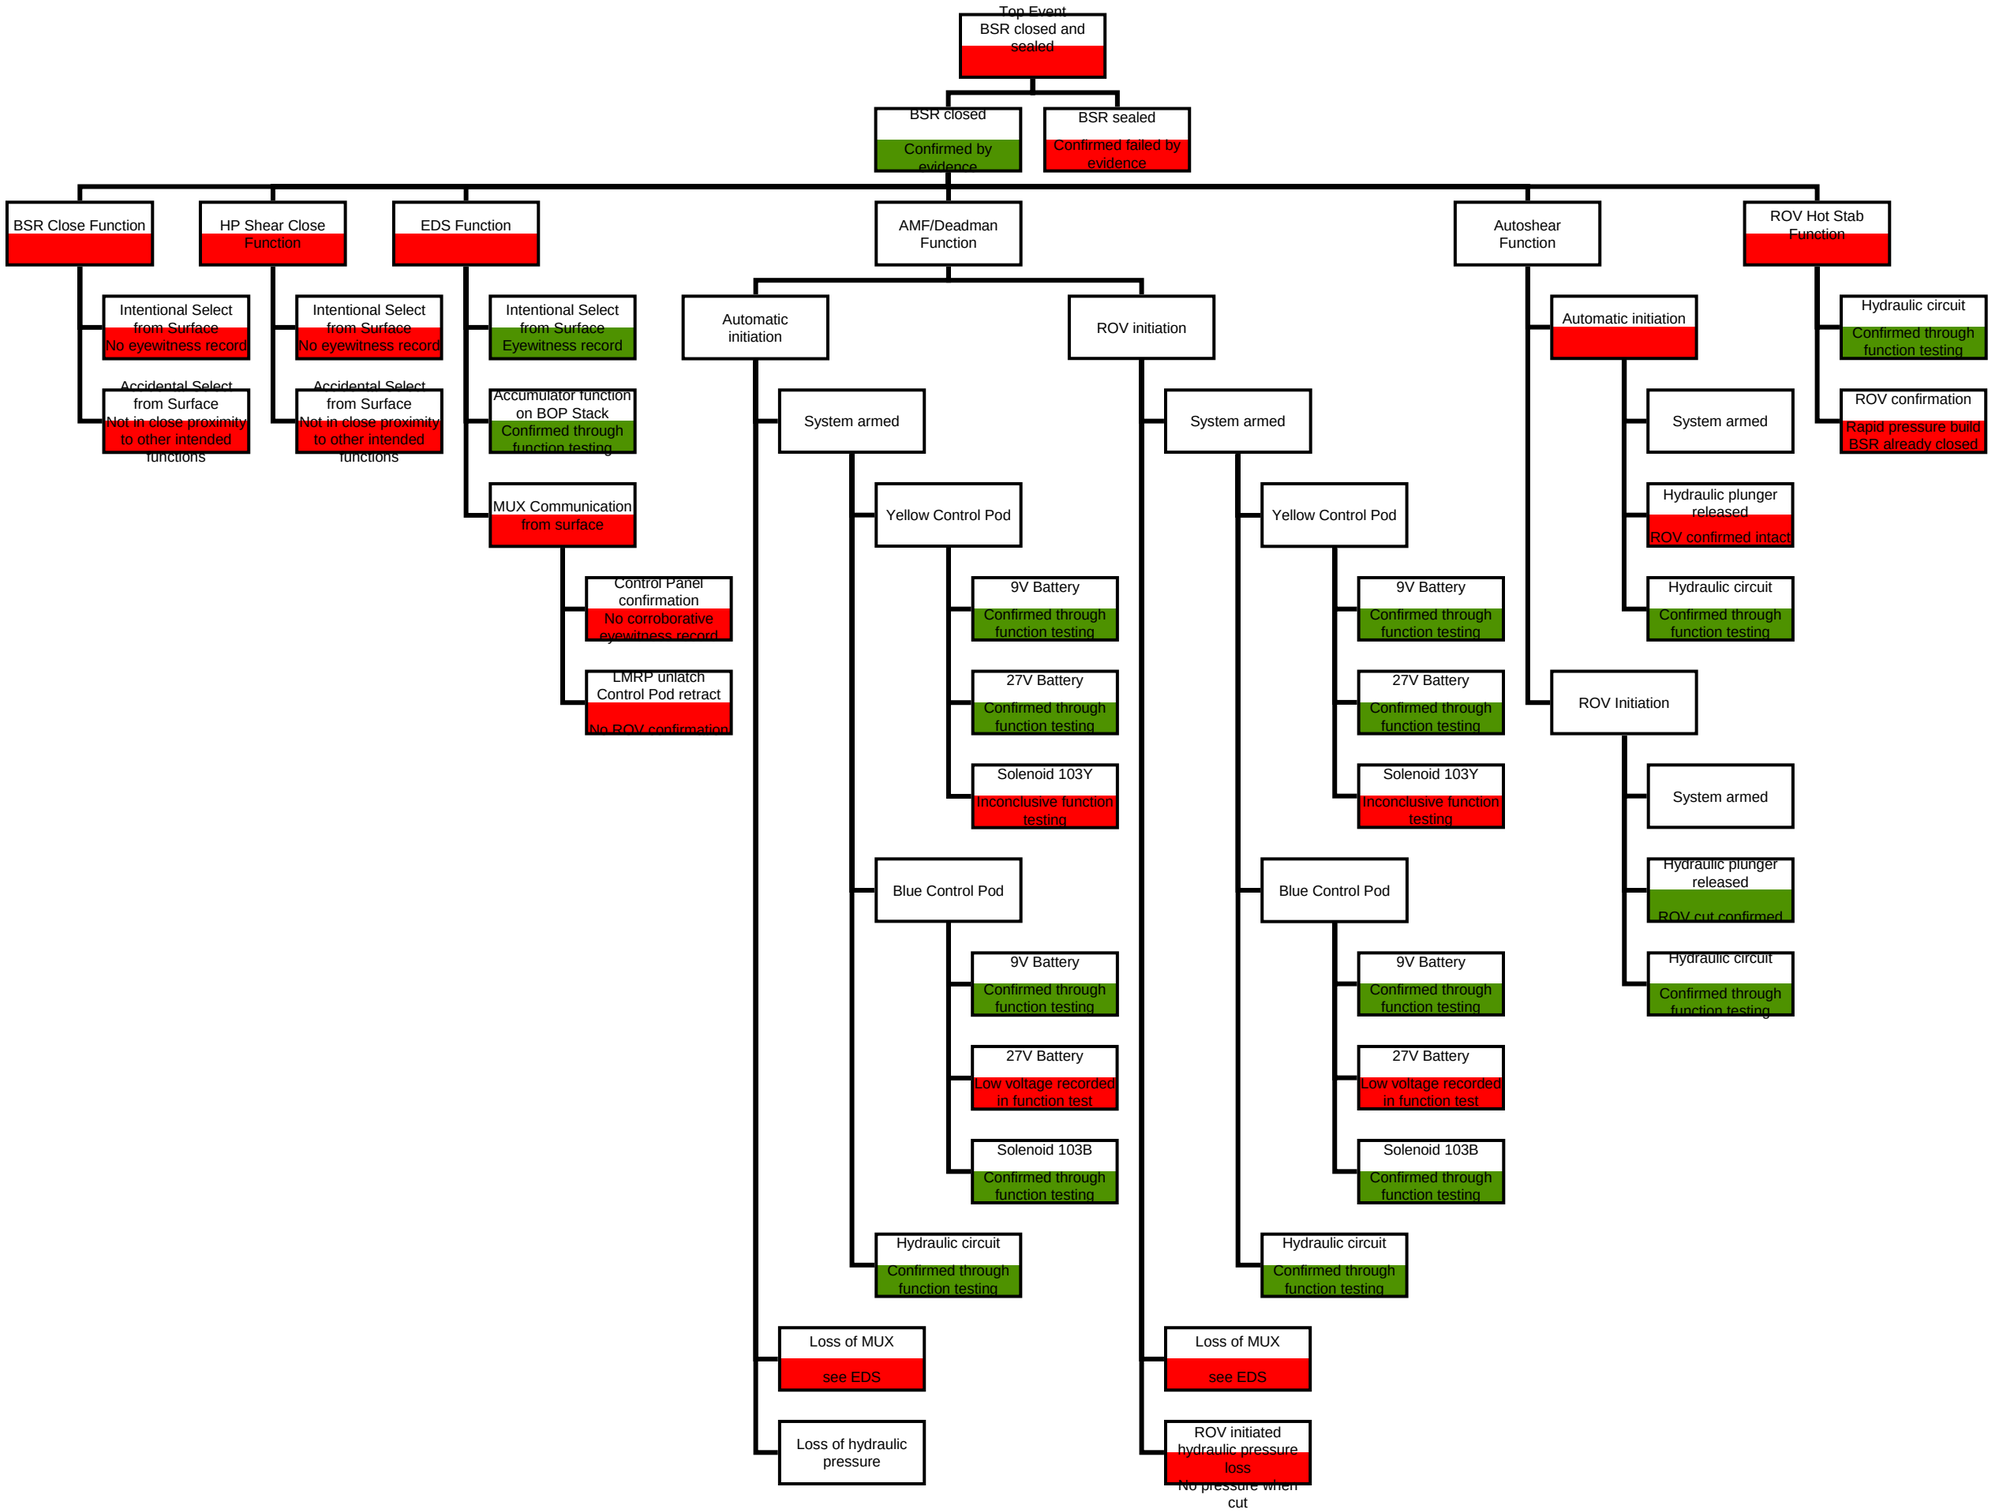
FAULT TREE

Top Event
BSR closed and sealed
BSR closed
Confirmed by evidence
BSR sealed
Confirmed failed by evidence
BSR Close Function
Intentional Select from Surface
No eyewitness record
Accidental Select from Surface
Not in close proximity to other intended functions
HP Shear Close Function
Intentional Select from Surface
No eyewitness record
Accidental Select from Surface
Not in close proximity to other intended functions
EDS Function
Intentional Select from Surface
Eyewitness record
Accumulator function on BOP Stack
Confirmed through function testing
MUX Communication from surface
Control Panel confirmation
No corroborative eyewitness record
LMRP unlatch Control Pod retract
No ROV confirmation
AMF/Deadman Function
Automatic initiation
System armed
Yellow Control Pod
9V Battery
Confirmed through function testing
27V Battery
Confirmed through function testing
Solenoid 103Y
Inconclusive function testing
Blue Control Pod
9V Battery

Confirmed through function testing
27V Battery
Low voltage recorded in function test
Solenoid 103B
Confirmed through function testing
Hydraulic circuit
Confirmed through function testing
Loss of MUX
see EDS
Loss of hydraulic pressure
ROV initiation
System armed
Yellow Control Pod
9V Battery
Confirmed through function testing
27V Battery
Confirmed through function testing
Solenoid 103Y
Inconclusive function testing
Blue Control Pod
9V Battery
Confirmed through function testing
27V Battery
Low voltage recorded in function test
Solenoid 103B
Confirmed through function testing
Hydraulic circuit
Confirmed through function testing
Loss of MUX
see EDS
ROV initiated hydraulic pressure loss
No pressure when cut
Autoshear Function
Automatic initiation
System armed
Hydraulic plunger released
ROV confirmed intact
Hydraulic circuit
Confirmed through function testing
ROV Initiation
System armed
Hydraulic plunger released
ROV cut confirmed
Hydraulic circuit
