***ASSESSMENT OF FIXED OFFSHORE  
PLATFORM PERFORMANCE IN HURRICANES  
ANDREW, LILI AND IVAN***

**December 2005**

**MMS Project No.: 549  
Energo Engineering Project No.: E05114**

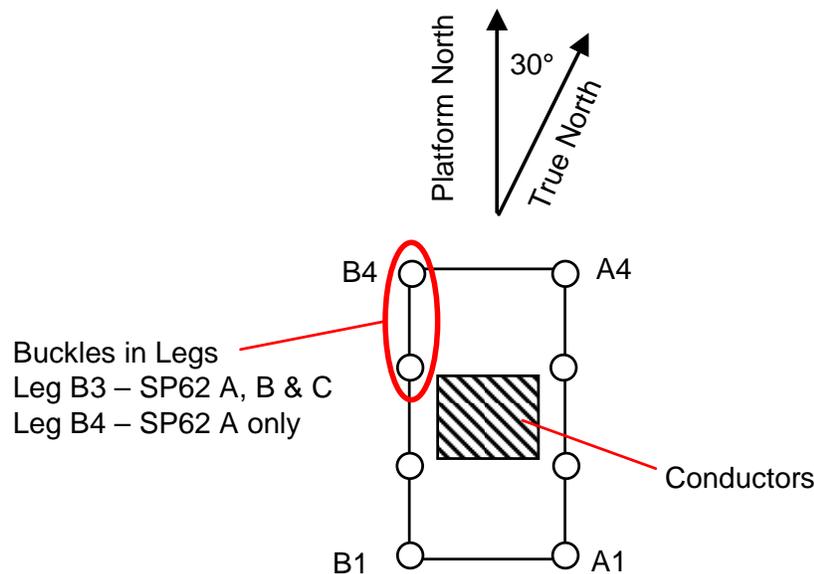
**Figure 2.8 – Platform Orientation of SP62 Platforms**

Local buckling was observed on four of the platforms that sustained major damage. Three of the platforms (SP 62 A/B/C) the platforms are very similar designs, installed in late 1960s in approximately 230 feet of water. All three have an 8 pile with 8 skirt piles configuration and are orientated in the same direction. The orientation is shown in Figure 2.8. During hurricane Ivan wave-in-deck was observed on all three platforms and local buckles were observed on the North/Northwest legs. The storm track of Ivan approached the platforms from the southeast. Hence it was the leeward side legs that had the leg buckles.

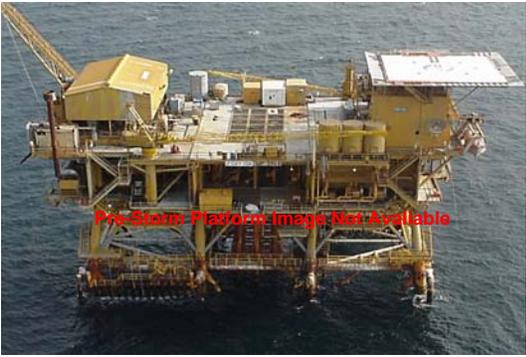
<b>Platform Damage Summary</b>			
Platform	Main Pass 296 B		
Operator	GOM Shelf LLC		
<b>Platform Description</b>			
Water Depth	225 ft

Deck Height	52 ft		
No. of Slots	18		
No. of Conductors	19		
Installation Date	1982		
API 2A Assessment Category	L2		
Jacket Type	Platform		
No. of Piles	8 Piles and 4 Skirt piles		
Distance from Shore	24 mi		
Bracing Configuration	Tran Frame: Rows 1 & 4: K bracing for bottom bay and XH bracing above it. Rows 2 & 3: XH bracing on one vertical half side and / bracing on the other. Long Frame: Bottom bay of both faces have XH bracing. Among the top bays, the center bay has XH bracing and the end bays have / bracing.		
<b>Storm Exposure</b>			
Min. Distance/Direction from Eye	35 mi	Maximum Storm Surge	1.2 ft
Maximum Wave Height	68 ft	Maximum Wind Speed	63 kts
Significant Wave Height	38 ft	Current Speed	2.4 kts
Wave Crest Elevation	41 ft		
<b>Storm Damage</b>			
Structural Damage	Yes	Evidence of Wave in Deck	No

Structural Damage Description	1. Damaged VD from B4(+)-14' level to B3(-)-62' level. It has 2" high x 6" wide bulge at the (-)39' level and another slight bulge near where it ties into the B3 leg. 2. Damaged VD from A4(+)-14' level to A3 (-)-52' level. It has a 1/4" high bulge at the (-) 40' level and another slight bulge where the member ties into the A3 leg. 3. Damaged HZ brace at the (-)-62' level connecting leg B1 to leg B2. It has a slight bulge or ripple at about 20' from leg B1.		
Non-structural Damage (wiring, piping, safety systems, etc.)	None documented		
Major Infrastructure Damage (Pipelines)	-		
<b>Response / Repair / Mitigation</b>			
Down Time After Storm	Unknown		
Drivers for Down Time	-		
Performed Analysis Summary	Design Level Analysis

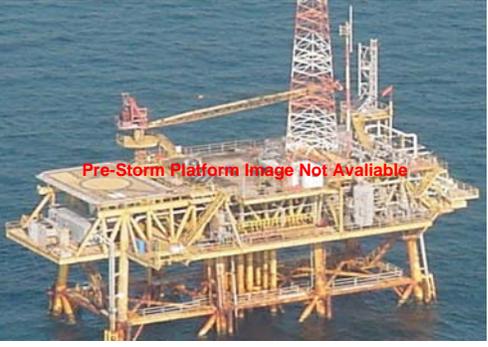
<b>Platform Damage Summary</b>			
Platform	<b>Main Pass 289 B</b>		
Operator	<b>Apache Corporation</b>		
<b>Platform Description</b>			
Water Depth	<b>301 ft</b>

Significant Wave Height	<b>41 ft</b>	Current Speed	<b>1.8 kts</b>
Wave Crest Elevation	<b>44 ft</b>		
<b>Storm Damage</b>			
Structural Damage	<b>Yes</b>	Evidence of Wave in Deck	<b>Yes</b>
Structural Damage Description	1. An underwater inspection during September and October 2004 found five dented jacket braces. 2. A 26" diagonal brace on row B from leg 2 at the (+)10' level to leg 3 at the (-)42' level was found to have a midspan crack. 3. A VD from leg B2 at (-)98' level to leg B3 at (-)42' level had a dent 10"L x 8"W x 0.5"D at the (-)72' elevation. 4. A VD from leg B3 at (-)160' level to leg B2 at (-)98' level had a dent 11"L x 6"W x 1"D at the (-)155' elevation. 5. A VD from leg B3 at (-)160' level to leg B2 at (-)98' level had a dent 7"L x 4"W x 1"D at the (-)156' elevation. 6. A HD from midpt. of A1-A4 to midpt. of B1-B4 had a 10"L x 10"W x 2"D dent at 13.5' from row 4.		
Non-structural Damage (wiring, piping, safety systems, etc.)	Four broken well conductors were found during the Level II underwater inspections.

Response / Repair Description	An ultimate strength analysis was performed in accordance with the API RP2A 21st edition using level I criteria. The 26" diagonal brace containing dents, holes and cracks was removed for the analysis to be consistent with the proposed repair plan. The dented members were checked for residual strength using an OTC paper on Residual Strength of Dent-Damaged Platform Bracing, and were found to be okay.		
Mitigation to Prevent Future Damage (reinforcement, remove unused equipment, relocate critical systems, etc.)	None		
<b>Contributing Factors to Platform Damage</b>			
Perceived Reasons for Damage (e.g., low deck, installation defect, falling debris, etc.)	Low deck - The deck was exposed to wave heights in exceedence of 90 feet (Ref: Report submitted to MMS by Operator, 24 Mar 2005).

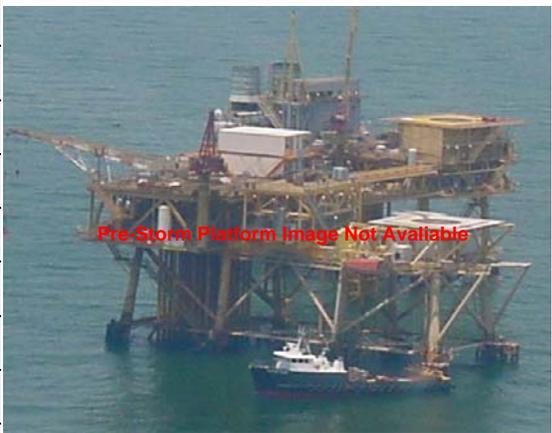
<b>Platform Damage Summary</b>			
Platform	South Pass 62 C		
Operator	Apache Corporation		
<b>Platform Description</b>			
Water Depth	328 ft

<b>Storm Damage</b>			
Structural Damage	Yes	Evidence of Wave in Deck	Yes
Structural Damage Description	Two local buckles were found on a thin walled segment of jacket leg B3, at(-) 265' and (-) 276' levels. The buckles each protruded 1/4 inches from the legs original straight configuration.		
Non-structural Damage (wiring, piping, safety systems, etc.)	None Documented		
Major Infrastructure Damage (Pipelines)	-		
<b>Response / Repair / Mitigation</b>			
Down Time After Storm	Unknown		
Drivers for Down Time	-		
Performed Analysis Summary	Design Level Analysis

Response / Repair Description	A design level analysis was performed on the structure per API RP2A 21st edition. The section of the jacket leg containing the beginnings of local buckling, and an adjacent HZ at the (-) 261' level which was found to be overstressed, were removed from the model. The analysis confirmed that the repair of the minor local leg buckling is unnecessary.		
Mitigation to Prevent Future Damage (reinforcement, remove unused equipment, relocate critical systems, etc.)	None		
<b>Contributing Factors to Platform Damage</b>			
Perceived Reasons for Damage (e.g., low deck, installation defect, falling debris, etc.)	None noted.

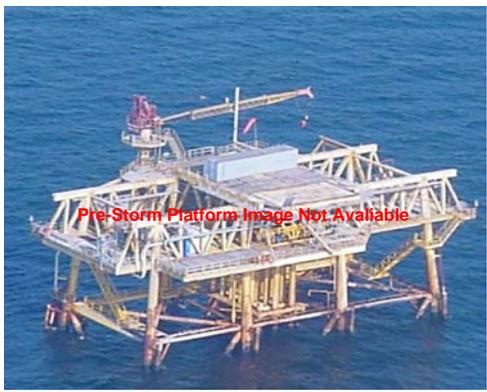
<b>Platform Damage Summary</b>			
Platform	Main Pass 290 A		
Operator	Apache Corporation		
<b>Platform Description</b>			
Water Depth	288 ft

Deck Height	44 T.O.S		
No. of Slots	18		
No. of Conductors	18		
Installation Date	1966		
API 2A Assessment Category	L2		
Jacket Type	Platform		
No. of Piles	8 piles		
Distance from Shore	38 mi		
Bracing Configuration	<b>Long Frame: Both the faces have / bracing throughout.</b> <b>Tran Frame: All four faces have K bracing in the bottom bay alone and / bracing all that way above it.</b>		
<b>Storm Exposure</b>			
Min. Distance/Direction from Eye	22 mi	Maximum Storm Surge	1.1 ft
Maximum Wave Height	68 ft	Maximum Wind Speed	67 kts
Significant Wave Height	38 ft	Current Speed	1.8 ft
Wave Crest Elevation	41 ft		
<b>Storm Damage</b>			
Structural Damage	Yes	Evidence of Wave in Deck	Yes
Structural Damage Description	<ol style="list-style-type: none"> <li>1. A VD from leg A1 at (-)50' level to leg A2 at (-)94' level had a dent 36"L x 23"W x 4.75"D at (-)74' elevation.</li> <li>2. A VD from leg A1 at (-)150' level to leg A2 at (-)218' level had a dent 12"L x 20"W x 2"D at (-)169' elevation, a dent 44"L x 24"W x 3.625"D at (-)184' elevation and had a scrape 26"L x 3"W x 0.25"D at (-)190' elevation. In addition, at elevation (-)218' the manufactured weld seam had a crack along the seam.</li> <li>3. VD from A2 to B2 has a 2"L x 2"W x 0.5"D pit at the cap of the weld, at the B2 leg (-)49' elevation.</li> <li>4. VD from A1 to A2 has a 2"L x 2"W x 0.5"D pit at the cap of the weld, at the A1 leg (-)49' elevation.</li> <li>5. A HD at the (-)218' elevation, from the mid points of A1-A2 to A2-B2 was damaged and required repair.</li> </ol>

Non-structural Damage (wiring, piping, safety systems, etc.)	<ol style="list-style-type: none"> <li>1. One of the J-tubes was found to be broken.</li> <li>2. Movement was noted on 5 of the conductors.</li> <li>3. A deck extension broke loose during the storm and damaged a lot of members during its descent.</li> <li>4. All of the topside members were found to be in fair condition with moderate corrosion and moderate coating loss.</li> </ol>		
Major Infrastructure Damage (Pipelines)	-		
<b>Response / Repair / Mitigation</b>			
Down Time After Storm	Unknown		
Drivers for Down Time	-		
Performed Analysis Summary	Design Level Analysis

Response / Repair Description	A design level analysis was performed on the structure per API RP2A 21st edition. Conservatively, 9 of the braces were either assigned zero axial strength or were removed from the analysis. Two of those nine braces were permanently removed as part of the repair plan. The platform was found to pass the Level-II environmental criteria.		
Mitigation to Prevent Future Damage (reinforcement, remove unused equipment, relocate critical systems, etc.)	None		
<b>Contributing Factors to Platform Damage</b>			
Perceived Reasons for Damage (e.g., low deck, installation defect, falling debris, etc.)	None noted.

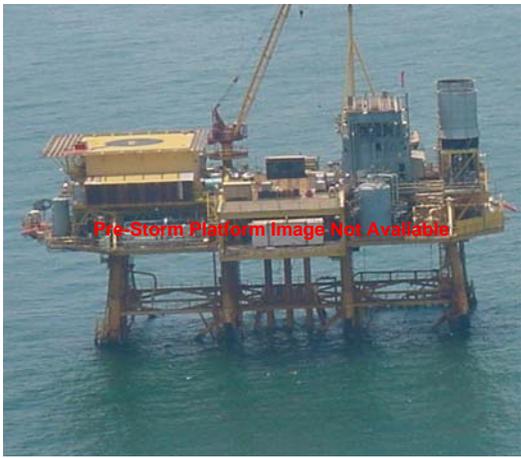
<b>Platform Damage Summary</b>			
Platform	South Pass 62 B		
Operator	Apache Corporation		
<b>Platform Description</b>			
Water Depth	322 ft

Wave Crest Elevation	44 ft		
<b>Storm Damage</b>			
Structural Damage	Yes	Evidence of Wave in Deck	Yes
Structural Damage Description	1. There was a 5"W x 42"L bulge on leg B3 at (-) 281' elevation.		
Non-structural Damage (wiring, piping, safety systems, etc.)	None documented		
Major Infrastructure Damage (Pipelines)	-		
<b>Response / Repair / Mitigation</b>			
Down Time After Storm	Unknown		
Drivers for Down Time	-		
Performed Analysis Summary	Design Level Analysis

Response / Repair Description	A design level analysis was performed on the structure per API RP2A 21st edition. The section of the jacket leg B3 between El. (-)260' and (-)289' containing the beginnings of local buckling, and an adjacent HZ at the (-) 260' level which was found to be overstressed, were removed from the model. The analysis confirmed that the repair of the minor local leg buckling is unnecessary.		
Mitigation to Prevent Future Damage (reinforcement, remove unused equipment, relocate critical systems, etc.)	None		
<b>Contributing Factors to Platform Damage</b>			
Perceived Reasons for Damage (e.g., low deck, installation defect, falling debris, etc.)	None noted.

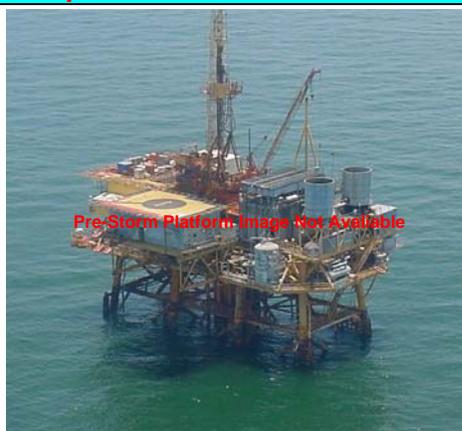
<b>Platform Damage Summary</b>			
Platform	South Pass 62 A		
Operator	Apache Corporation		
<b>Platform Description</b>			
Water Depth	340 ft

<b>Storm Damage</b>			
Structural Damage	Yes	Evidence of Wave in Deck	Yes
Structural Damage Description	<ol style="list-style-type: none"> <li>1. Three local buckles were found on the B4 leg at elevations (-)266' all around the circumference, at (-)274' from 6:00 to 1:00 and at (-)283' from 6:00 to 10:00. The width of the bulges vary along the circumference.</li> <li>2. A buckle 4"W x 360 degrees was found in leg B3 at (-)294' level. The bulge extends 6" on the outboard side of the leg and 3" on the inboard side of the leg.</li> <li>3. A buckle 3"W x 360 degrees was found in leg B3 at (-)289' level. The bulge extends 3" on the outboard side of the leg and 1.5" on the inboard side of the leg.</li> <li>4. A buckle 3"W x 360 degrees was found in leg B3 at (-)278' level. The bulge extends 3" on the outboard side of the leg and 1.5" on the inboard side of the leg.</li> <li>5. A dent 24"L x 10"W x 4"D was found on the HZ B1-B2 at (+)15' level, 10' from leg B1 at 3:00.</li> <li>6. A dent 12"L x 8"W x 1.5"D was found on VD B1 at (+)15' to B2 at (-)30' level, 8' from Leg B1 at 12:00.</li> </ol>

Response / Repair Description	<p>An ultimate strength analysis was performed on the structure per API RP2A 21st edition. The locally buckled sections of legs B3 and B4 between elevations (-)265' and (-)299' were removed from the model. The analysis confirmed that the repair of the minor local leg bucklings was unnecessary.</p>		
Mitigation to Prevent Future Damage (reinforcement, remove unused equipment, relocate critical systems, etc.)	None		
<b>Contributing Factors to Platform Damage</b>			
Perceived Reasons for Damage (e.g., low deck, installation defect, falling debris, etc.)	None noted.

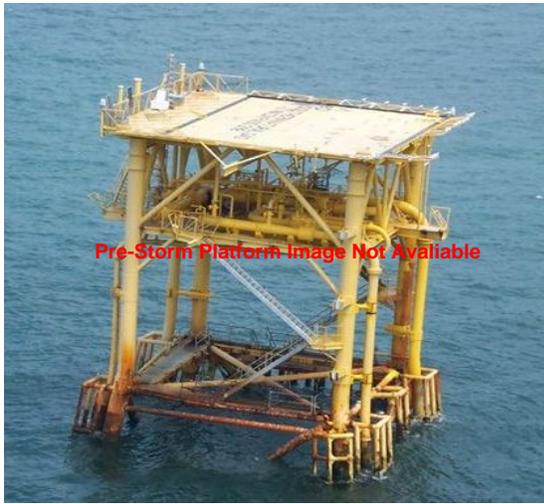
<b>Platform Damage Summary</b>			
Platform	<b>Main Pass 298 B-Valve</b>		
Operator	<b>Southern Natural Gas</b>		
<b>Platform Description</b>			
Water Depth	<b>222 ft</b>

Deck Height	<b>43 ft</b>		
No. of Slots	<b>None</b>		
No. of Conductors	<b>4 Risers</b>		
Installation Date	<b>1972</b>		
API 2A Assessment Category	<b>L2</b>		
Jacket Type	<b>Platform</b>		
No. of Piles	<b>4</b>		
Distance from Shore	<b>20.0 ft</b>		
Bracing Configuration	<b>Both long frame and tran frame have KH type of bracing.</b>		
<b>Storm Exposure</b>			
Min. Distance/Direction from Eye	<b>39 mi</b>		Maximum Storm Surge <b>1.3 ft</b>
Maximum Wave Height	<b>67 ft</b>		Maximum Wind Speed <b>63 kts</b>
Significant Wave Height	<b>37 ft</b>		Current Speed <b>2.7 ft</b>
Wave Crest Elevation	<b>41 ft</b>		
<b>Storm Damage</b>			
Structural Damage	<b>Yes</b>	Evidence of Wave in Deck	<b>Unknown</b>
Structural Damage Description	1. Crack on VD from leg B2 at (+)10' level to leg A2 at (-)29' level, 3' from leg B2. 2. Crack on HZ from leg B2 to A2 at (+)8' level, 8' from leg B2. 3. Dent on HZ from A2 to B2 at (+)8' level, 4' from leg A2. 4. Crack on VD from leg B1 at (+)10' level to leg B2 at (-)29' level, 2' from leg B1.

Response / Repair Description	In all the cases, the damaged section of the member was cut out and a repair section was welded in its place.		
Mitigation to Prevent Future Damage (reinforcement, remove unused equipment, relocate critical systems, etc.)	None		
<b>Contributing Factors to Platform Damage</b>			
Perceived Reasons for Damage (e.g., low deck, installation defect, falling debris, etc.)	None noted.

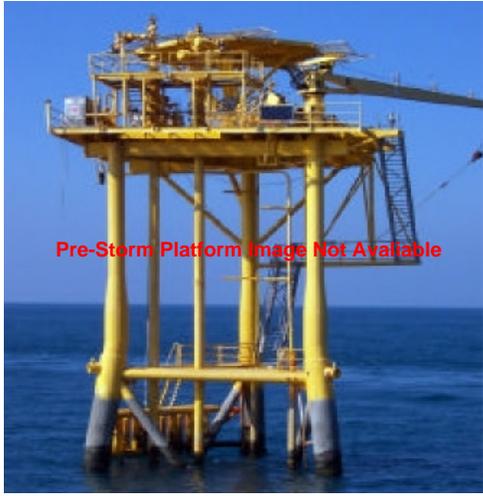
<b>Platform Damage Summary</b>			
Platform	<b>Main Pass 280 C</b>		
Operator	<b>Dominion E &amp; P</b>		
<b>Platform Description</b>			
Water Depth	<b>302 ft</b>

Deck Height	<b>Unknown</b>		
No. of Slots	<b>Unknown</b>		
No. of Conductors	<b>Unknown</b>		
Installation Date	<b>1998</b>		
API 2A Assessment Category	<b>L3</b>		
Jacket Type	<b>Platform</b>		
No. of Piles	<b>3</b>		
Distance from Shore	<b>55 mi</b>		
Bracing Configuration	<b>Unknown</b>		
<b>Storm Exposure</b>			
Min. Distance/Direction from Eye	<b>7 mi</b>		Maximum Storm Surge <b>1.3 ft</b>
Maximum Wave Height	<b>74 ft</b>		Maximum Wind Speed <b>75 kts</b>
Significant Wave Height	<b>41 ft</b>		Current Speed <b>1.8 ft</b>
Wave Crest Elevation	<b>44 ft</b>		
<b>Storm Damage</b>			
Structural Damage	<b>Yes</b>		Evidence of Wave in Deck <b>Unknown</b>
Structural Damage Description	1. One jacket member was damaged.		
Non-structural Damage (wiring, piping, safety systems, etc.)	None documented

Response / Repair Description	The structure was re-analyzed with the metocean criteria per API RP2A 21st edition.		
Mitigation to Prevent Future Damage (reinforcement, remove unused equipment, relocate critical systems, etc.)	None		
<b>Contributing Factors to Platform Damage</b>			
Perceived Reasons for Damage (e.g., low deck, installation defect, falling debris, etc.)	None noted.

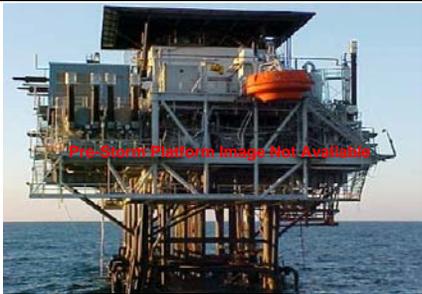
<b>Platform Damage Summary</b>			
Platform	Viosca Knoll 900 A		
Operator	Chevron		
<b>Platform Description</b>			
Water Depth	340 ft

Structural Damage Description	<p>1. The following members were found to be flooded:</p> <p>a. A HZ A4-B4 at the (-)80' level, has a linear indication at its mid point.</p> <p>b. VD from A1 and (-)32' to A2 at (+)12', was a repaired member.</p> <p>c. HZ A4-B4 at the (-)32' level was separated at the mid point of the member. There is a vertical gap of 5.75" between the centers of the separated members.</p> <p>2. VD A4 at (-)32' level to B4 at (+)12' level is separated where it connects to leg A4 at (-)32'. Leg A4 has a hole 39.5"L x 24"W, resultant of the VD being torn from the leg and the VD retaining the coupon. A tear was noted on the A4 leg at 7:00 with the lip protruding 0.5". At this location, a 3" crack was also noted.</p> <p>3. A dent 6.5"dia. x 1.5"D was found on HZ B4-B3 at (-)32' level 6' from leg B4 from 12:00 to 2:00.</p> <p>4. A dent 12" dia. x 6"D was found on HZ A4-B4 at (+)12' level from 6:00 to 12:00.</p> <p>5. A dent 12"L x 6"W x 4"D was found on HZ A4-B4 at (+)12' level, 7' from Leg A4 from 12:00 to 3:00.</p> <p>6. A linear indication 21.5"L x 0.25"W was found on HD A4-B4 to B3 at (-)80' level from 6:00 to 12:00, on the node side of the weld.</p> <p>7. A suspect visual indication was noted on weld 22/02 in the T.O.W HD A4-B4 to A3 at (-</p>

Response / Repair Description	<p>1. Members below water line: Stress grouted clamps were designed for all damaged underwater jacket members.</p> <p>2. Members above water line: Two permanent vertical posts were installed at the (+)12'-6" level to reduce the effective column length of members between column rows A1 and A2 and also between B3 and B4. Additionally a repair clamp for the (+)12'-6" elevation HZ was designed for load transfer in the horizontal member framing from row A to B.</p> <p>3. Repair of tubular diagonals in the superstructure: Fabrication and repairs to the lateral bracing for the diagonals located in truss rows 3 and 4 framing from the production deck to elevation (+)23'-6" have been completed. Additional tubular members were designed and installed to provide out-of-plane support at the point of maximum eccentricity.</p>		
Mitigation to Prevent Future Damage (reinforcement, remove unused equipment, relocate critical systems, etc.)	None

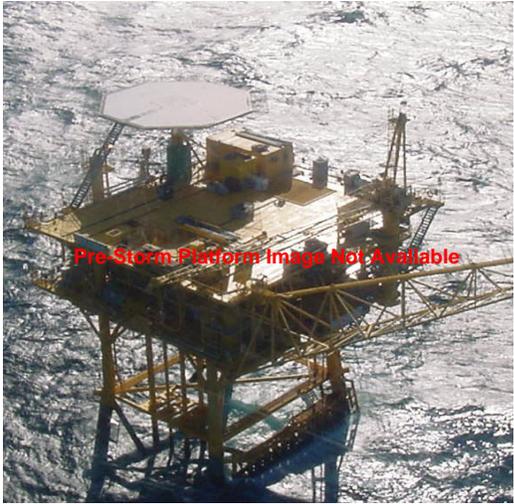
<b>Platform Damage Summary</b>			
Platform	<b>Main Pass 279 B</b>		
Operator	<b>Dominion E &amp; P</b>		
<b>Platform Description</b>			
Water Depth	290 ft

Deck Height	Not Documented		
No. of Slots	6		
No. of Conductors	4		
Installation Date	Not Documented		
API 2A Assessment Category	Not Documented		
Jacket Type	Platform		
No. of Piles	4		
Distance from Shore	51 mi		
Bracing Configuration	The bottommost bay of all faces have XH bracing and all the other bays have / bracing.		
<b>Storm Exposure</b>			
Min. Distance/Direction from Eye	10 mi	Maximum Storm Surge	1.3 ft
Maximum Wave Height	74 ft	Maximum Wind Speed	75 kts
Significant Wave Height	41 ft	Current Speed	1.8 ft
Wave Crest Elevation	45 ft		
<b>Storm Damage</b>			
Structural Damage	Yes	Evidence of Wave in Deck	Yes
Structural Damage Description	1. The A1 leg has a buckle at the (-)90' level and is also broken and seperated at the (-)110' level.		
Non-structural Damage (wiring, piping, safety systems, etc.)	1. Major damage to the production equipment on the cellar deck. 2. Damage to handrails, grating and stairs.

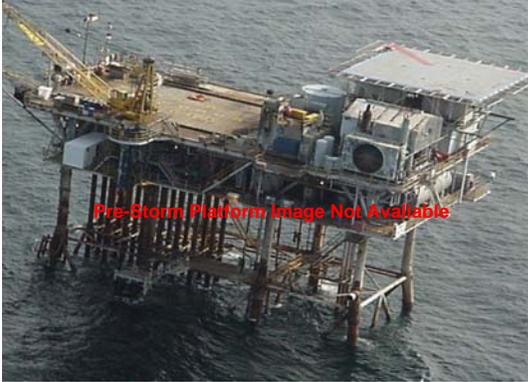
<b>Platform Damage Summary</b>			
Platform	Main Pass 305 A		
Operator	Noble Energy, Inc.		
<b>Platform Description</b>			
Water Depth	244 ft

Deck Height	45 ft		
No. of Slots	24		
No. of Conductors	Not Documented		
Installation Date	1968		
API 2A Assessment Category	L2		
Jacket Type	Platform		
No. of Piles	8 Pile		
Distance from Shore	28 mi		
Bracing Configuration	Long Frame: All the bays of both faces have / bracing. Tran Frame: All four faces have K- bracing on all the bays.		
<b>Storm Exposure</b>			
Min. Distance/Direction from Eye	30 mi	Maximum Storm Surge	1.1 ft
Maximum Wave Height	69 ft	Maximum Wind Speed	64 kts
Significant Wave Height	39 ft	Current Speed	2.2 ft
Wave Crest Elevation	44 ft		
<b>Storm Damage</b>			
Structural Damage	Yes	Evidence of Wave in Deck	No
Structural Damage Description	1. The storm disconnected the conductor tray and damaged several supporting secondary steel members at the (-)40' elevation. 18 anomalies were discovered at this level. A drawing has been provided showing the locations of all these anomalies. 2. A dent 18"L x 10"W x 2"D was found on a VD on row A from leg1 at (+)10' level to leg2 and (-)40' level, 20' from leg A2.

Response / Repair Description	1. A design level analysis was performed per API RP2A 21st edition, Section 17, using the L2 sudden hurricane environmental loading criteria. The damages in the structure were taken into account. 2. The analysis performed revealed some member and joint overstresses, and therefore an ultimate strength analysis was performed per API RP2A Section 17, based on L2 criteria. The analysis demonstrated the structure to be adequate for manning so that repairs could be made. 3. The conductor tray at the (-)40' elevation was repaired. 4. The platform in its repaired state was again subject to a design level analysis and to an ultimate strength analysis to confirm the adequacy of the repairs.		
Mitigation to Prevent Future Damage (reinforcement, remove unused equipment, relocate critical systems, etc.)	None		
<b>Contributing Factors to Platform Damage</b>			
Perceived Reasons for Damage (e.g., low deck, installation defect, falling debris, etc.)	None noted.

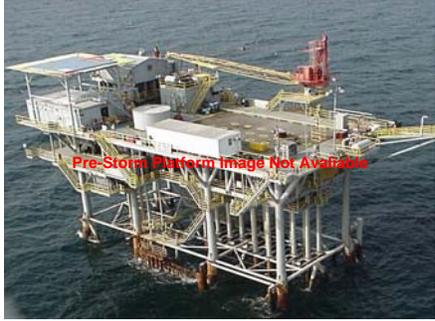
<b>Platform Damage Summary</b>			
Platform	Main Pass 305 B		
Operator	Noble Energy, Inc.		
<b>Platform Description</b>			
Water Depth	241 ft

Deck Height	46 ft		
No. of Slots	24		
No. of Conductors	Not Documented		
Installation Date	1968		
API 2A Assessment Category	L2		
Jacket Type	Platform		
No. of Piles	8 Pile		
Distance from Shore	28 mi		
Bracing Configuration	Long Frame: All the bays of both faces have / bracing. Tran Frame: All four faces have K bracing on all the bays.		
<b>Storm Exposure</b>			
Min. Distance/Direction from Eye	30 mi	Maximum Storm Surge	1.1 ft
Maximum Wave Height	72 ft	Maximum Wind Speed	65 kts
Significant Wave Height	40 ft	Current Speed	1.7 ft
Wave Crest Elevation	44 ft		
<b>Storm Damage</b>			
Structural Damage	Yes	Evidence of Wave in Deck	No
Structural Damage Description	1. The storm disconnected the conductor tray and damaged several supporting secondary steel members at the (-)40' elevation. A total of 22 anomalies were found at the (-)40' elevation. A drawing has been provided showing the locations of all these anomalies. 2. A dent 12"L x 12"W x 2"D was found on HZ A1-A2 at (-)90' elevation, 7' from leg A1 from 12:00 to 10:00. 3. A linear indication 3"L x 0.375"W was found on HD B3/B4 to B4 at (-)243' elevation, 30' from the mid pt. of B3/B4 at 12:00. 4. A hole 1"L x 2.5"W was found on VD B3/A3 at (-)189' to B3 at (-)140', 19' from the mid point of A3/B3 at 9:00. 5. The VD A2 at (-)140' to A3 at (-)90', 5' from A2 is buckled from 7:00 to 3:00. 6. A dent 16"L x 8"W x 2"D was found on VD A3 at (+)10' to A4 at (-)40', 12' from leg A3 at 12:00. 7. A dent 9"L x 5"W x 1.5"D was found on VD B4 at (+)10' to B3 at (-)40', 20' from leg B4 at 12:00. 8. The weld on VM A1/B1 at (-)40' to A1/B1 at (-)90' is broken at the (-)40' attachment to the HZ. 9. A gouge 3"L x 0.25"W x 0.125"D was found on HZ B4-B3 at (-)90' level, 24' from leg B4 at 3:00. 10. Several dents 29"L x 13"W x 3.5"D were found on VD from B3 (-)40' to B3/A3 (-)90', 24'

Response / Repair Description	1. A design level analysis was performed per API RP2A 21st edition, Section 17, using the L2 sudden hurricane environmental loading criteria. The damages in the structure were taken into account. 2. The analysis performed revealed some member and joint overstresses, and therefore an ultimate strength analysis was performed per API RP2A section 17, based on L2 criteria. The analysis demonstrated the structure to be adequate for manning so that repairs could be made. 3. The conductor tray at the (-)40' elevation was repaired. 4. The platform in its repaired state was again subjected to a design level analysis and to an ultimate strength analysis to confirm the adequacy of the repairs.		
Mitigation to Prevent Future Damage (reinforcement, remove unused equipment, relocate critical systems, etc.)	None		
<b>Contributing Factors to Platform Damage</b>			
Perceived Reasons for Damage (e.g., low deck, installation defect, falling debris, etc.)	None noted.

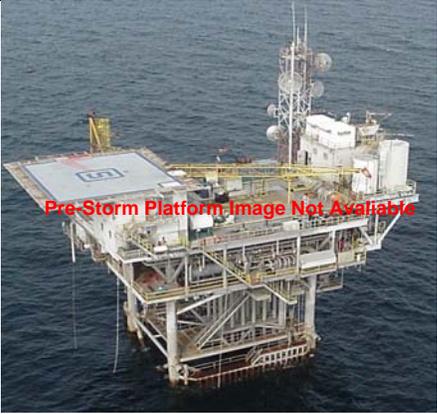
<b>Platform Damage Summary</b>			
Platform	Main Pass 306 F		
Operator	Noble Energy, Inc.		
<b>Platform Description</b>			
Water Depth	293 ft

Deck Height			
No. of Slots	18		
No. of Conductors	Not Documented		
Installation Date	1977		
API 2A Assessment Category	L2		
Jacket Type	Platform		
No. of Piles	4 Piles and 4 Skirt Piles		
Distance from Shore	31 mi		
Bracing Configuration	Long Frame: The center bay has XH bracing throughout, on both faces. The end faces have / bracing. Tran Frame: Both the faces have XH bracing, throughout.		
<b>Storm Exposure</b>			
Min. Distance/Direction from Eye	27 mi	Maximum Storm Surge	1.0 ft
Maximum Wave Height	74 ft	Maximum Wind Speed	67 kts
Significant Wave Height	42 ft	Current Speed	1.5 ft
Wave Crest Elevation	45 ft		
<b>Storm Damage</b>			
Structural Damage	Yes	Evidence of Wave in Deck	No
Structural Damage Description	Damage surveys following the hurricane revealed several anomalies to the platform in the upper four cross braces on row A & row B. Damage to the horizontal framing at the (-)28' and (-)75' levels were also discovered. A total of 22 anomalies were discovered. The complete description of the anomalies, as well as drawings of the anomalies are available in the report.

Response / Repair Description	1. A design level analysis was performed per API RP2A 21st edition, Section 17, using the L2 sudden hurricane environmental loading criteria. The damages in the structure were taken into account. 2. Due to the damage revealed during the level III inspection, an ultimate strength analysis was performed per API RP2A section 17, based on L3 criteria. The analysis demonstrated the structure to be adequate for manning so that repairs could be made. 3. All the damaged cross bracing and horizontal framing of the jacket were repaired. 4. The platform in its repaired state was again subject to a design level analysis and to an ultimate strength analysis (L2 criteria) to confirm the adequacy of the repairs.		
Mitigation to Prevent Future Damage (reinforcement, remove unused equipment, relocate critical systems, etc.)	None		
<b>Contributing Factors to Platform Damage</b>
