Results of the Long-Term Subsea 10,000hr Testing

Final Report

Prepared for:
**Bureau of Safety and Environmental Enforcement / Pipeline and
Hazardous Materials Safety Administration**
Houston, Texas

SES Document No.: 1461191-PL-RP-04 (Rev 0)

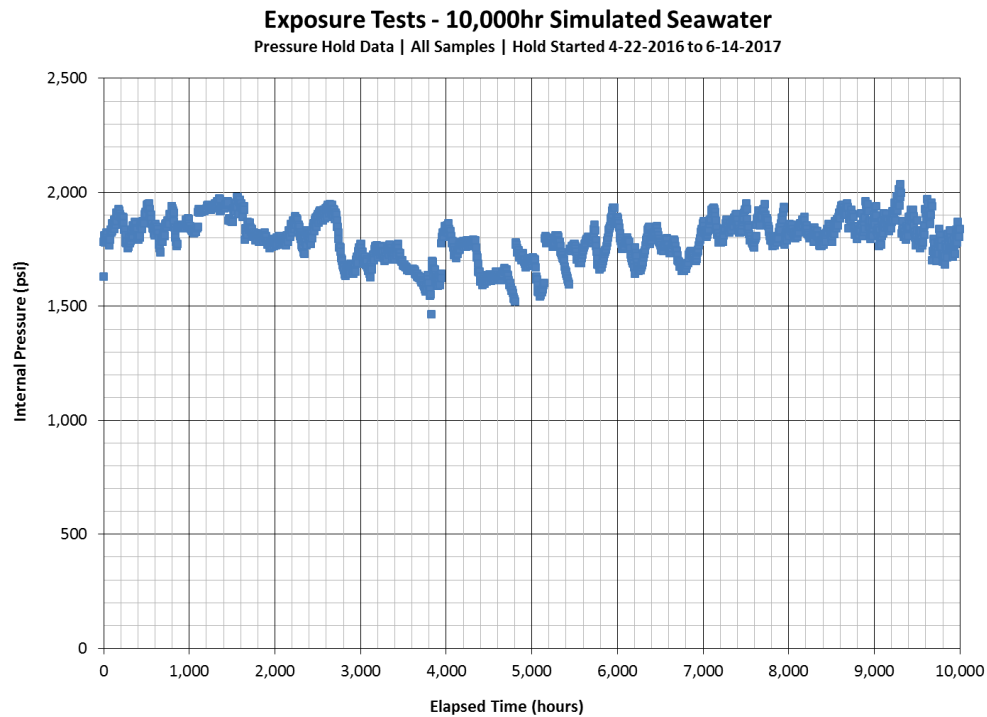
All 15 samples survived the 10,000hr salt water exposure tests without leaking. As shown in Figure 4-3, the internal pressure was maintained between 1,500 psi and 2,000 psi during the 10,000 hours. All samples were connected to a common pressure line and pressure transducer. The weldable strain gages installed under the composite repairs were not monitored during the pressure hold. Figure 4-4 is a photograph of the 15 samples following the pressure hold and draining of the saltwater bath.

Figure 4-3: Pressure vs. time plot for all samples during 10,000hr pressure hold

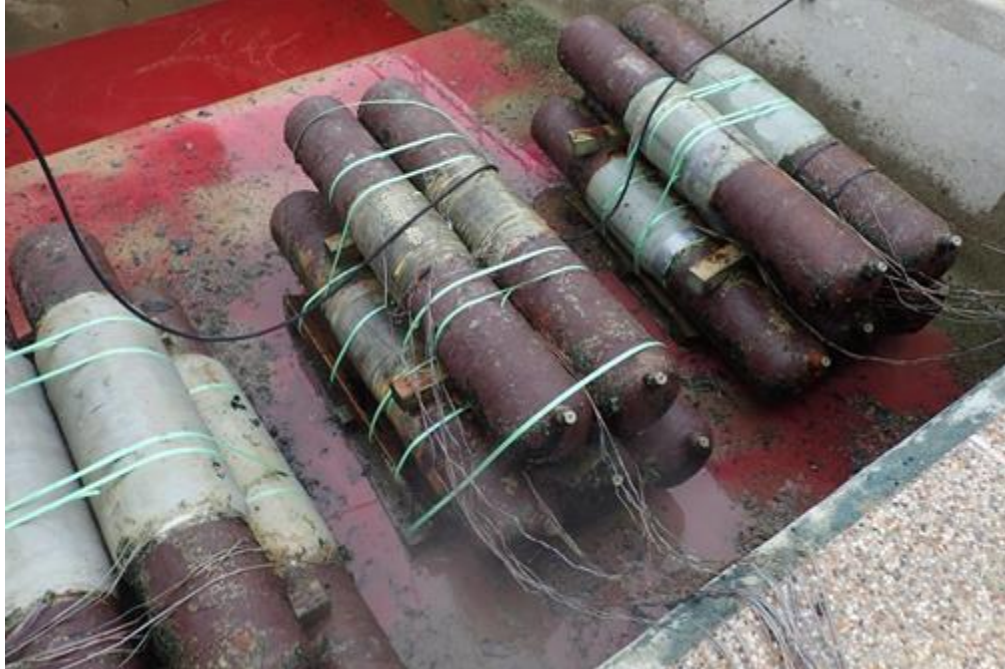
Figure 4-4: Photograph of samples after completion of 10,000 hour hold.

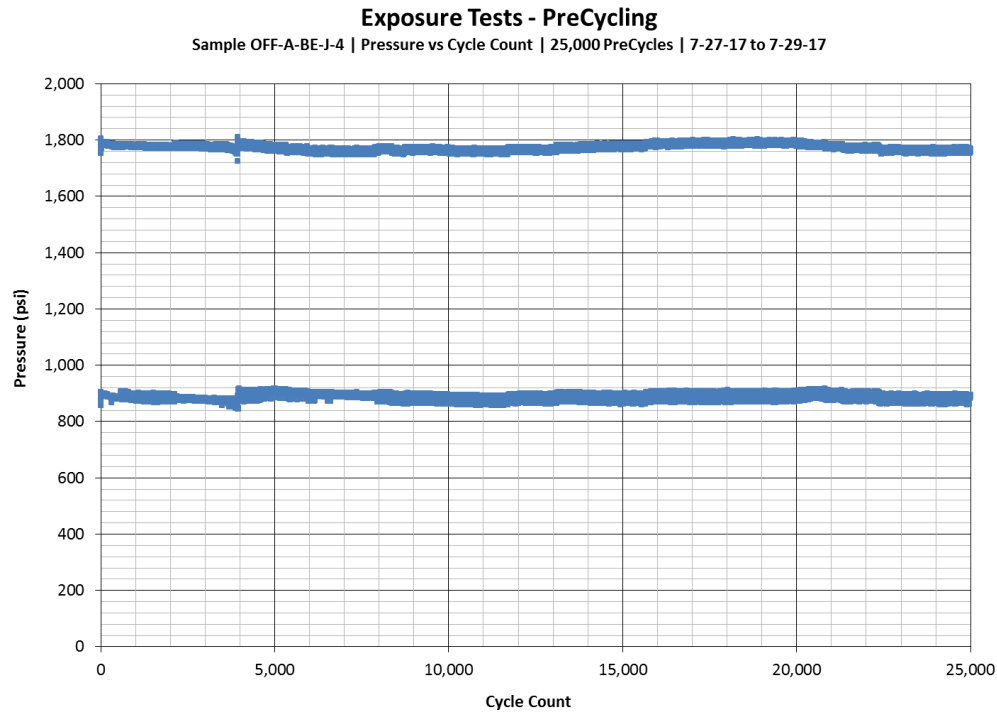
Figure 4-9: Max/min pressure vs. cycle count for 25,000 pre-cycles of sample OFF-A-BE-J1-4 (Manufacturer A’s bending sample)

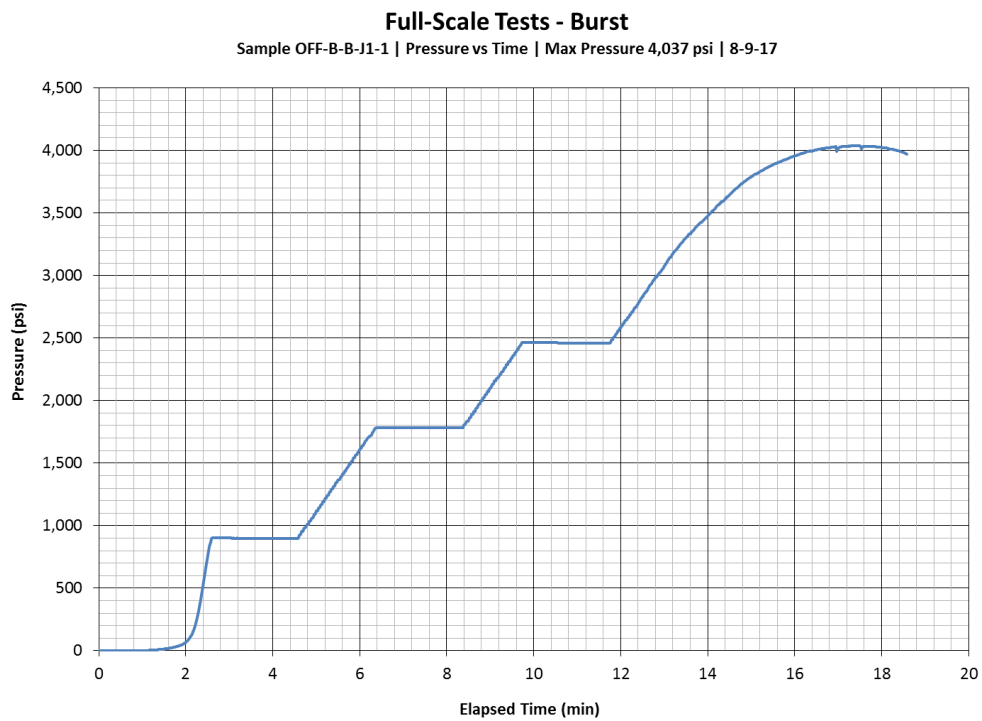
Manufacturer B's burst sample (OFF-B-B-J1-1) reached a maximum pressure of 4,037 psi (163% SMYS) before failure occurred outside of the repair in the base pipe (Figure 5-2). There was no visible damage to the outer surface of Manufacturer B's repair following the test. Figure 5-3 displays the internal pressure vs. elapsed time for the burst test. The three (3) hold points at 36%, 72%, and 100% SMYS are visible in the plot. The hoop strain measurements in Figure 5-4 indicate significant deformation in the base pipe and corrosion region during the test (corrosion region gage 2H was the only operable gage during the burst of this sample). The gages on the outside of the composite repair measured little in the way of hoop strain during the test.

Figure 5-3: Internal pressure vs. elapsed time for Manufacturer B's burst sample (OFF-B-B-J1-1)

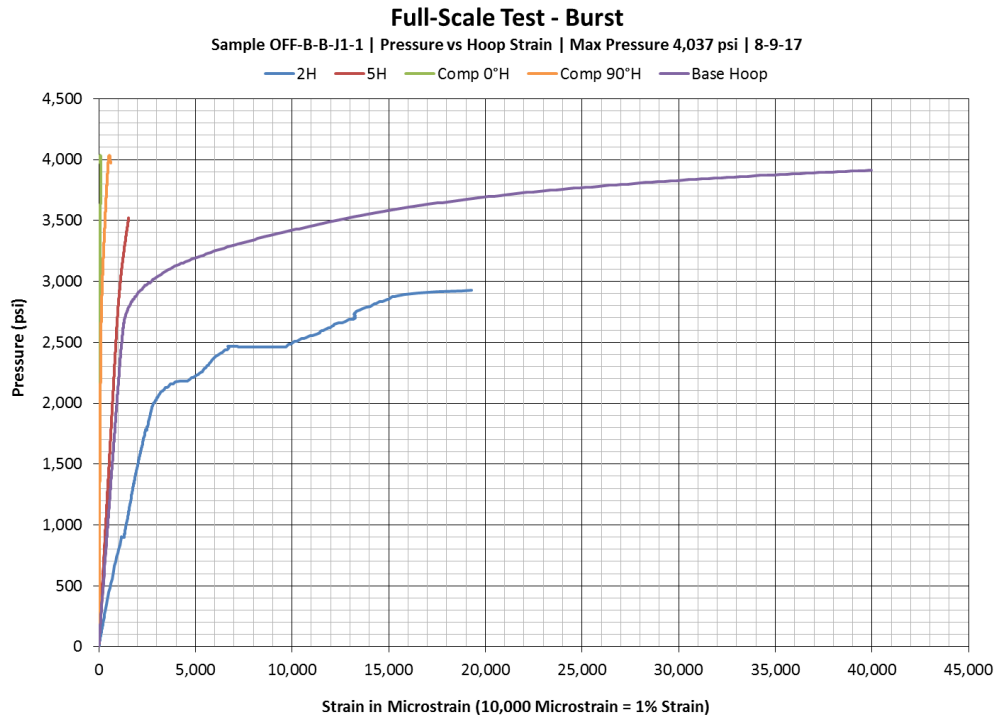
Figure 5-4: Internal pressure vs. hoop strains in corrosion region, base pipe, and on outer layer of composite repair for Manufacturer B’s burst sample (OFF-B-B-J1-1)

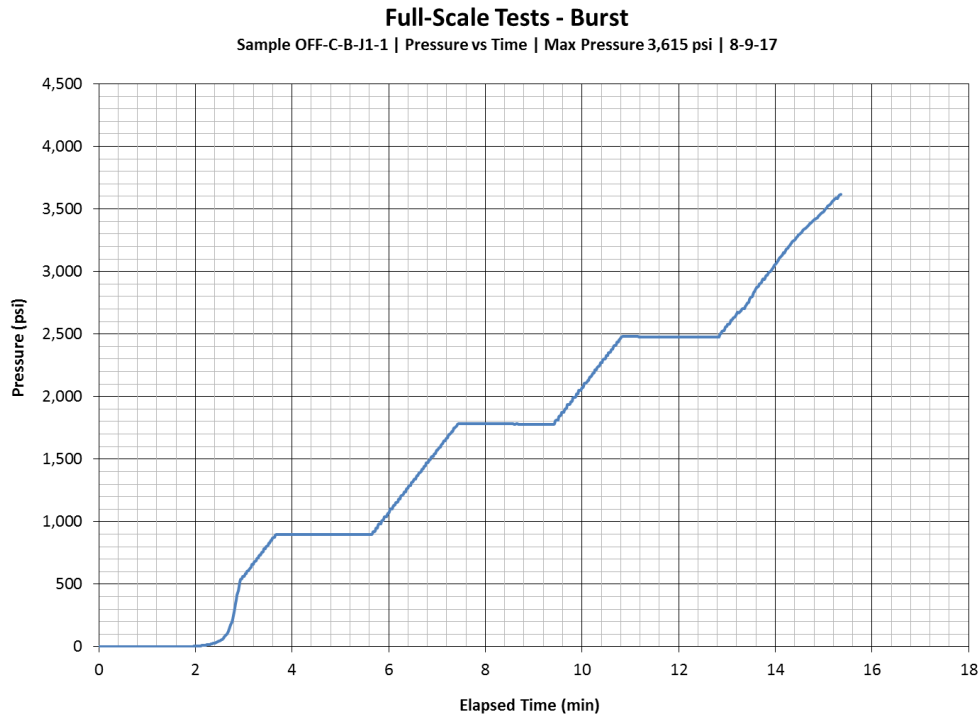
The Manufacturer C’s burst sample (OFF-C-B-J1-1) reached a maximum pressure of 3,615 psi (146% SMYS) before failure occur in the simulated corrosion defect as shown in Figure 5-5. Figure 5-6 displays a plot for the internal pressure vs. elapsed time during the burst. Similar to Manufacturer B’s sample, the hoop strain measurements in Figure 5-7 also indicated deformation in the base pipe with little change on the surface of the composite repair. No gages in the simulated defect were operable during the burst.

Figure 5-6: Internal pressure vs. elapsed time for Manufacturer C's burst sample (OFF-C-B-J1-1)

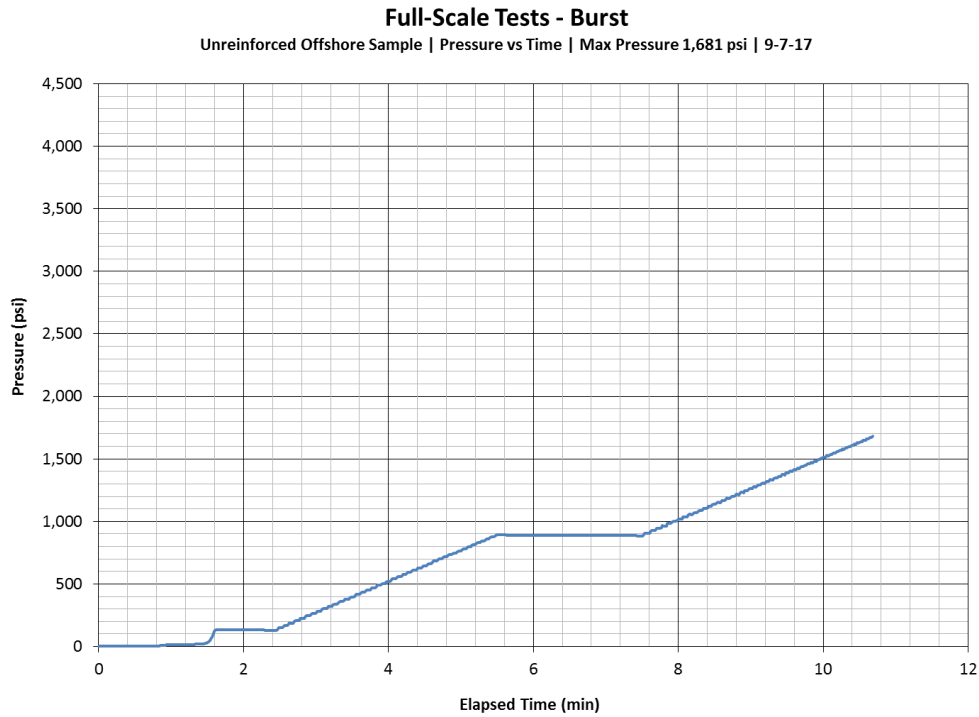
The 75% corrosion unreinforced sample burst at a pressure of 1,681 psi (68% SMYS) in the corrosion region. This sample did not reach the second hold point of 72% SMYS. A strain gage installed in the corrosion region indicated yielding occurred at just over 600 psi.

Figure 5-8: Internal pressure vs. elapsed time for unreinforced sample with 75% corrosion defect

The results in Table 5-2 demonstrate that the composite repairs were successful in reinforcing the corrosion defects in an aggressive cycling environment even after the exposure tests. From Figure 5-8, an unreinforced sample would not have reached the peak cycle pressure of 72% SMYS (1,780 psi) before failure.

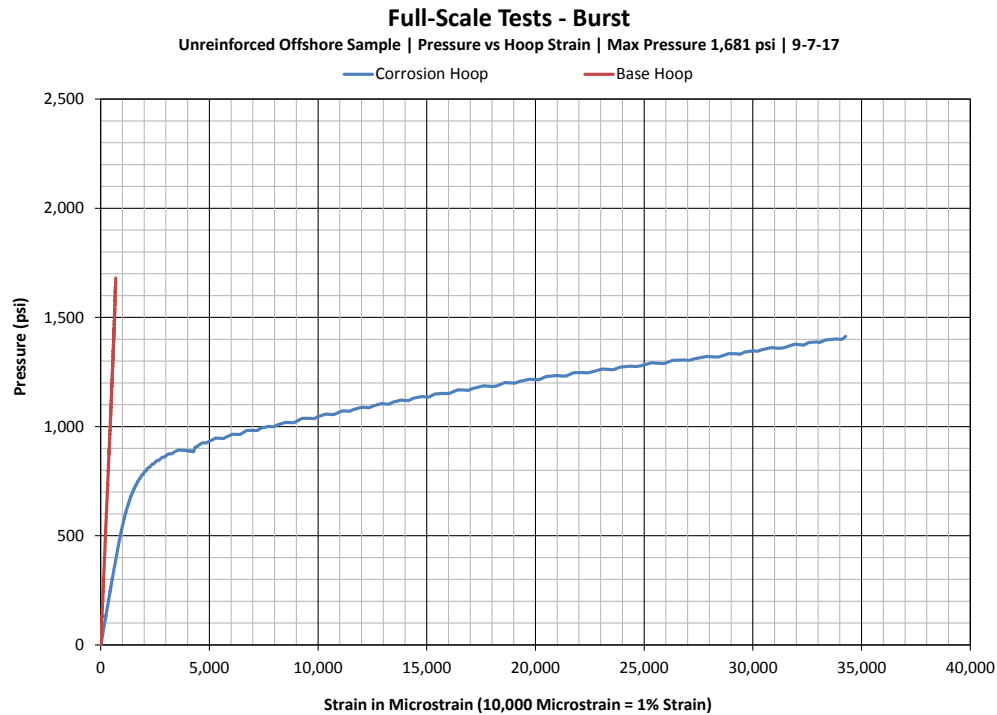
Figure 5-9: Internal pressure vs. hoop strain for unreinforced sample with 75% corrosion defect

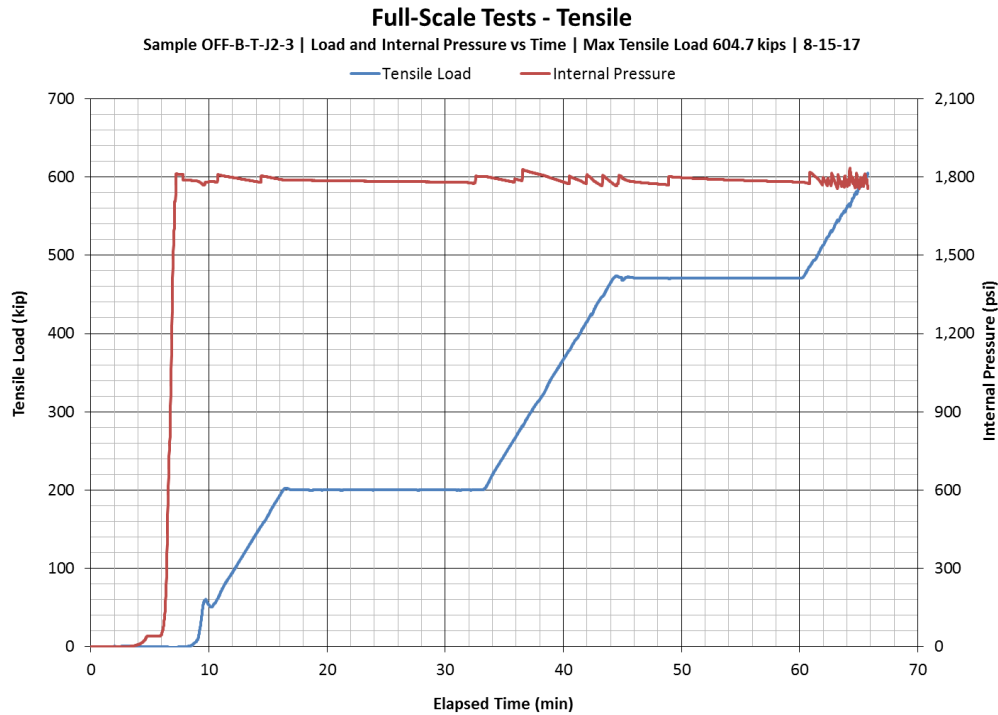
Manufacturer B's sample reached a maximum applied tensile load of 604.7 kips as shown in Figure 5-13 before failure. Failure occurred when the sample was no longer able to maintain the internal pressure, and a leak path developed from the corrosion defect to the edge of the repair. SES inspected the repair following the failure, but there was no other visible damage.

Figure 5-13: Load and internal pressure vs. elapsed time for Manufacturer B’s tensile sample (OFF-B-T-J2-3)

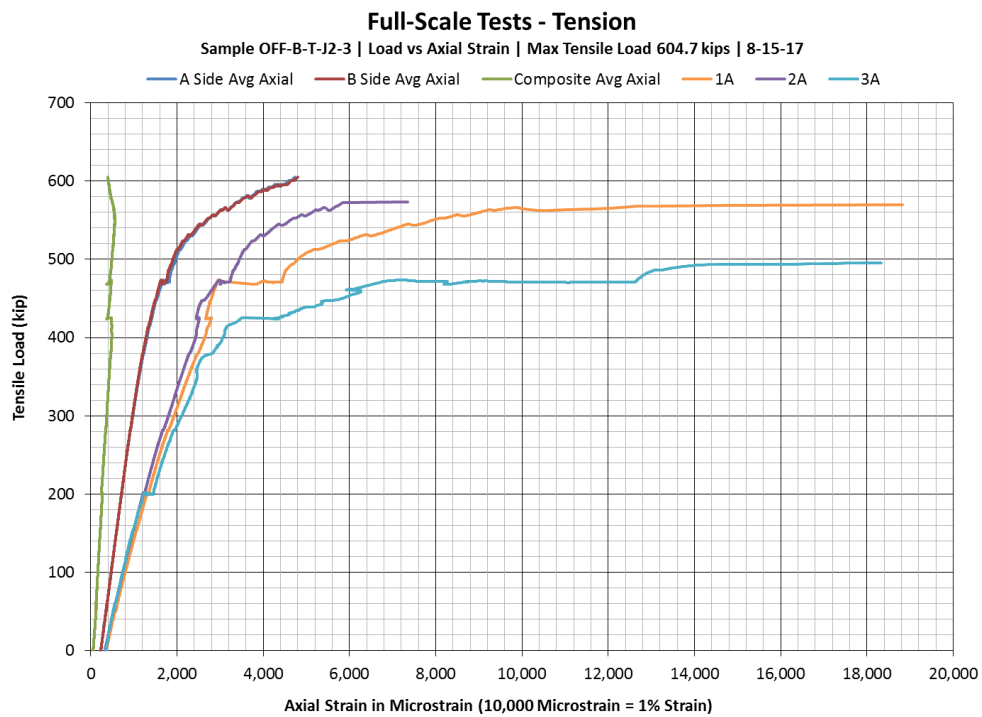
Strain measurements in Figure 5-14 indicate that the base pipe to either side of the repair had begun to plastically deform and reached a maximum axial strain of 4,700 to 4,800 microstrain before failure in the corrosion defect. It should be noted that the base pipe axial strains in Figure 5-14 are the average of the four strain gages installed per side. Manufacturer B's sample had three operable axial gages in the corrosion defect that indicated a significant increase in strain after an applied load of 350 kips. A maximum axial strain of 559 microstrain was measured on the outer layer of the composite. This is not insubstantial for Manufacturer B's carbon fiber repair and indicates that load was being transferred throughout the composite.

Figure 5-14: Tensile load vs axial strain for Manufacturer B’s tensile sample (OFF-B-T-J2-3)

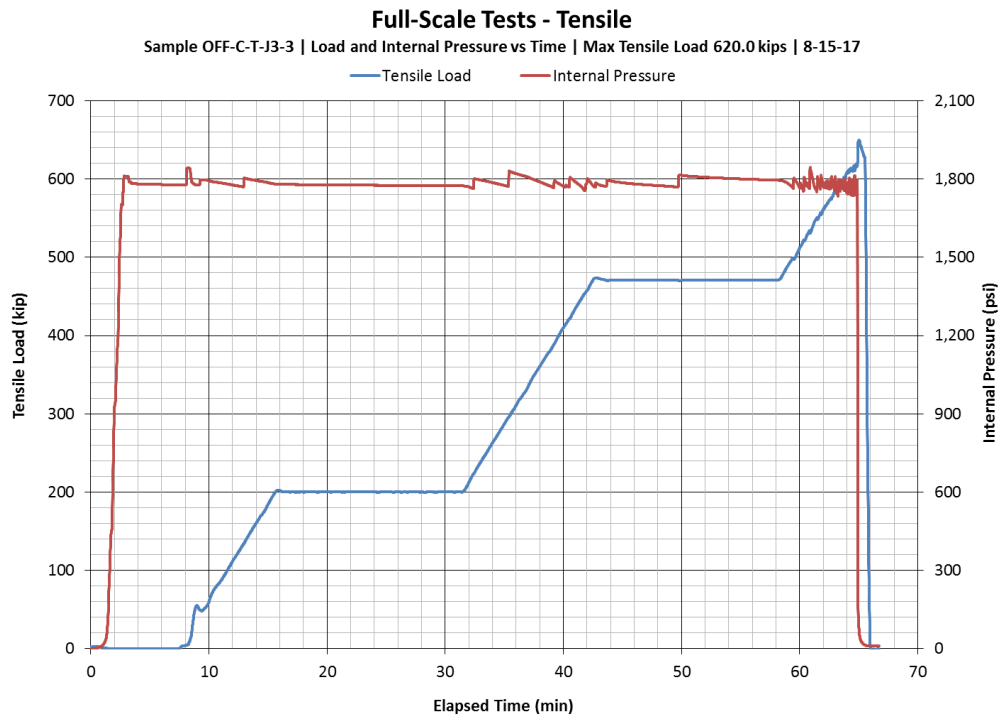
Manufacturer C’s sample reached a maximum applied tensile load of 620.0 kips as shown in Figure 5-15 before failure. The failure occurred before the five minute hold at 620 kips began. The sample was no longer able to maintain pressure at this load and a leak path developed from the corrosion defect to the edge of the repair. Post-test examination of the repair revealed cracks near the edge of the repair as shown in Figure 5-17.

Figure 5-15: Load and internal pressure vs. elapsed time for Manufacturer C’s tensile sample (OFF-C-T-J3-3)

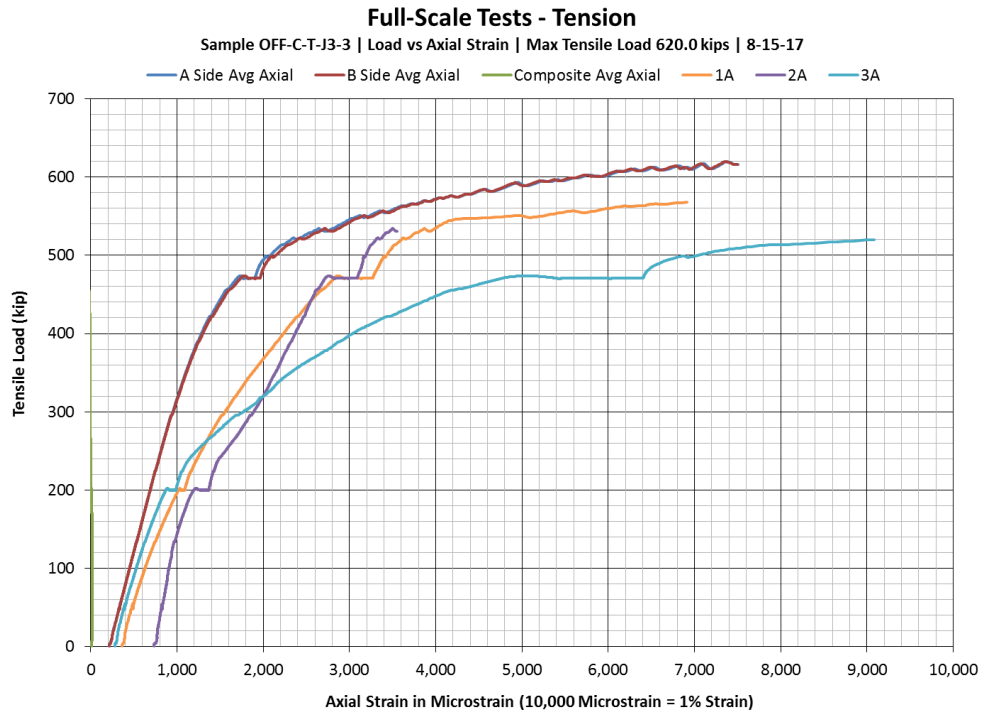
Figure 5-16: Tensile load vs axial strain for Manufacturer C's tensile sample (OFF-C-T-J3-3)

The strain measurements in Figure 5-16 indicate plastic deformation in the base pipe on both sides of the repair which reached nearly 8,000 microstrain in the axial orientation before the failure. Manufacturer C’s sample also had three operable axial strain gages in the corrosion defect at the start of the test. Gage 3A reached a maximum axial strain of 9,000 microstrain at an applied load of just over 510 kip before the gage failed. The axial strain on the surface of the composite remained near zero during the test.

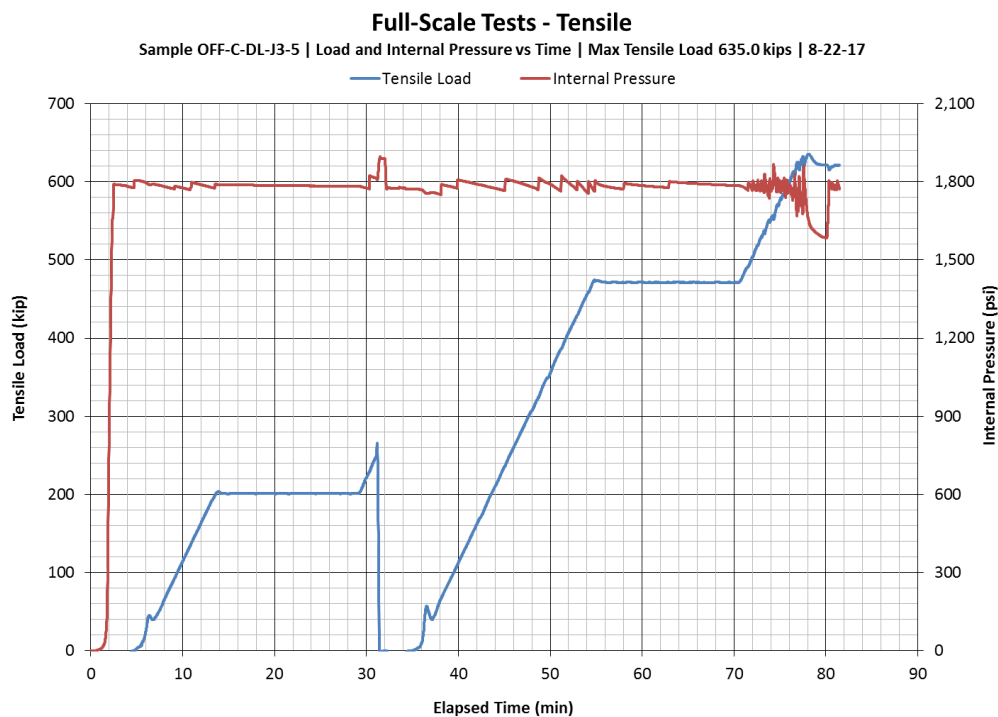
Figure 5-18: Load and internal pressure vs. elapsed time for Manufacturer C’s delamination sample (OFF-C-DL-J3-5)

The test results in Figure 5-18 indicate that the delaminations had little effect on the repair’s tensile test performance. Manufacturer C’s delamination sample reached a maximum applied tensile load of 635.0 kips, which was slightly higher than the previous Manufacturer C tensile sample with no delaminations. The drop in load in Figure 5-18 was to repair a leak in a pressure line and does not represent a failure of the sample. Similar to the previous tests, failure occurred when a leak path developed in the simulated corrosion region under the composite repair.

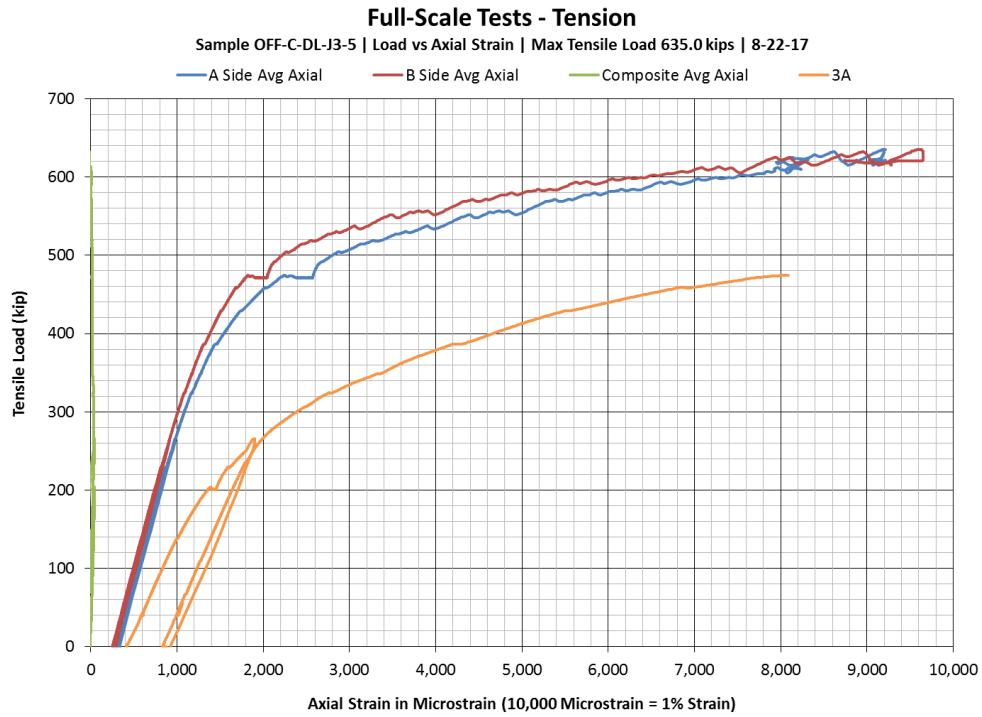
Figure 5-19: Tensile load vs axial strain for Manufacturer C’s delamination sample (OFF-C-DL-J3-3)

Axial strain measurements in Figure 5-19 indicate the base pipe in this sample reached nearly 10,000 microstrain before failure. The one operable axial strain gage in the corrosion defect reached over 8,000 microstrain before it became inoperable at an applied load of 490 kips. Similar to the previous Manufacturer C tension sample, there was little to no increase in axial strain on the outer surface of the repair. This Manufacturer C repair also exhibited cracks in the repair post-test as shown in Figure 5-20.

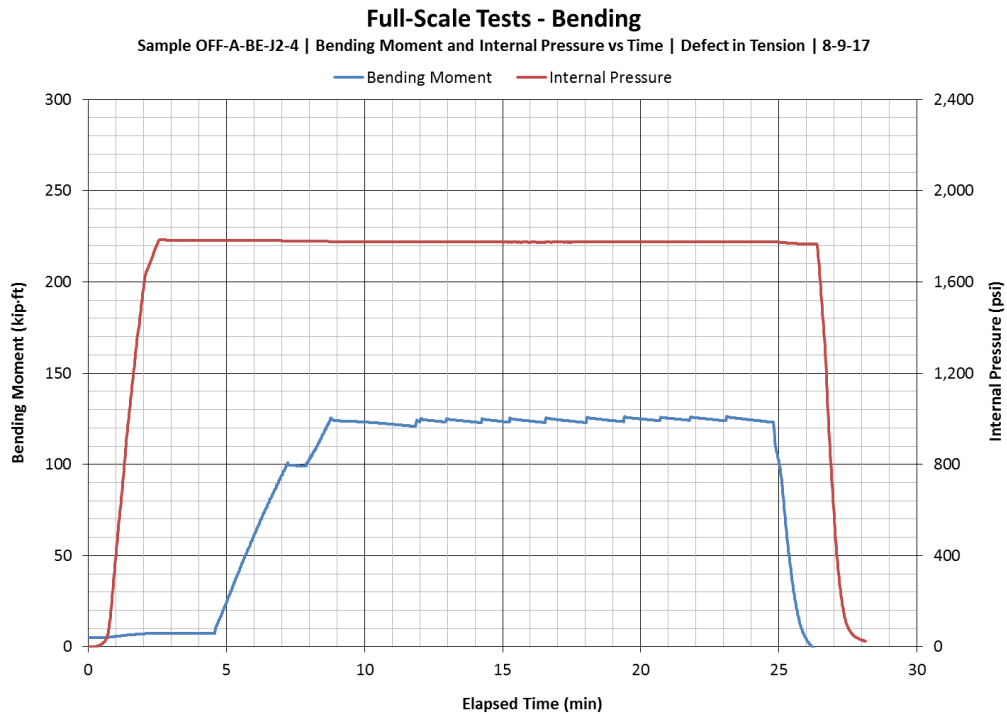
Figure 5-23: Manufacturer A’s bending sample (OFF-A-BE-J2-4) moment and internal pressure vs. elapsed time with corrosion defect in tension

Manufacturer A's bending sample survived the first phase of testing to a maximum bending moment of 125 ft·kips with the defect in tension as shown in Figure 5-23. The axial strains in the base pipe and corrosion defect were similar to those observed in Manufacturer B and C's samples (Figure 5-24). After the sample was rotated to place the corrosion defect in compression, the sample failed at a bending moment of 264.6 ft·kips (Figure 5-25). The base pipe axial strains in Figure 5-26 for Manufacturer A's sample were slightly lower than the other bending samples at just over 5,000 microstrain (0.5% strain).

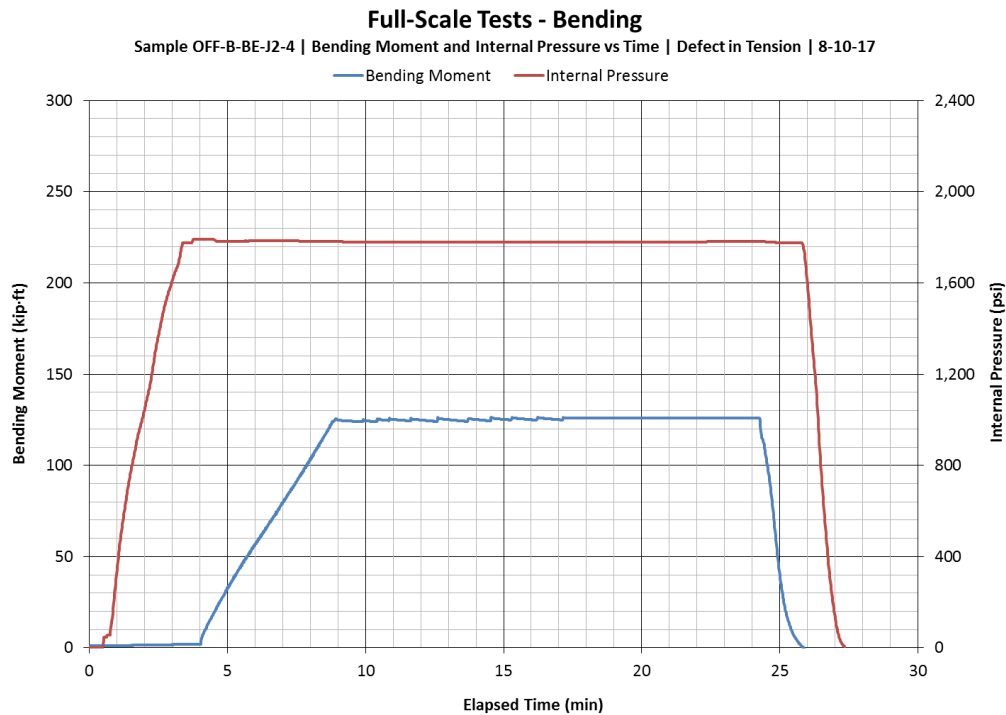
Figure 5-28: Manufacturer B’s bending sample (OFF-B-BE-J2-4) moment and internal pressure vs. elapsed time with corrosion defect in tension

Manufacturer B’s bending sample completed the first phase the bend test without failure (defect in tension) as shown in Figure 5-28. The bending moment and internal pressure both remained stable during the 15 minute pressure hold. Figure 5-29 indicates the maximum axial strains in the base pipe were under 1,500 microstrain at 125ft-kips. Figure 5-29 does not include any of the weldable strain gages installed under the composite repair as none survived the exposure testing. After the bending moment was removed, Manufacturer B’s sample was rotated so the corrosion defect was in compressed.

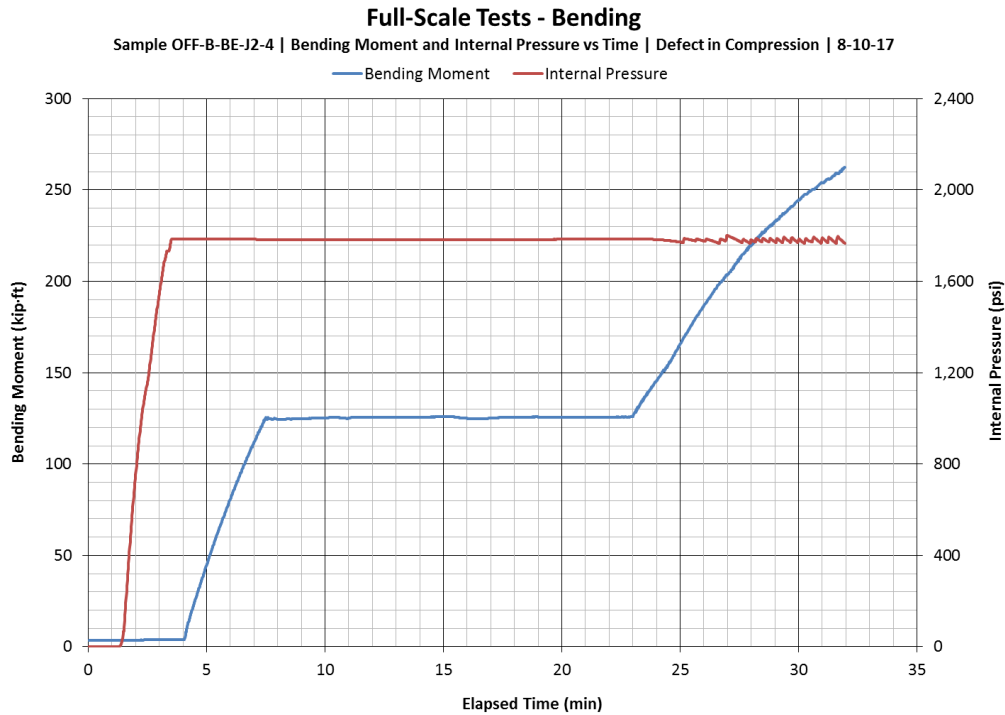
Figure 5-30: Manufacturer B’s bending sample (OFF-B-BE-J2-4) moment and internal pressure vs. elapsed time with corrosion defect in compression

Manufacturer B’s sample failed at a bending moment of 262.4 kip-ft with the defect in compression as shown in Figure 5-30. Beyond a load of 175 ft-kips, the internal pressure was difficult to maintain due to deformation in the base pipe. This deformation is confirmed by the base pipe axial strains in Figure 5-31 (note the 0° location is now in compression since the sample was rotated). The maximum axial strain in the composite was 1,230 microstrain (0.12% strain). The maximum axial strain in the base pipe was approximately 11,900 (1.19% strain) at the time of failure. Failure occurred by a loss of internal pressure when a leak path developed from the corrosion defect to the edge of the repair. Figure 5-32 is Manufacturer B’s sample post-test after the bending moment was removed. The sample experienced permanent deformation and exhibited a visible curvature following the bend test.

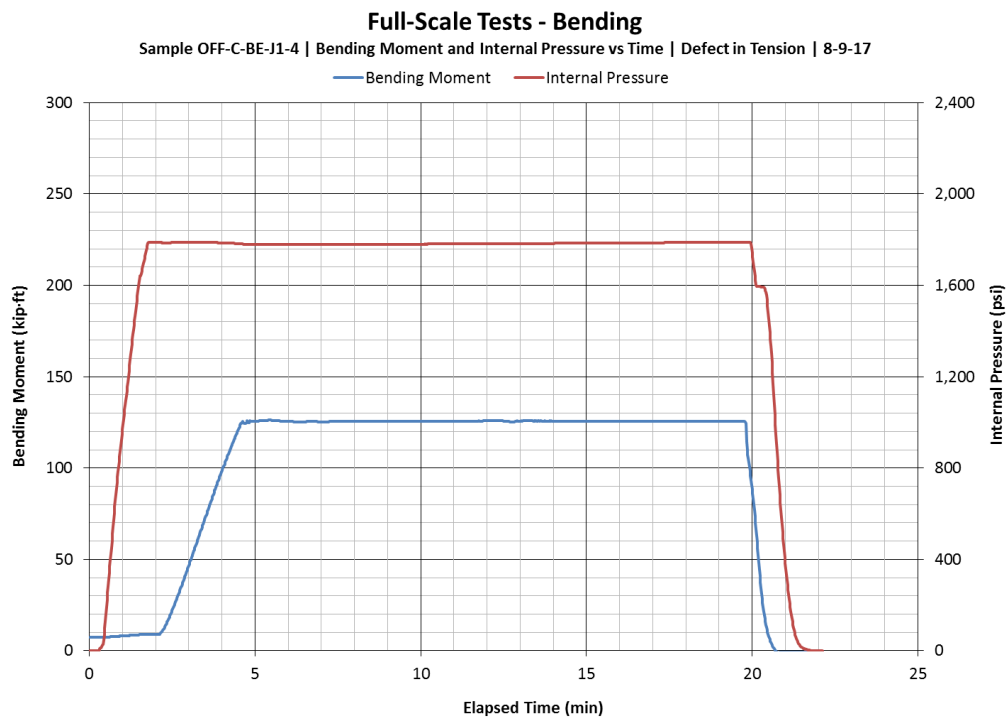
Figure 5-33: Manufacturer C’s bending sample (OFF-C-BE-J1-4) moment and internal pressure vs. elapsed time with corrosion defect in tension

Manufacturer C’s sample also successfully completed the first phase of the bend test with the defect in tension. Figure 5-33 displays the bending moment and internal pressure vs. elapsed time for this phase of the test. The base pipe axial strains in Figure 5-34 are similar to those observed in Manufacturer B’s sample. Three weldable axial strain gages in the corrosion defect were still functioning after the exposure tests and are included in Figure 5-34. The 3A axial gage in the corrosion defect recorded the highest defect axial strain of 3,100 microstrain during the bend test. After completing the first phase of the bend test with the corrosion defect in tension, the sample was rotated 180° to place the defect in compression for the second phase of the test.

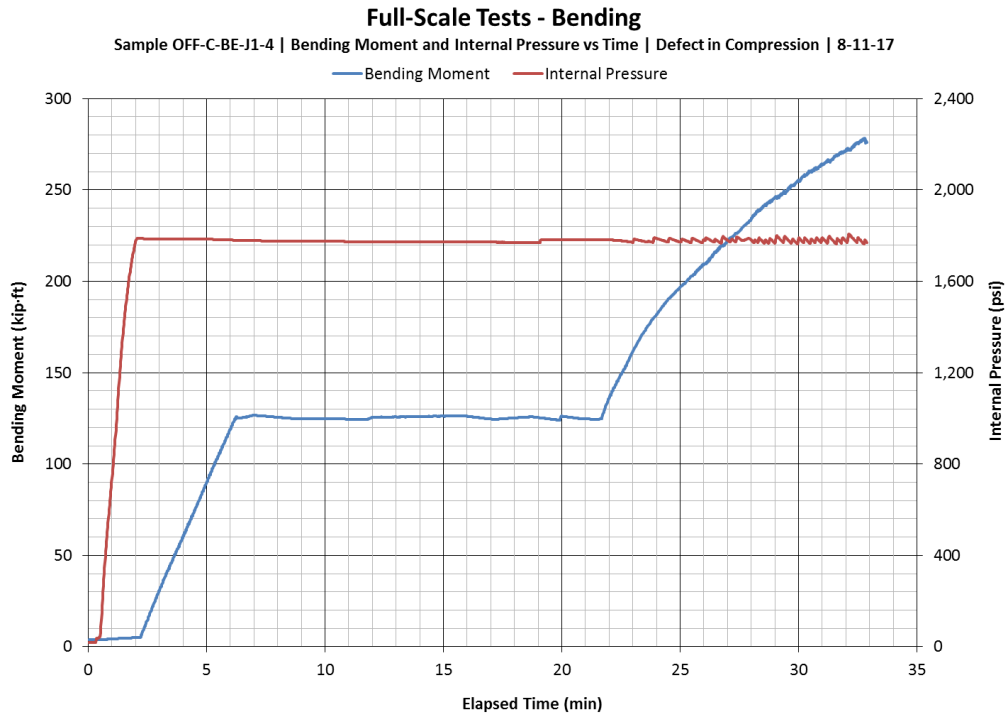
Figure 5-35: Manufacturer C’s bending sample (OFF-C-BE-J1-4) moment and internal pressure vs. elapsed time with corrosion defect in compression

With the corrosion in compression, Manufacturer C’s sample reached a bending moment of 278.4 kip·ft as shown in Figure 5-35 before failure occurred at the corrosion defect. Similar to Manufacturer B’s sample, the sample began to deform near the end of the test and it became difficult to maintain the internal pressure. Figure 5-36 indicates that the axial strains in the base pipe ranged from 10,000 to 20,000 microstrain (1% to 2% strain) prior to failure. The strains on the outer surface of the composite repair during the test were low (under 300 microstrain) which indicates the majority of the load was carried by the inner layers of the repair. The permanent shape of Manufacturer C’s sample after failure and removal the bending moment is shown in Figure 5-37. Unlike Manufacturer B’s sample that developed a leak at the edge of the repair at failure, the corrosion defect in Manufacturer C’s sample ruptured through the composite as illustrated in Figure 5-38.

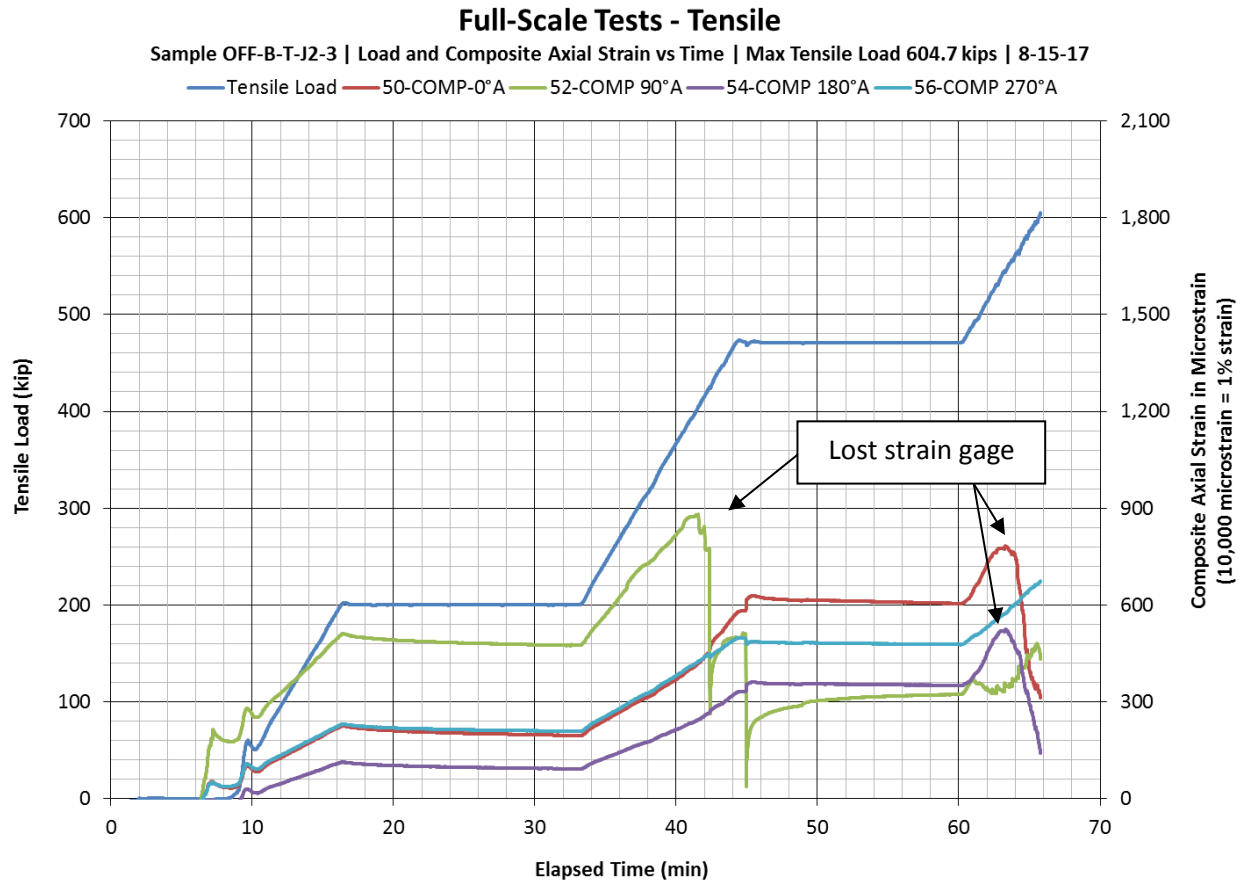
Figure 6-1: Plot of axial load and composite axial strain vs elapsed time during tension test

Strain gage results from the tension sample do not point to significant reinforcement being provided by the composite repair. Axial strains in the simulated corrosion region are consistently greater than those recorded in the base pipe outside the repair. This is not necessarily an indication of damage due to exposure testing, but could reflect the design of the composite repair itself. Achieving the test pressure of 72% SMYS shows that adequate reinforcement was provided in the hoop direction, but the tension test requires substantial reinforcement in the axial direction. Although it appears that the composite is not providing a significant amount of reinforcement, it is clear that there is load transfer to the composite due to the correlation between composite axial strain and increasing axial load during testing (Figure 6-2).

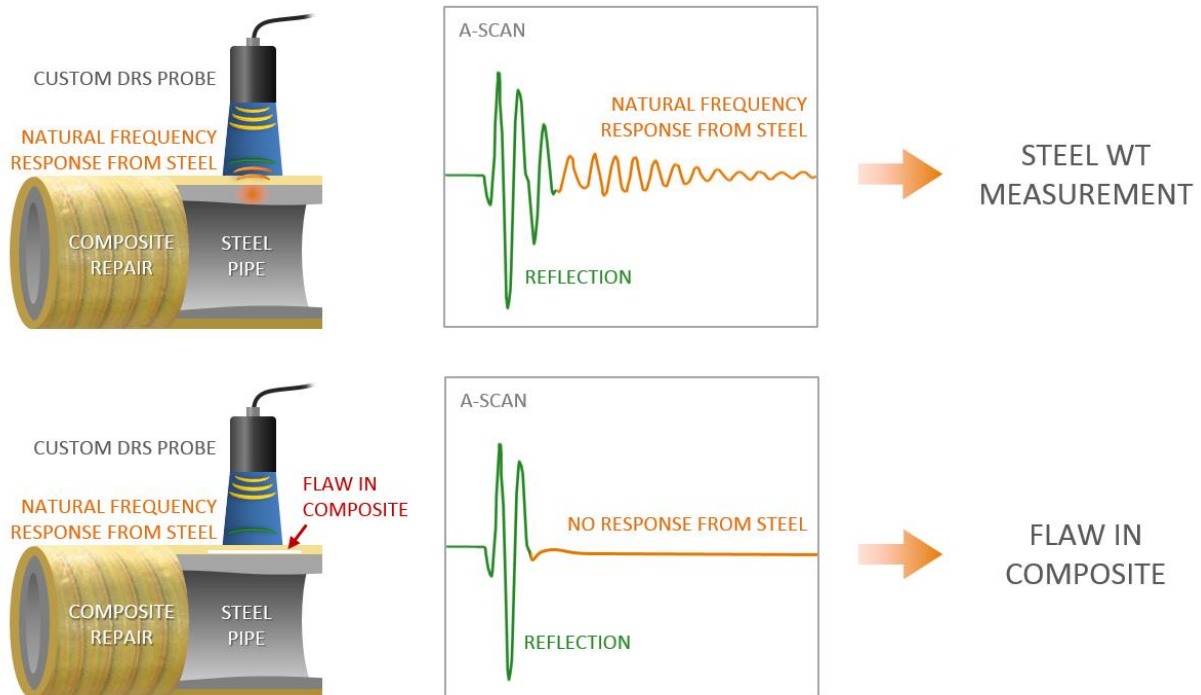
Figure 5. Diagram illustrating the effect of a flaw in the composite on the DRS signals.

It should be noted that for repairs suitable for DRS inspection, a loss of signal from the steel indicates a flaw in the composite (such as a delamination), as shown in Figure 5 and Figure 6. However, for repairs such as those evaluated in this study, it is not possible to identify delaminations as they are indistinguishable from the loss of signal due to attenuation in the thick composite.

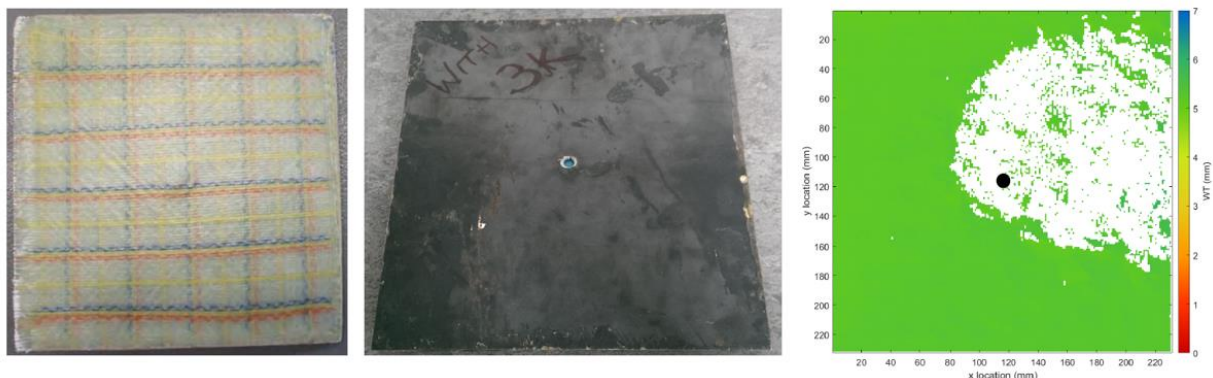
Figure 6. DRS inspection of a blow-off test plate sample. Green shows the steel WT where the composite remains bonded, white shows where the DRS signals are lost due to delamination.

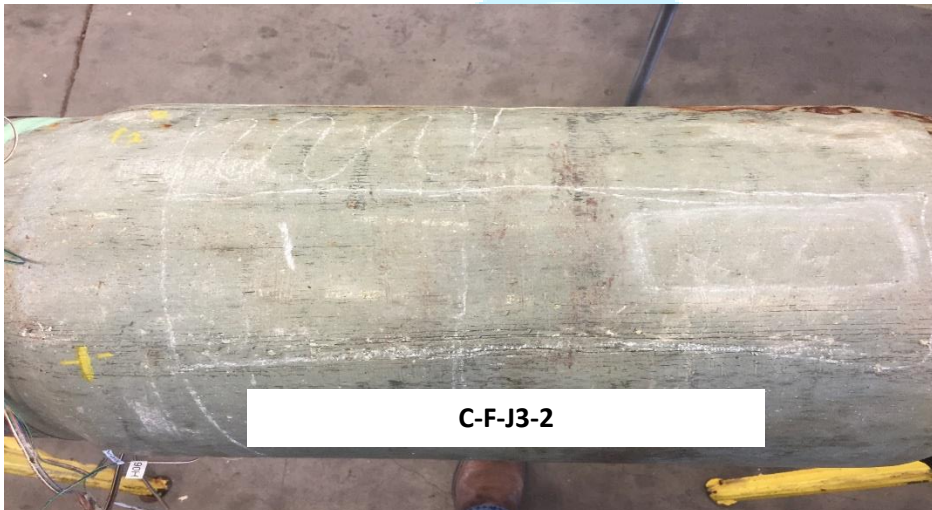
Indication # 2 (All around the circumference of the wrap. From Nozzle end – Starting 2" to 3" from edge of wrap; 6" wide (radius)).

- Note these could be non-relevant indications based on the inconsistency of the readings and lower amplitude of the signals.

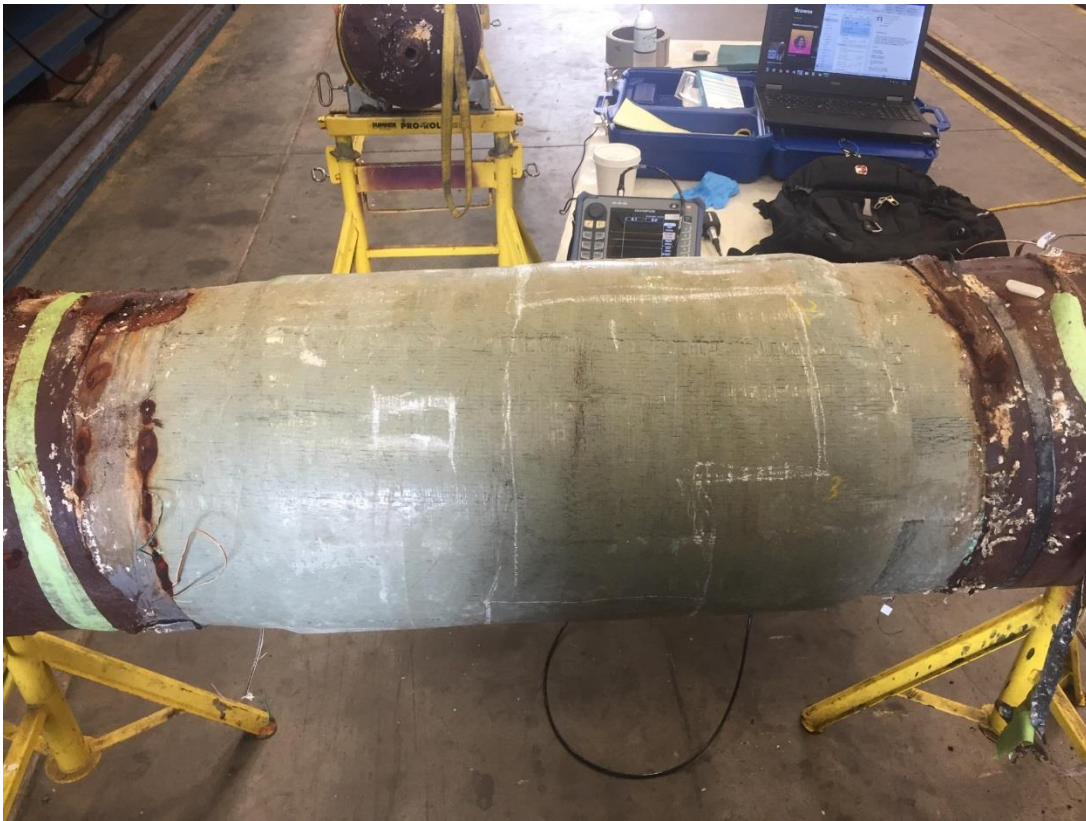
Subsea Composite Test Sample # C-F-J3-2

Indication # 1 Starting about 2" from nozzle end running around the circumference of the wrap inconstantly

- Approximately 10" Long (axially) (Could be non-relevant)

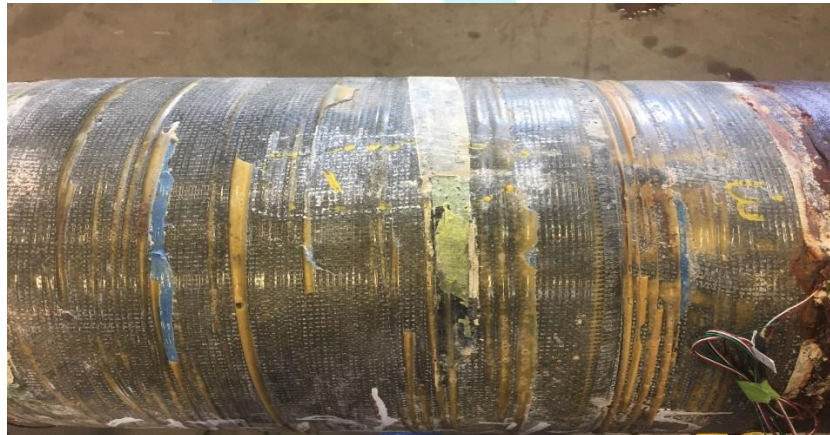
Subsea Composite Test Sample # B-DL-J1-5

Indication # 3 (between the 0 & 1 marker). In middle of wrap but closer to opposite of nozzle side. Could be non-relevant

- Approximately 5" x 3"

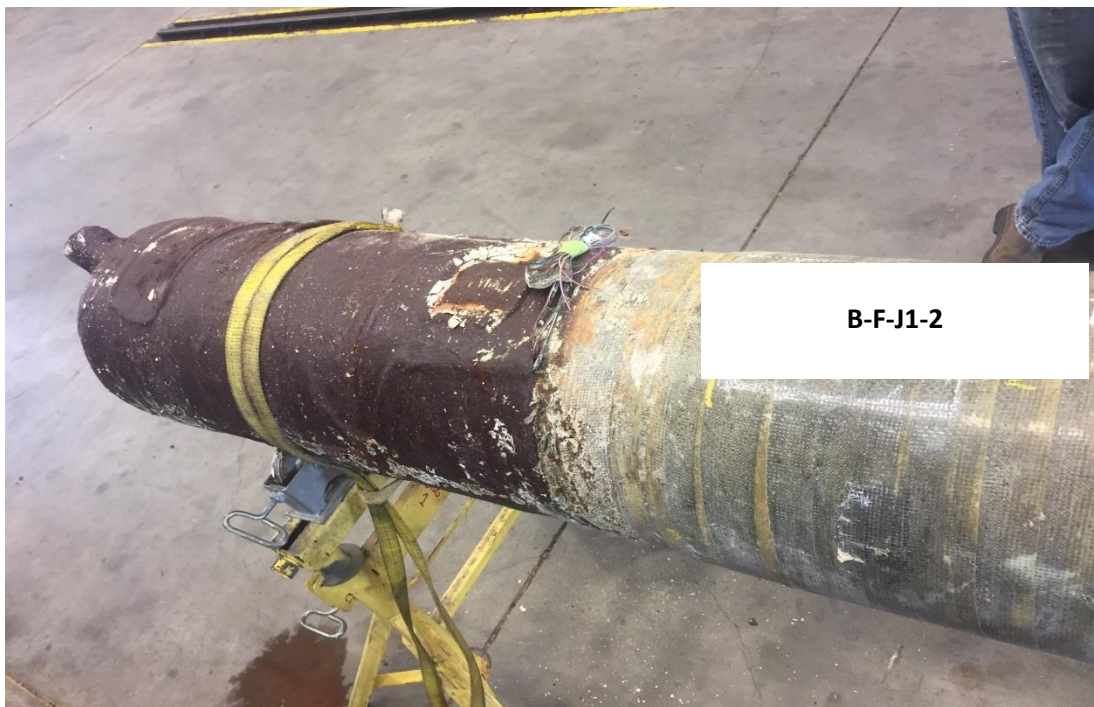
Subsea Composite Test Sample # B-F-J1-2

Relevant Indication # 1 (At the 0 marker / Nozzle). 3" from edge of wrap closer to nozzle

- Approximately 8" x 6"
