Results of the Long-Term Subsea 10,000hr Testing

Final Report

Prepared for:
**Bureau of Safety and Environmental Enforcement / Pipeline and
Hazardous Materials Safety Administration**
Houston, Texas

SES Document No.: 1461191-PL-RP-04 (Rev 0)

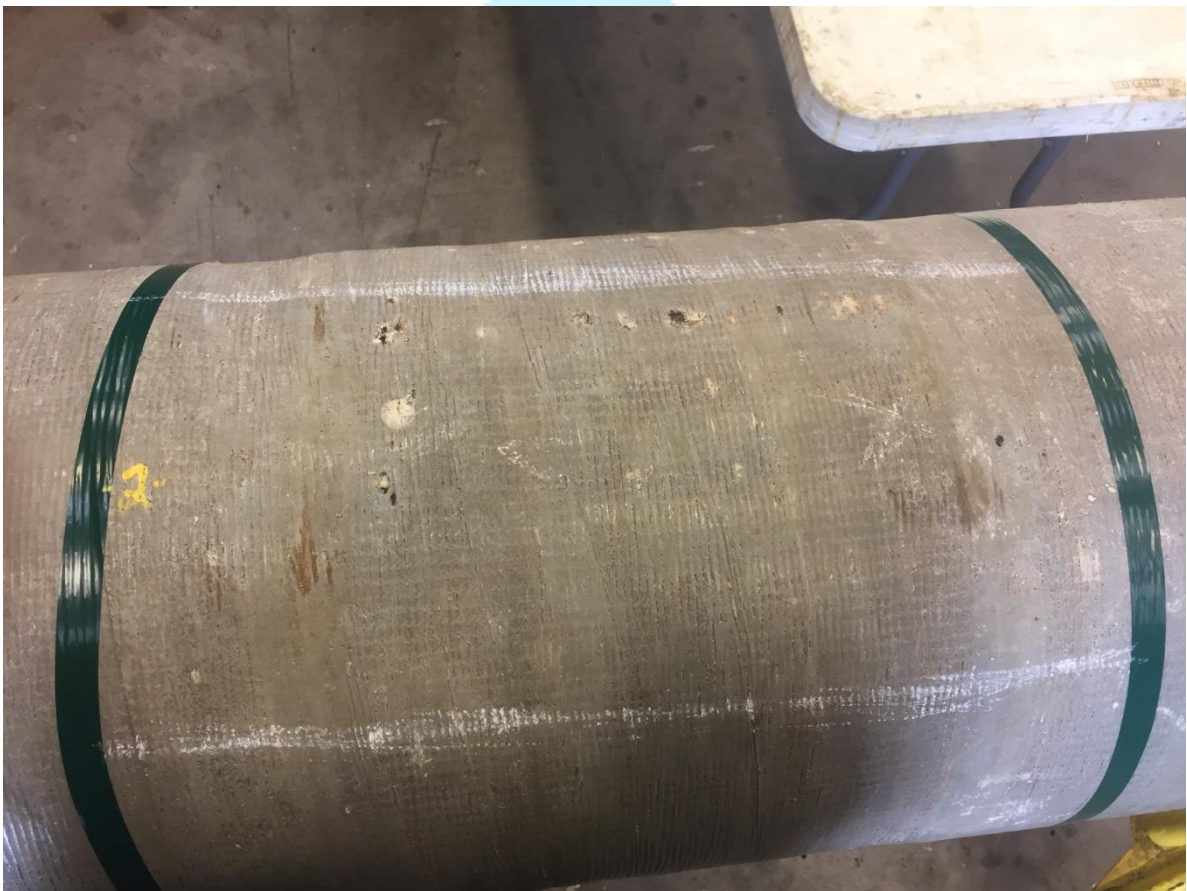
Subsea Composite Test Sample # A-DL-5

Indication # 2 (At the 1 marker). 10" from nozzle end of wrap.

- Approximately 3" x 3"
- Could be non-relevant based on size and lower amplitude
