# SAFECOM\* SUMMARY

Apr - Oct 2016

# Case Study – Doors and Windows

# Case Study – Helideck Hazards

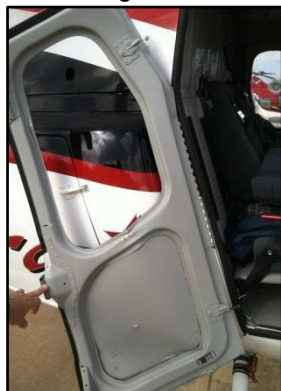
Figure 3

In the last six months of FY16, the majority of these events were due to mechanical issues while the rest were associated with human performance (e.g., not properly securing a door) or decision making/risk tolerance (e.g., choosing to fly with a broken door handle).

- **Oversight/Management.** A working group consisting of BSEE, Office of Aviation Services, and our aviation service provider has been established to review door/window incidents and develop corrective actions.
