**Investigation of March 10, 2016, Fatality
Lease OCS-04940, Green Canyon Area- Block 18**

**Gulf of Mexico Region, Houma District
Off Louisiana Coast**

March 8, 2017

**U.S. Department of the Interior
Bureau of Safety and Environmental Enforcement**

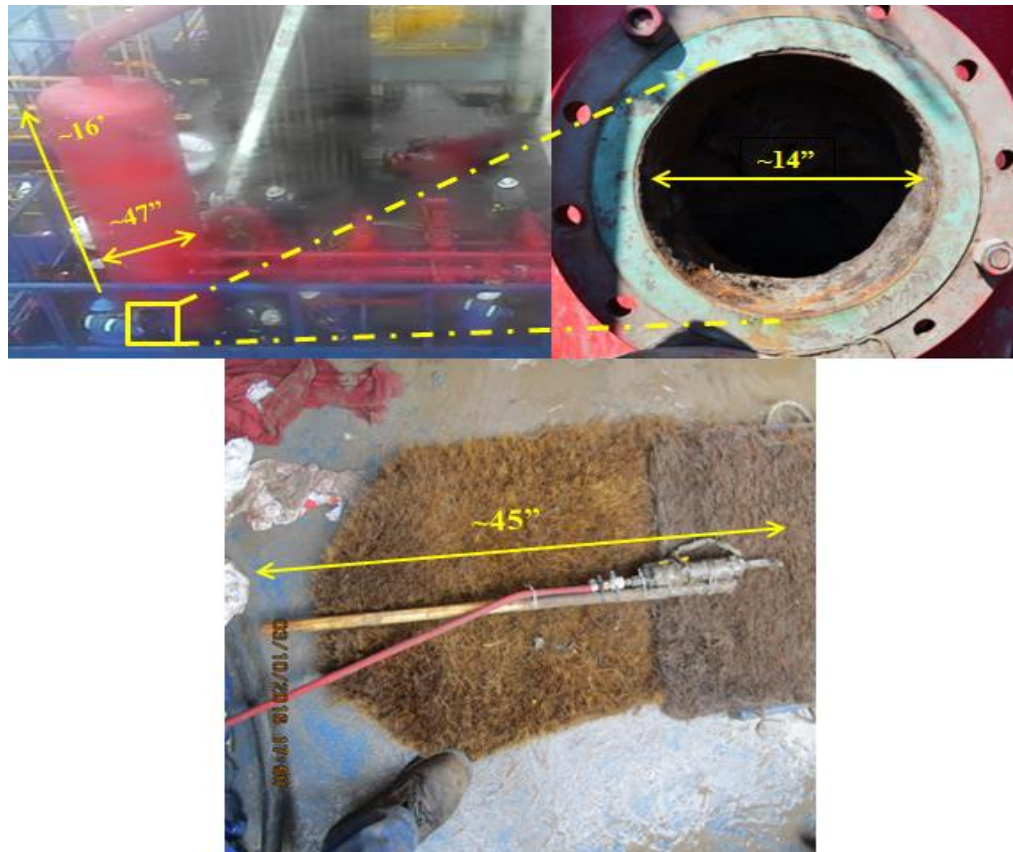
Figure 6: Depiction of approximate Dimensional Relationships between the MGS, its Inspection Hatch and the Chipping Tool.

Specifically, the JSA document did not list the pneumatic chipping tool being used for the task nor did it take into account unique hazards associated with its use. More specifically, the analysis of the task did not contemplate the limitations imposed by the 45 inch length of the rigid chipping tool as it related to the assignment of cleaning the interior of the 47 inch by 16 foot vertical MGS with internal baffles, through its 14 inch inspection hatch and 8 inch drain line openings (*see Figure 6*).

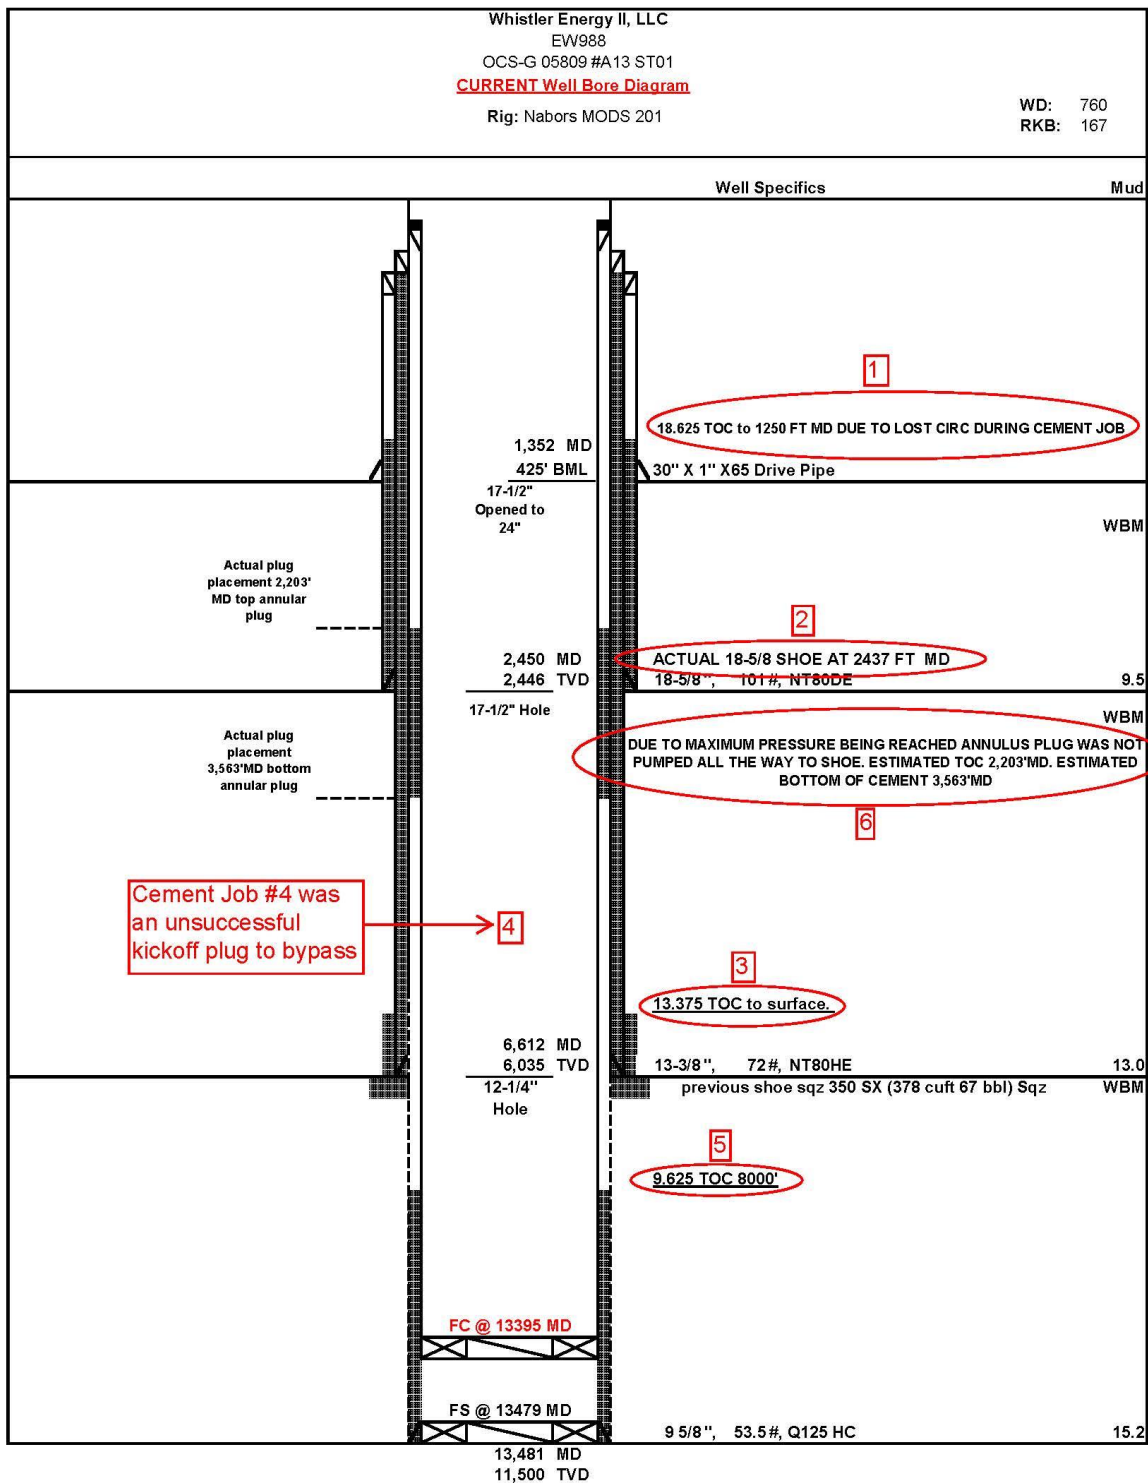
Figure 7: Wellbore Schematic Depicting the Six Different Cementing Operations.

During the permitted drilling operations for the well, cementing operations were conducted on six occasions (*see Figure 7*). Based upon the timeline of events and normal cement curing times, only the 9-5/8 inch intermediate casing and subsequent annulus squeeze plug cement jobs were evaluated. Therefore, the first four cementing jobs were not considered relevant in the analysis of cementing operations.

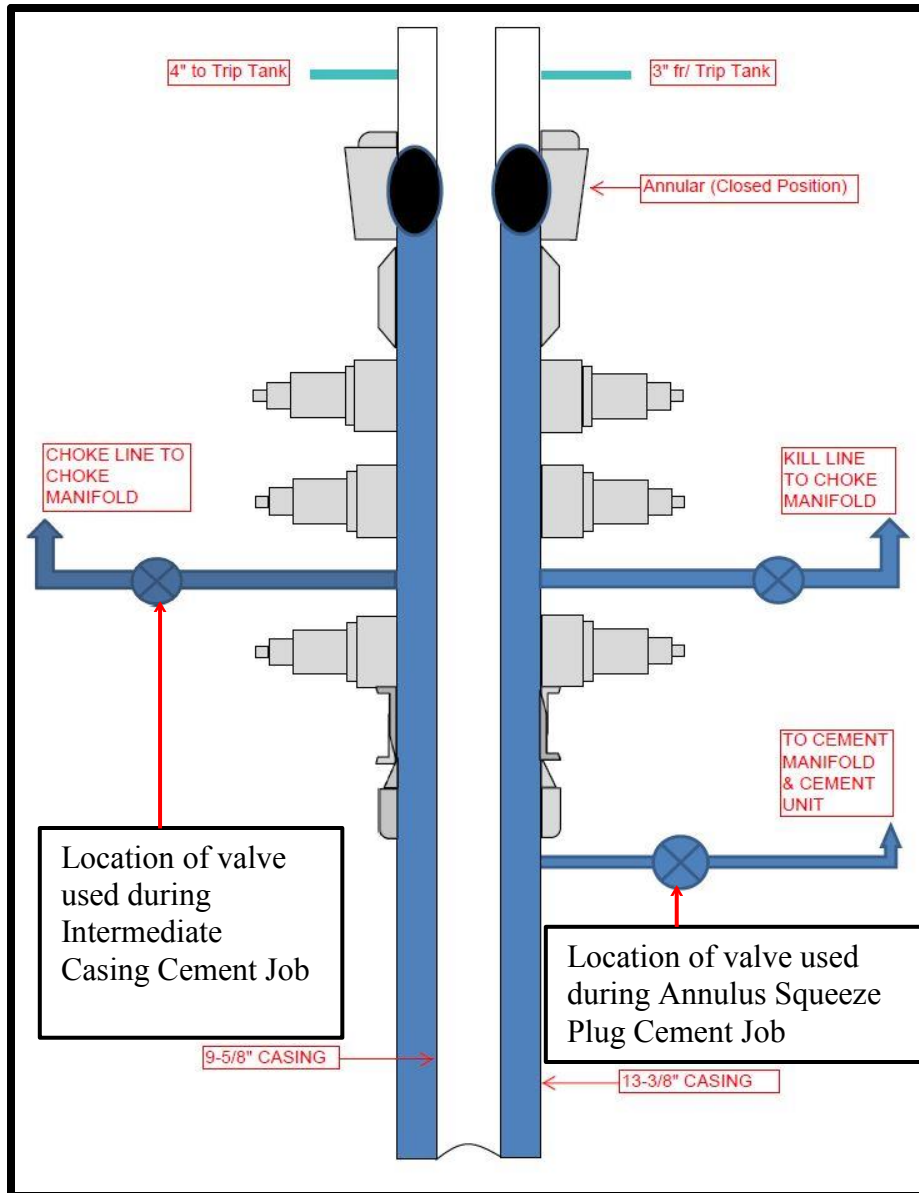
Figure 10: Representation of the BOP and the Bleed Paths.

The flow path of the intermediate casing job was through the annulus to the BOP, through the choke/kill lines, through the choke manifold, and then through the MGS. The flow path, during the pressure bleeds and after completion, of the annulus plug job was through the casing valve, through the cement manifold, through the choke manifold, and then through the MGS. However, flow from the annulus plug cement job could have flowed into the BOP, as there was ample pressure for the lighter-weighted cement to migrate upward into the BOP (*see Figure 10*).

It is possible that both cement jobs could have individually or jointly caused the cement contamination of the MGS. The panel concludes, based upon the totality of the information and circumstances, that it is more likely that the cement from the subsequent annulus squeeze plug cement job contaminated the MGS.

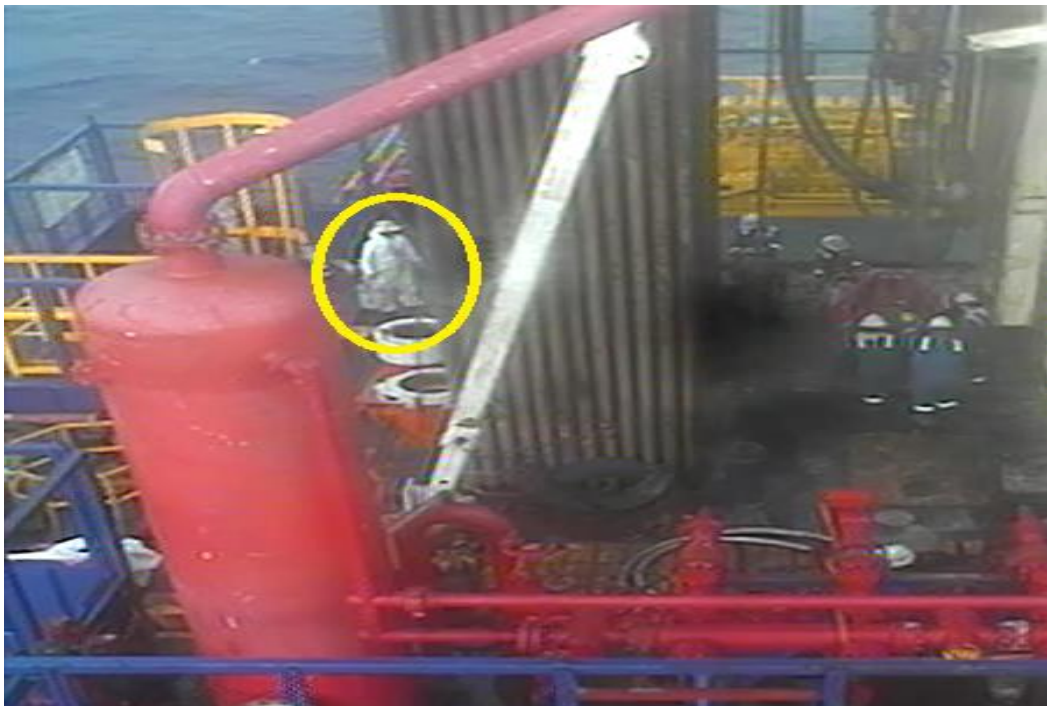
Figure 12: At approximately 07:04, the DH arrives on the Rig Floor in Unsoiled PPE with a Bucket to begin the Process of Cleaning the MGS (still image from rig video).

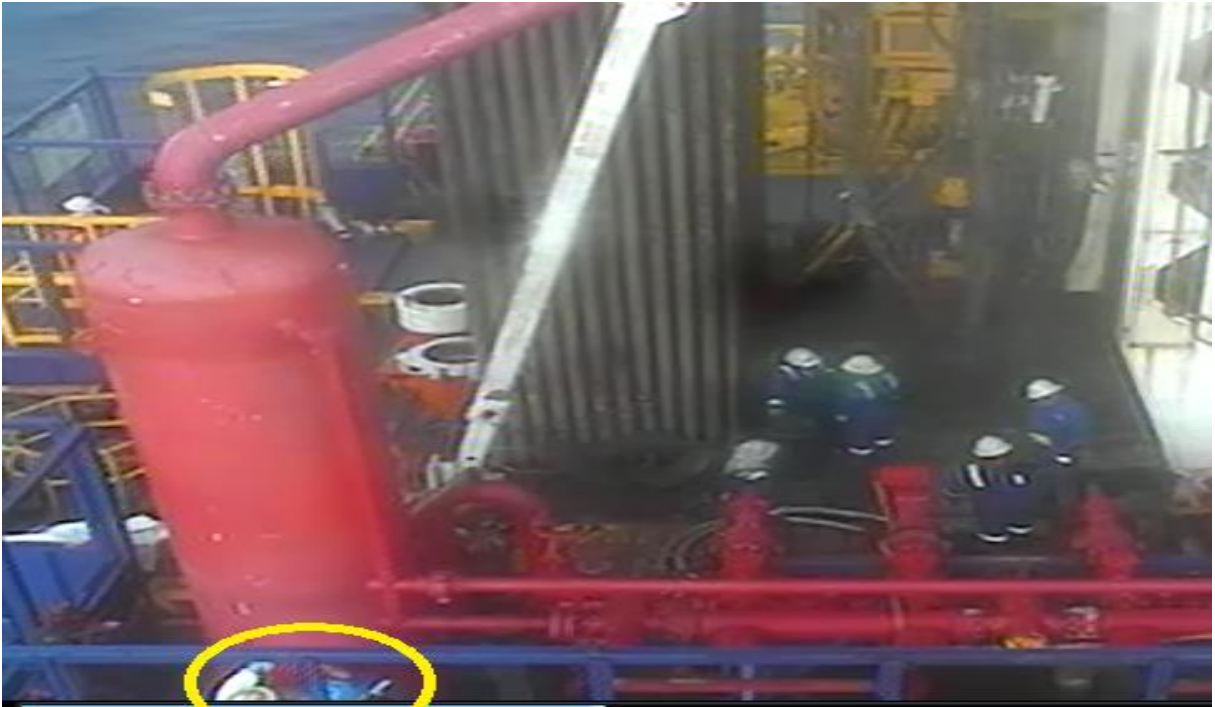
Figure 15: At approximately 07:11, the DH and the RM walk over to the MGS Inspection Hatch (still image from rig video).

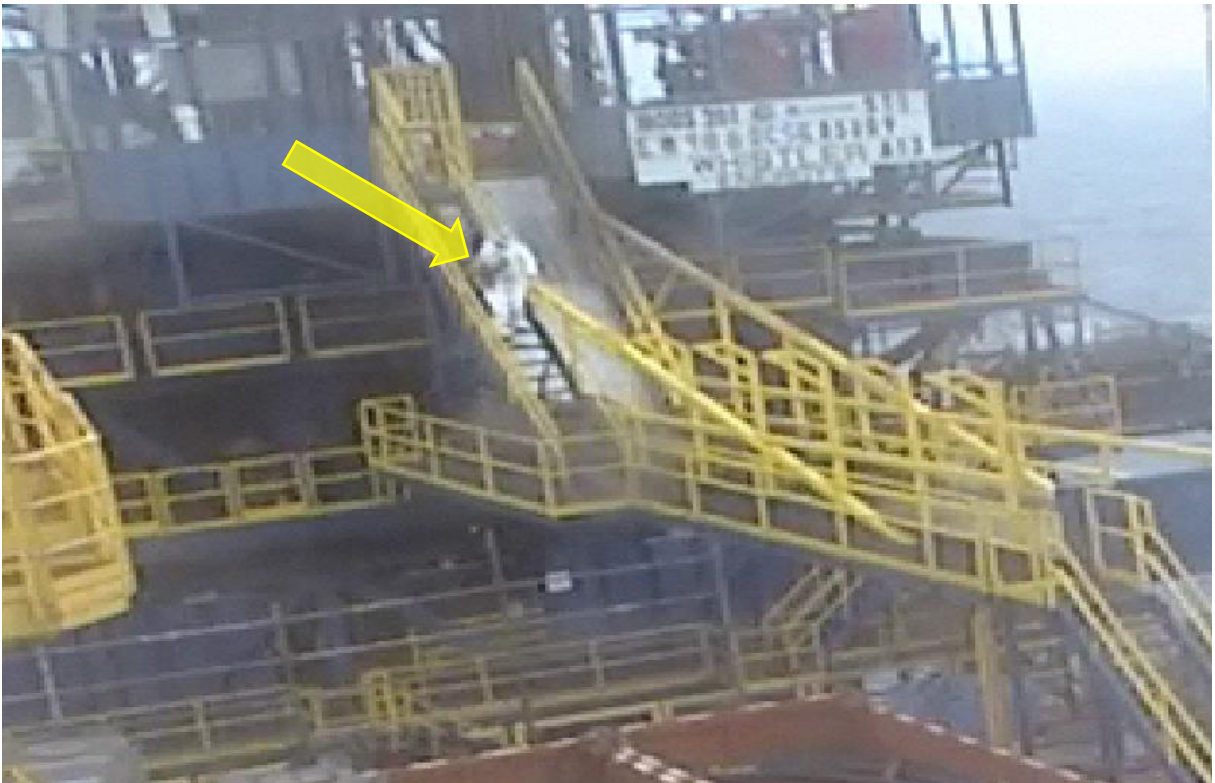
Figure 16: At approximately 07:46, the DH Walks Down the Stairs and off the Rig Floor in the Soiled PPE. This was the Last Time this Light Colored PPE was observed on the Rig Floor (still image from rig video).

The DH approached and engaged with the RM with the distinct and readily apparent discoloration of the light colored protective over-garment in plain view. The RM made multiple visits to the MGS area throughout the day shift. During one of those visits, from approximately 12:32 to 12:43, the RM appeared to reach into the MGS, tap on the exterior of the MGS and engage with multiple personnel while evaluating the working conditions. The video documentation of the rig floor area indicates that both the DH and the RM had placed their head and/or arm(s) into the MGS by this point, on this first day of the task.
