OCS REPORT
86-0101

**Investigation of September 1984 Blowout and Fire
Lease OCS-G 5893, Green Canyon Block 69
Gulf of Mexico,
Off the Louisiana Coast**

October 1986

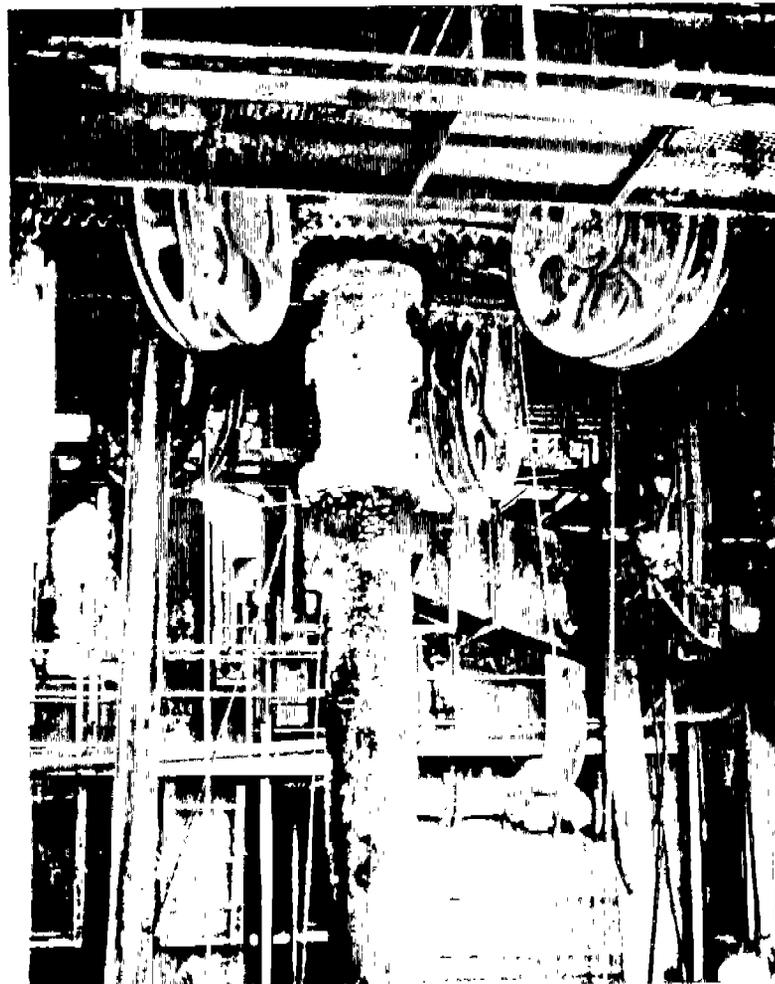
Diverter Bag

The rig sustained severe fire damage in the vicinity of the drill floor. The entire drill floor and associated equipment, including the derrick, had to be replaced. Costs to repair the damages to the *Zapata Lexington* are estimated at \$15 million.
