Bureau of
Safety and
Environmental
Enforcement

QC-FIT EVALUATION OF FASTENER FAILURES- ADDENDUM

QC-FIT Report # 2016-04
February 2016

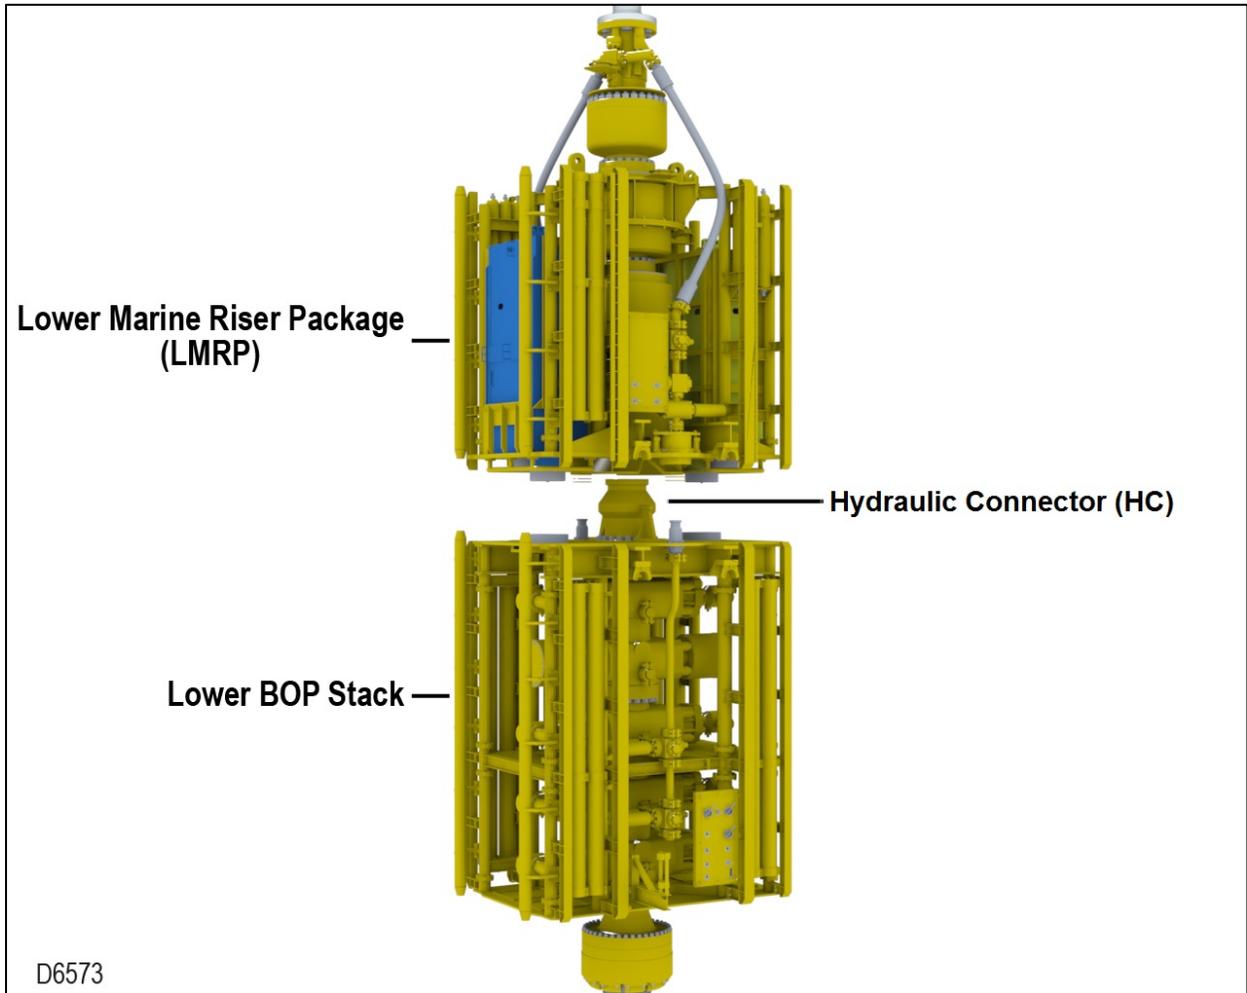
The hydraulic connector (HC), which is located in between the lower marine riser package (LMRP) and lower blowout preventer (LBOP), secures the LMRP to the LBOP (Figure 1). The twenty fasteners on top of the HC (see Figure 2) secure the HC to the bottom of the upper annular in the LMRP, and nine of those the twenty fasteners on the HC failed (Figure 3). Eight of the failed fasteners fractured at the first engaged thread, located below the upper annular flange (see Figure 4). One fastener failed below the nut on the top of the upper annular flange.

Figure 1: LMRP / HC / lower BOP assembly

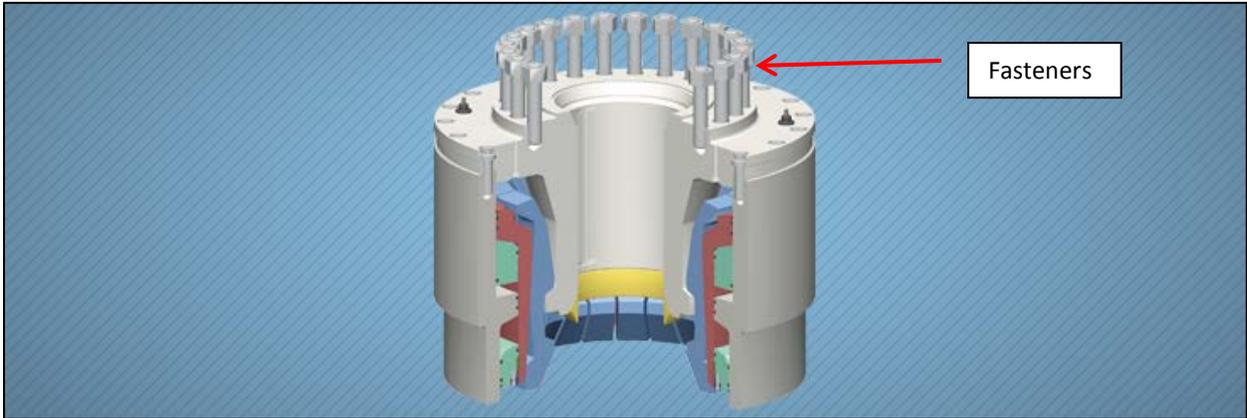
Figure 2: Hydraulic connector showing fasteners (WWW.C-A-M.COM)
