**Investigation of Pig Launcher Explosion,
Main Pass Block 41,
Gulf of Mexico,
Off the Louisiana Coast**

Frank Pausina
Leslie Monahan
Tom Perry
Carl Anderson

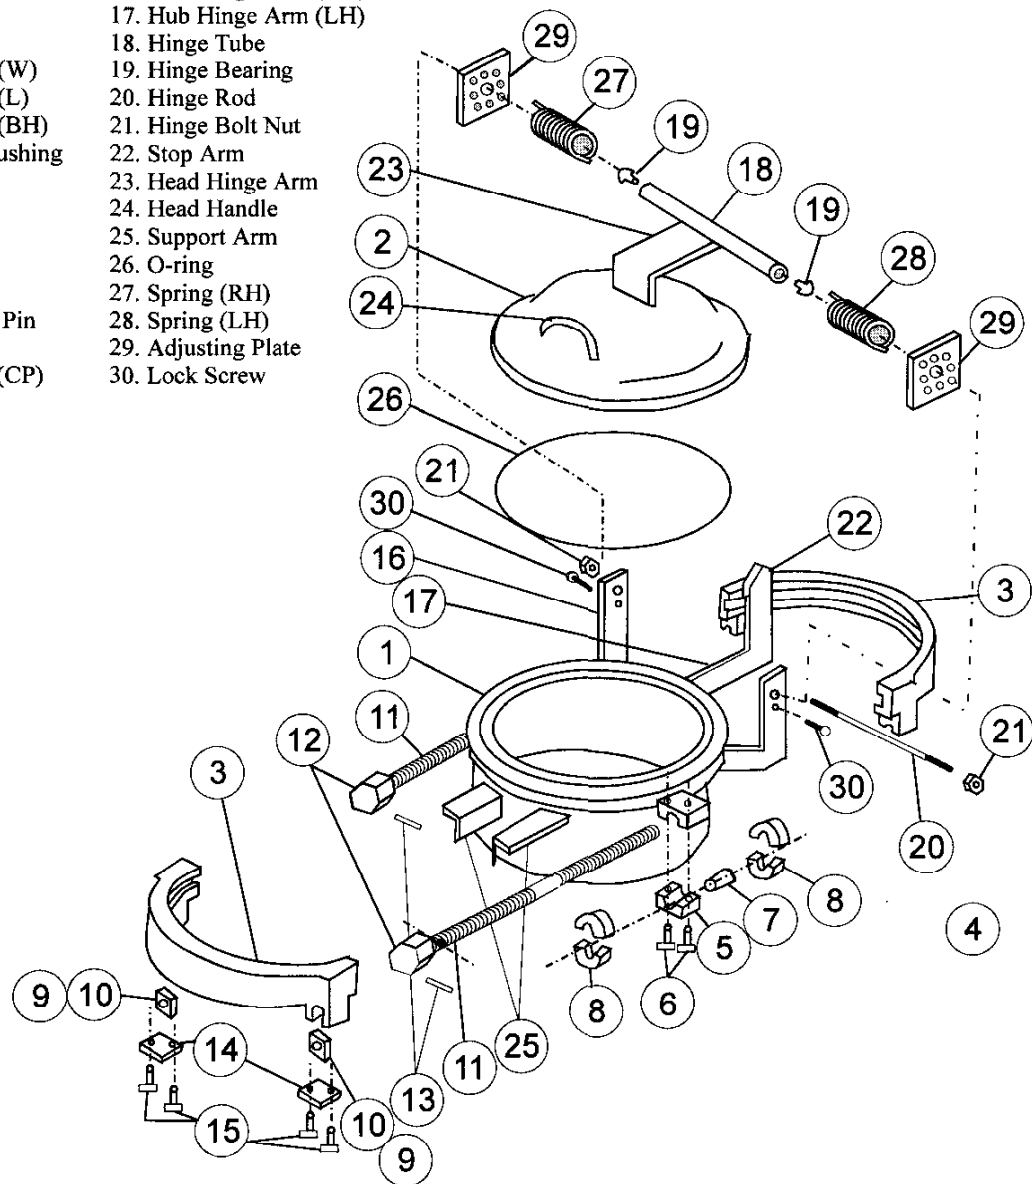
Pig Trap Operation Procedures

1. Do not stand in front of closure.
2. Isolate trap.
3. Open bleed valves.
4. Leave bleed valves open.
5. Crack open closure carefully.
6. Check, listen for pressure bleeding off.
7. After all pressure bled-off -- continue to open.
