Investigation of November 12, 2016 Fire with Multiple Injuries

Lease OCS-30206, Grand Isle Area-Block 115

**Gulf of Mexico Region, New Orleans District
Off Louisiana Coast**

August 29, 2018

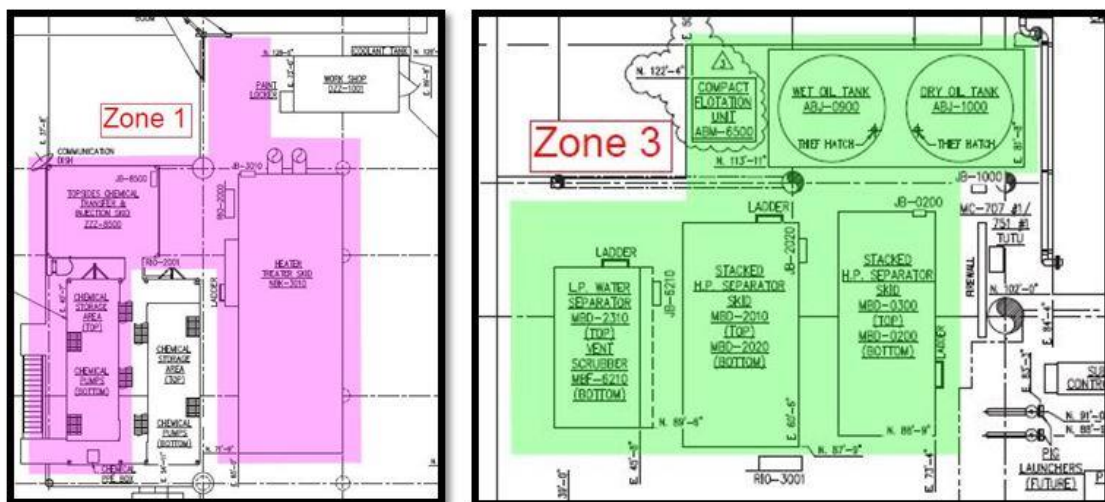
Figure 7: TSE Zone 1 (left) and TSE Zone 3 (right)

The platform uses TSE fusible plugs to shut in the platform if excessive temperature exists in the vicinity of production equipment. The platform safety shutdown system logs a fusible plug failure event according to a specific zone. The zones affected by the incident (Zones 1 & 3) are depicted in Figure 7 for the main deck and cellar deck, respectively.

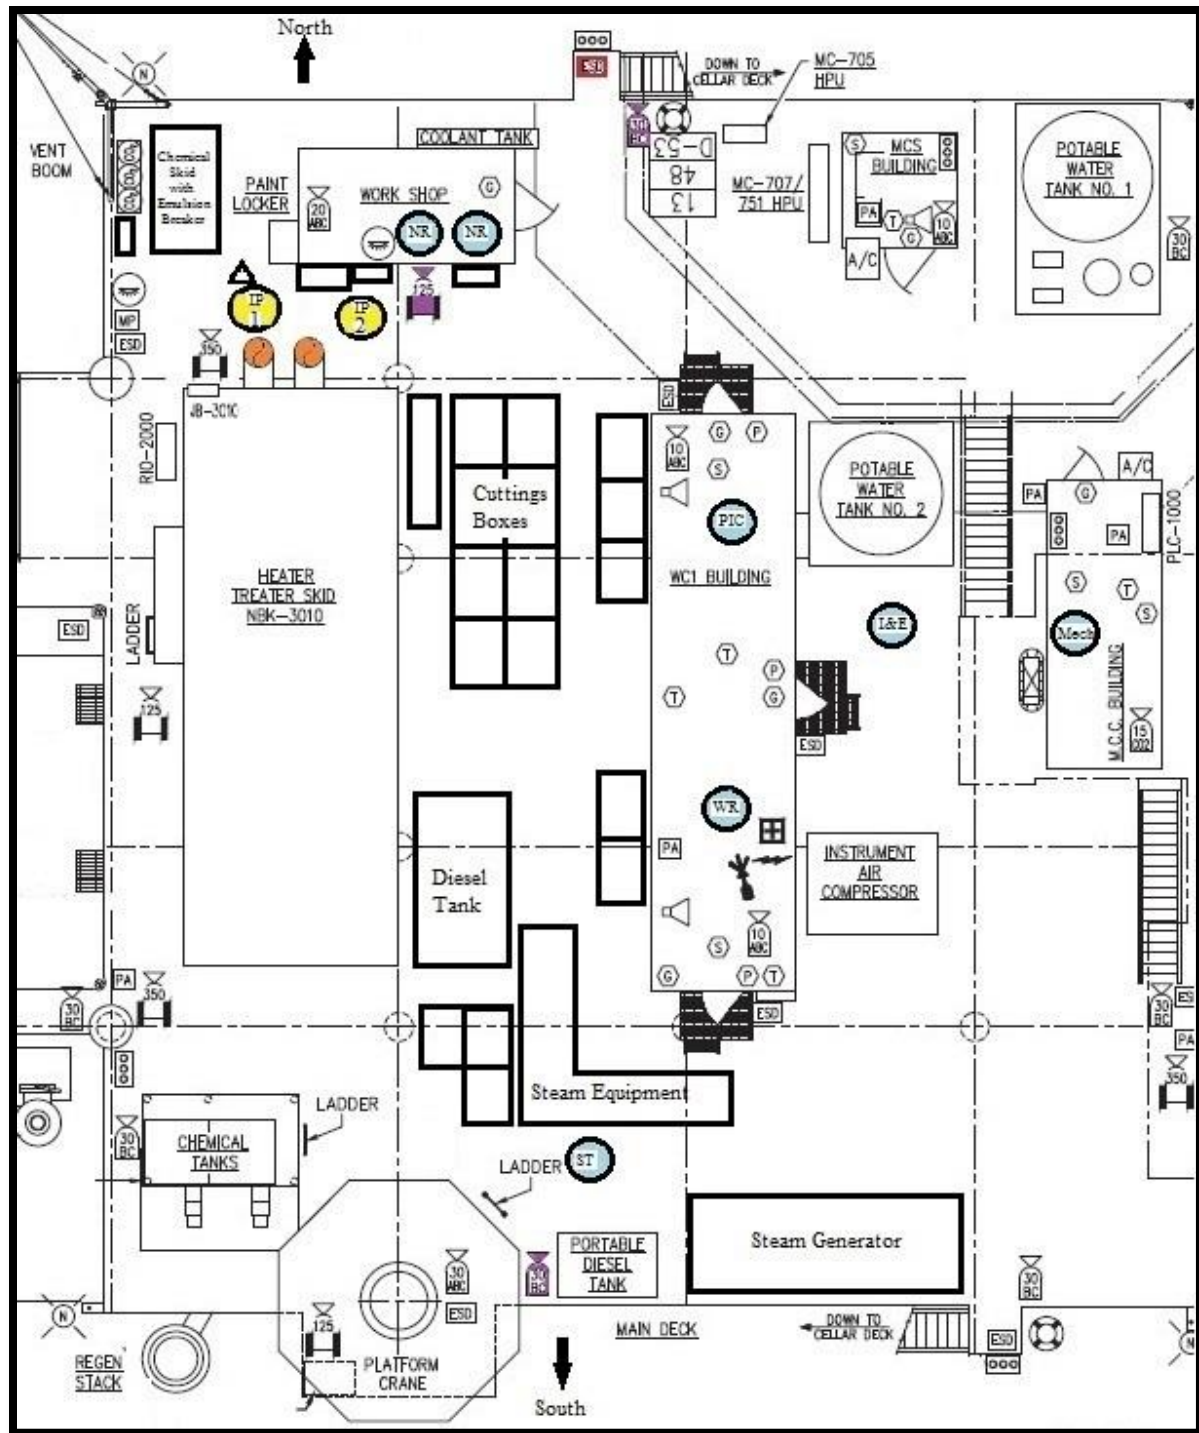
Figure 8: Approximate Personnel / Equipment Locations at the Time of the Incident

in Figure 8), between the chemical tank and the heater treater, with his forearms on his knees and his palms faced down (wearing rubber chemical gloves). Facing each other, IP-3 had the heater treater to his left and IP-1 had it to his right (each represented by yellow circles in Figure 8).

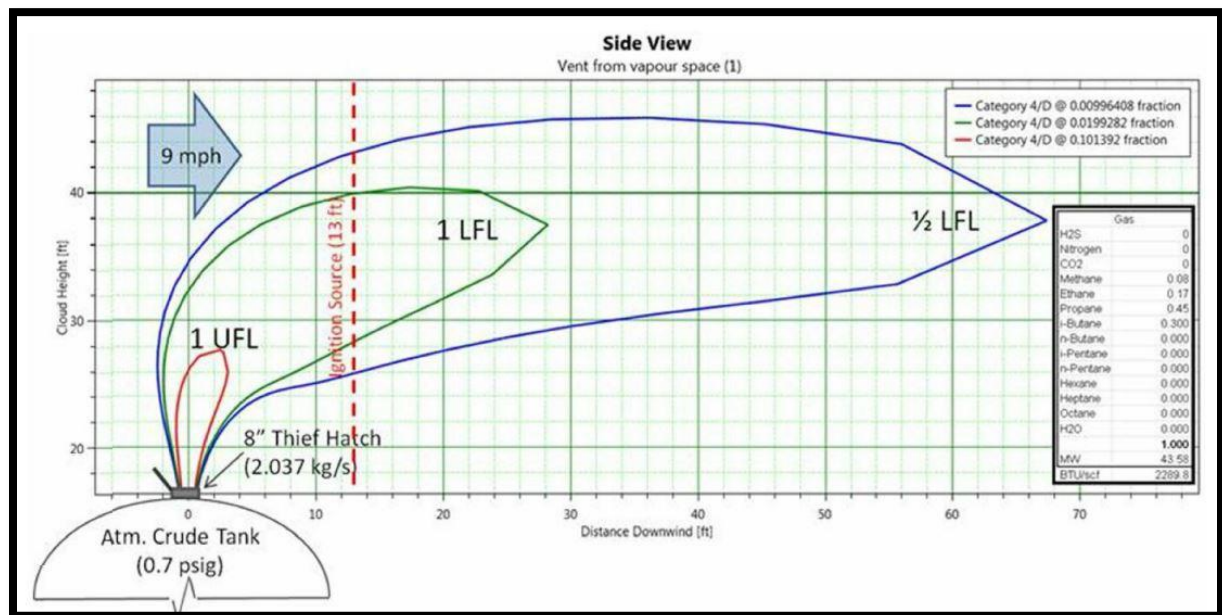
Figure 11: Gas Dispersion Model provided by Wood Group

Wood Group calculated and provided a dispersion model of the estimated gas cloud at the time of the incident (*see Figure 11*), based on an estimated wind speed of 9 mph and a specific gravity of 1.5, which is a conservative estimate based on the provided gas specific gravity at the VRU (1.2074). The dispersion model was produced using an estimated tank gage pressure of 0.7 pounds per square inch (psig).

Within the model, both the Upper Flammable Limit (UFL) and Lower Flammable Limit (LFL) are depicted. These limits are the maximum and minimum concentrations, respectively, of a combustible gas necessary to support its combustion in air. The presence of sufficient heat within the envelope of UFL and LFL equal to or greater than the flash point of the gas mixture would ignite the gas mixture. Using a 1:1 scale overlay of the Wood Group dispersion model and approximate wind conditions, Figures 12 and 13 depict the panel's estimate of the flammable envelope in relation to the platform and the related equipment.

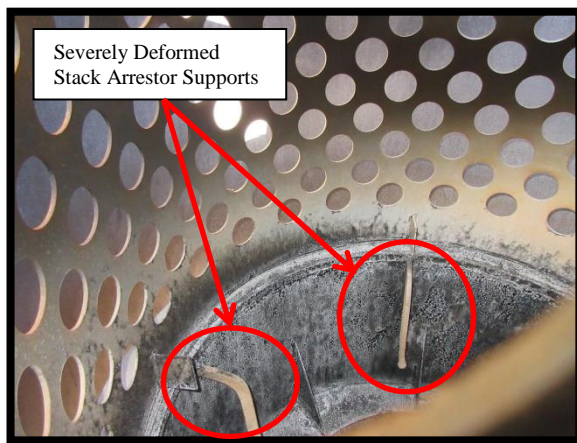
Figure 20: Right Stack Arrestor Housing

During an inspection of the stack arrestors on December 12, 2016, the panel identified deformation of the right stack arrestor¹¹ supports and discovered that the stack arrestor was missing from the right exhaust stack (*see Figure 20*). There was visible damage to the right stack weather cap, which also serves as the stack arrestor housing. The left stack arrestor housing appeared to be undamaged. The damage to the right stack arrestor prompted the panel to request a third-party inspection of the fire tubes.

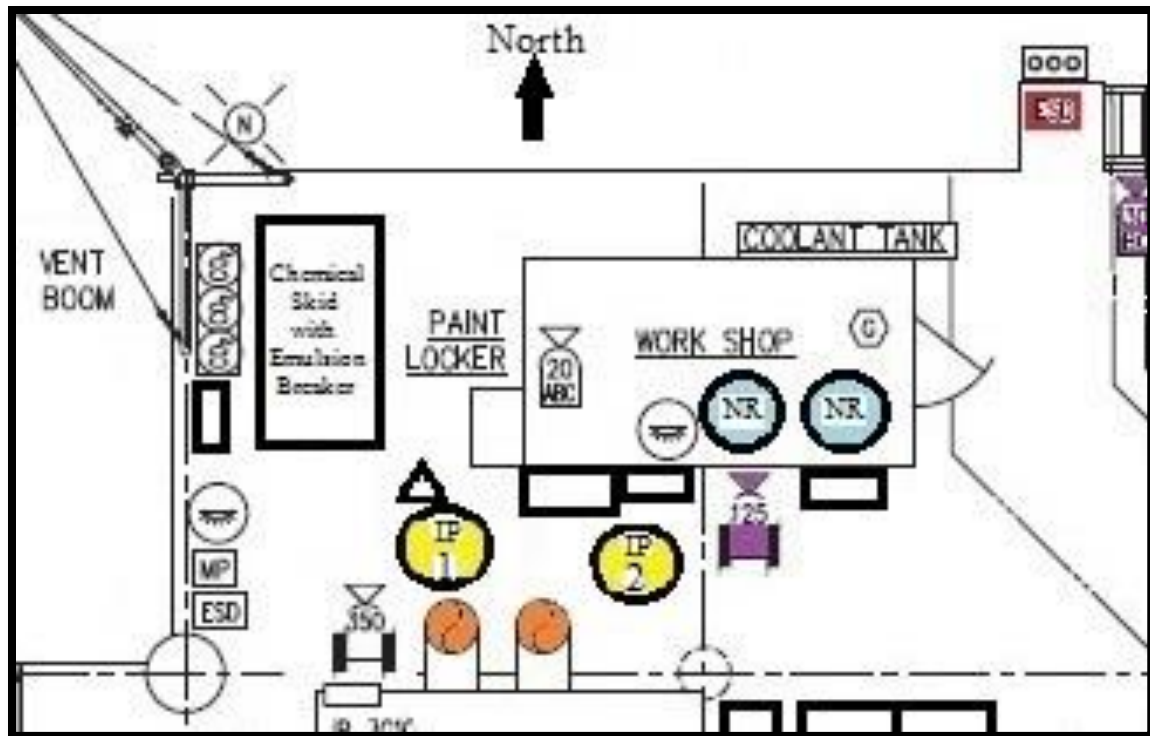
Figure 28: Approximate Positions of IP-1 and IP-2

As a result of the fire, three personnel on the platform sustained burn injuries. IP-1 was in a crouched position near the heater treater fire tube air intake (*see Figure 28*), facing away from the heater treater at the time of the incident. His forearms were resting on his knees with his palms down. He was wearing the prescribed FRC (sleeves down), hardhat, safety glasses and rubber chemical gloves. When he turned and saw the flame come from the area of the heater treater flame arrestor / burner he was suddenly engulfed in the flame until exiting it on the west side of the heater treater. He sustained second degree burn injuries to the exposed areas of his neck and face, as well as to the upper surface of both hands, some of which was exacerbated by the post-incident removal of the rubber gloves that had melted to his hands. He indicated that there were no burns to the palms of his hands.

IP-2 was standing on an access landing between the oil tanks on the cellar deck, having opened the thief hatch on the dry oil tank and was waiting for IP-1 to feed him a hose. At the time of the incident, he was wearing safety glasses and a hard hat, but he was not wearing safety gloves and he had the sleeves to his FRC shirt rolled up. When the fire surrounded him, being aware of the fuel source, he shut the hatch, jumped off of the access landing, and ran up to the main deck. Once the fire was out, he discovered that he sustained first and/or second degree burns to his right forearm and around his watch on his left arm. Part of his beard and hair were singed, and the head piece on his hard hat was melted in.

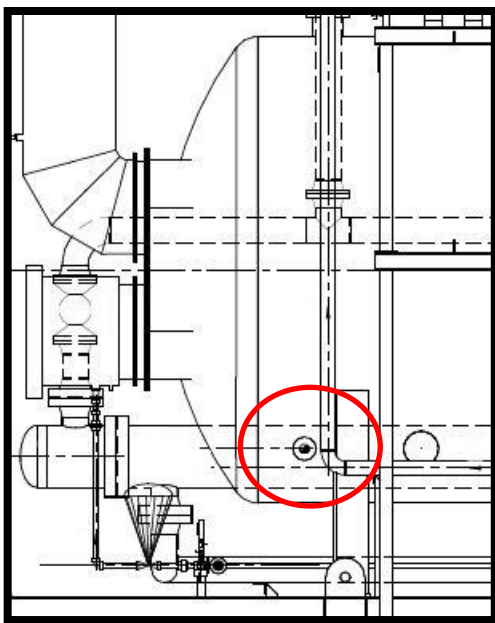
Figure 31: Partial Schematic of Heater Treater, with Location of 2-inch Front End Sand Jet Nozzle

The third step of the work sequence is “Hook up hoses to vessel.” In preparation for the fourth step (transfer fluid from the vessel to tank), a hose would be connected to the front end two-inch sand jet nozzle (see Figure 31). The hose would then be routed to the cellar deck, where it is inserted into the thief hatch opening of the dry (wet) oil tank. While the incident occurred prior to this step in the process, one of the IPs stated that he intended to try to treat the dry oil tank and the heater treater really fast with the chemical emulsion breaker, maybe eliminate the BS&W issue and come back online, which omitted this step.
