**Investigation of December 2, 2017 Fatality
Petrobras 10000 Drillship
Lease OCS-16997, Walker Ridge Area Block 469**

**Gulf of Mexico Region, Houma District
Off Louisiana Coast**

Feb. 13, 2019

U.S. Department of the Interior Bureau of Safety and Environmental Enforcement

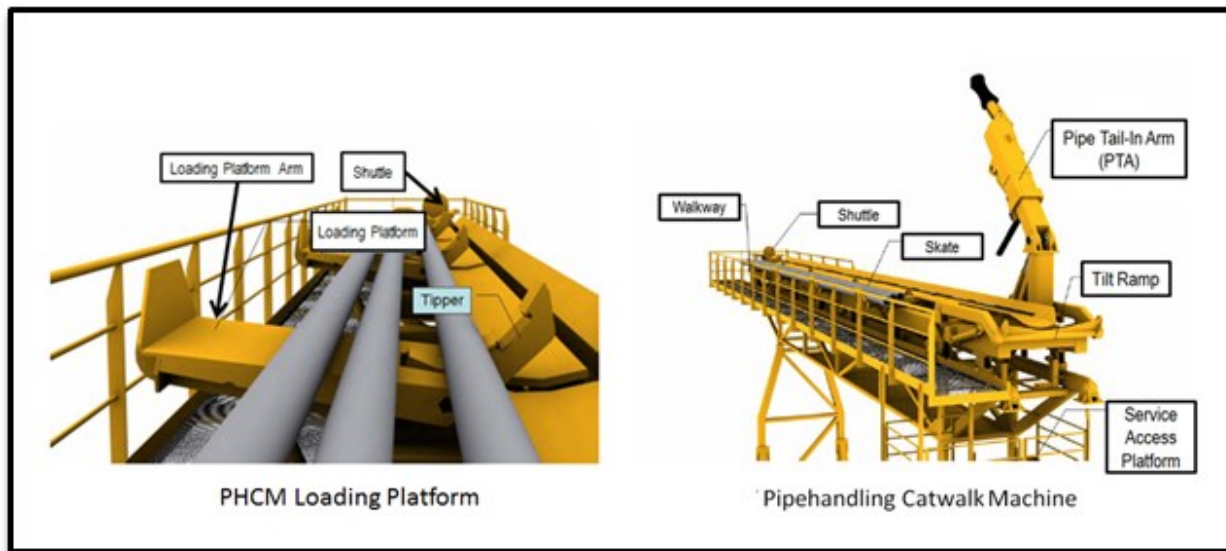
Figure 3: Pipe Handling Catwalk Machine schematic - created by BSEE using schematics from OEM manual

The skate is moved along a support structure, with a centerline pipe trough along which individual tubulars, such as DP, can be fed horizontally onto or off of the PHCM. The design allows the PHCM skate to run along rails on the structure and drill floor up toward the well center.

During the shift of the incident, the drill crew performed the operation of picking up DP by horizontally loading singles onto the PHCM loading platform arms in bundles of five. The skate operator used a portable remote with joysticks and control switches to activate a mechanism, called a tipper, which tipped a single joint of DP into the PHCM's shuttle cradle (see Figure 3).
