OCS Report  
BSEE 2012-01

# **Investigation of Fatal Fall West Cameron Block 643, Platform A Lease OCS-G 02241 18 April 2011**

**U.S. Department of the Interior  
Bureau of Safety and Environmental Enforcement  
Gulf of Mexico OCS Regional Office**

**New Orleans  
April 2012**

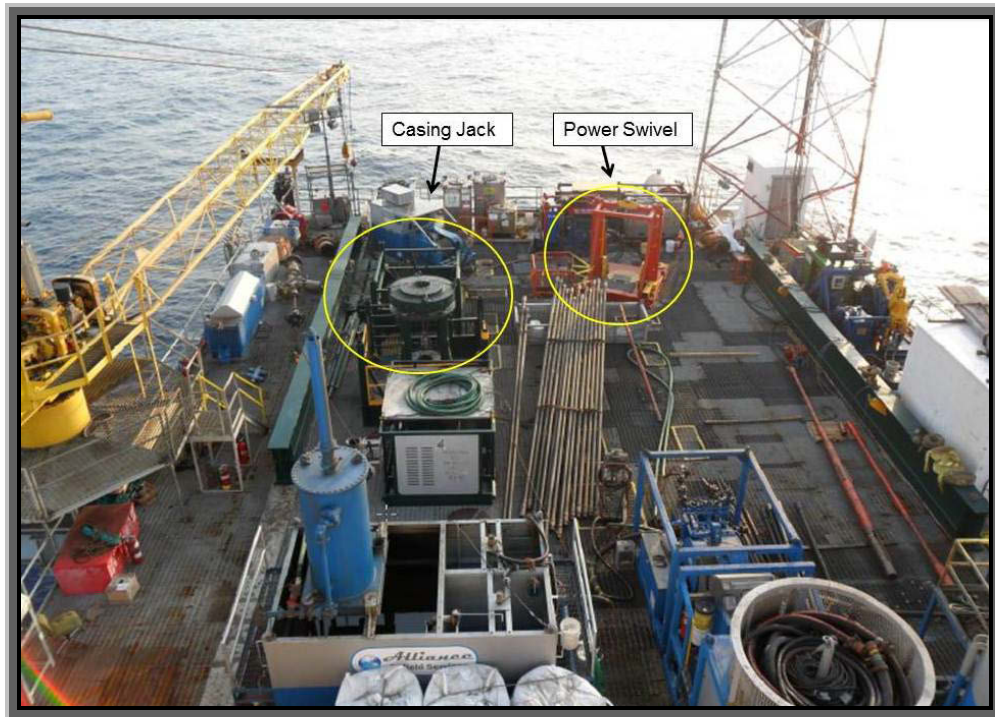
**Figure 6 – Power swivel (PS) and casing jack assembly (CJ) on main deck**

Key equipment to be used to complete the planned P&As, including that for the Well, were two skid mounted devices and the 20,000 pound pull-rated crane to substitute for the capabilities that would normally be provided by a conventional rig. A casing jack (CJ) provided the ability to pull a work string, tubing, and casing when the use of the crane could not accomplish the task. The power swivel (PS) provided the ability to trip and rotate a work string, pipe, or casing (*see figure 6*).

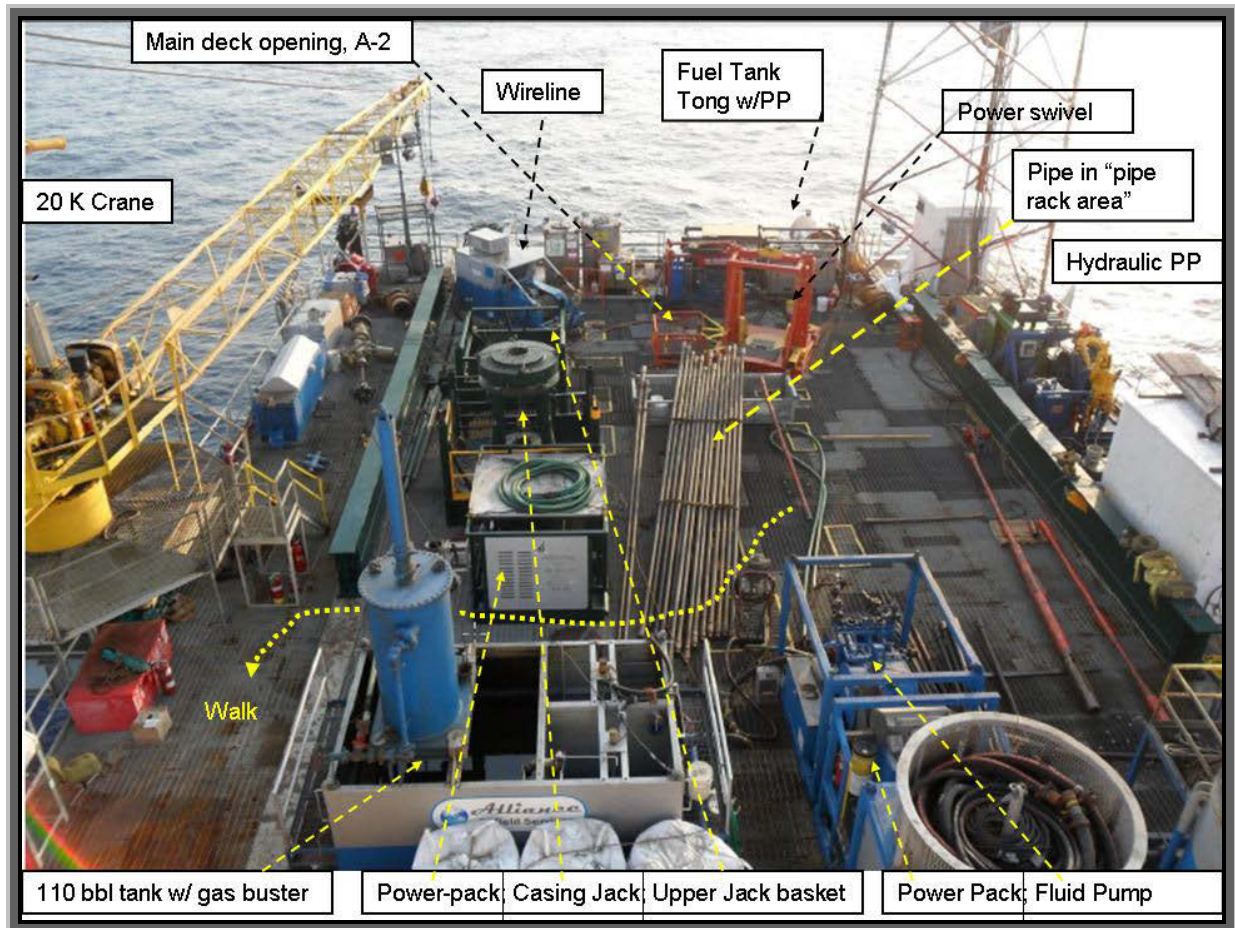
**Figure 8 –Equipment on main deck at time of Accident.**

The BOEMRE/BSEE inspections, multiple pictures, and the subsequent reenactment of the Accident allow a reasonably precise understanding of the physical environment on the Platform at the time of the Accident (*see figure 8*).

Pictures taken the morning of the Accident show the location of the number of incidental equipment skids, various pieces of pipe, casing, baskets, hoses, etc., on the main deck (*see figure 8*). Of note are the general restriction on man access-egress routes, and the limited work space on the main deck.

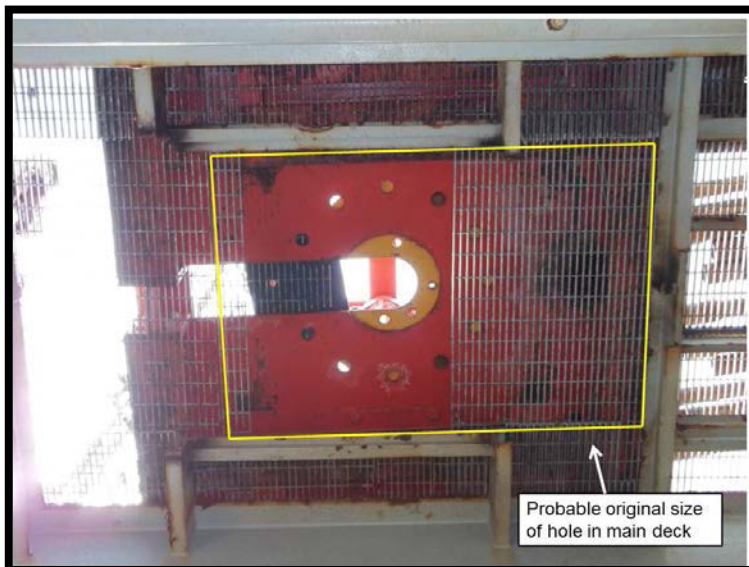
**Figure 21 – From below; PS over main deck Well access hole**

At the start of the reenactment, the PS was placed back into the original position. Photos were taken of the PS in its original position noting the relationship of the skid to the pipe rack. Photos were also taken of the PS in its original position from beneath the main deck to confirm the PS skid would have completely covered the opening in the deck when the Accident occurred (*see figure 21*).

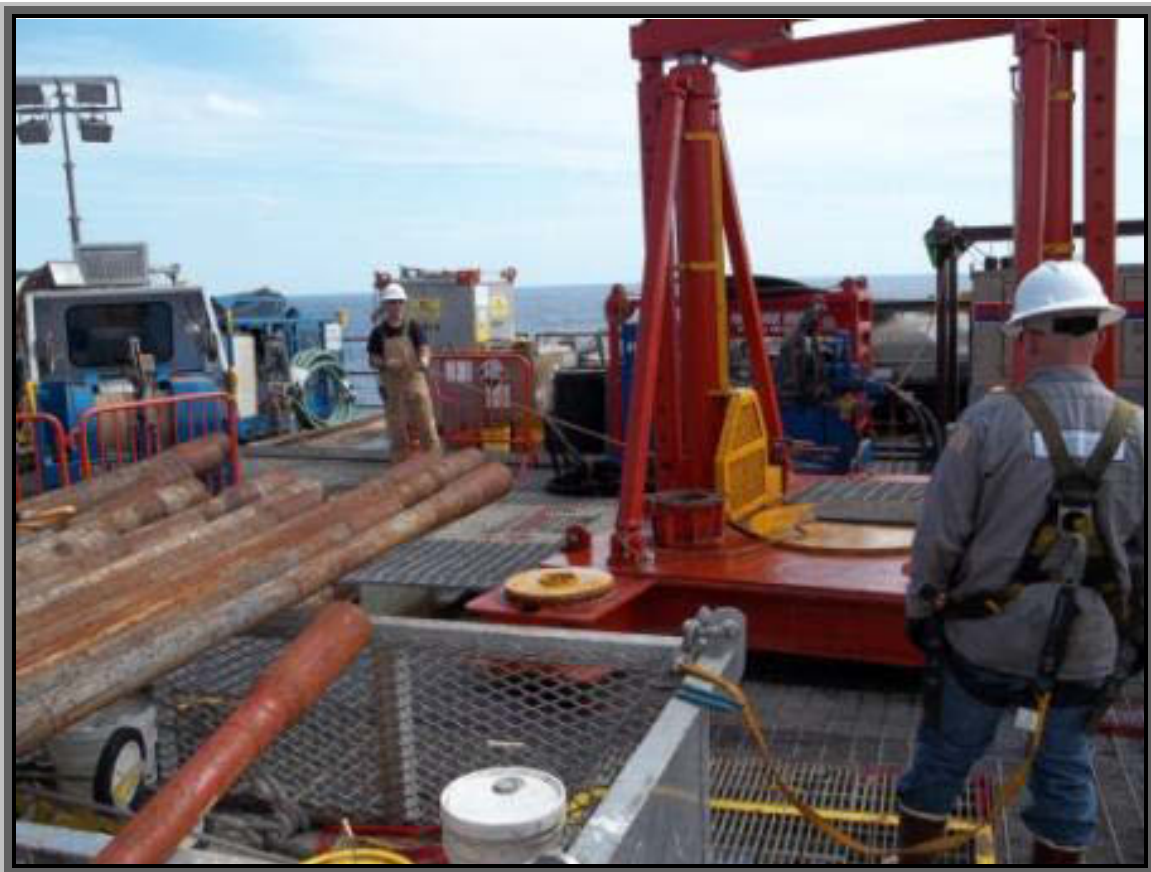
*Figure 22 – 20-foot tag lines utilized during reenactment*

Next, a simulated pre-lift “tool box” meeting was held to discuss the move. The two riggers wearing fall protection were provided with 20-ft rope tag lines attached to the opposite corners from those that had the original 3-ft tag lines. The length of the tag lines and their connection to the PS skid allowed the riggers to completely avoid the opening in the deck (*see figure 22*).
