**Investigation of Fatal Accident
V-Door Guide Post Failure
Chandeleur Block 31, Well No. 1
OCS-G 27214
18 July 2006**

**Gulf of Mexico
Off the Louisiana Coast**

Jack Williams – Chair
Tom Perry
David Emilien
Kevin Langlinais

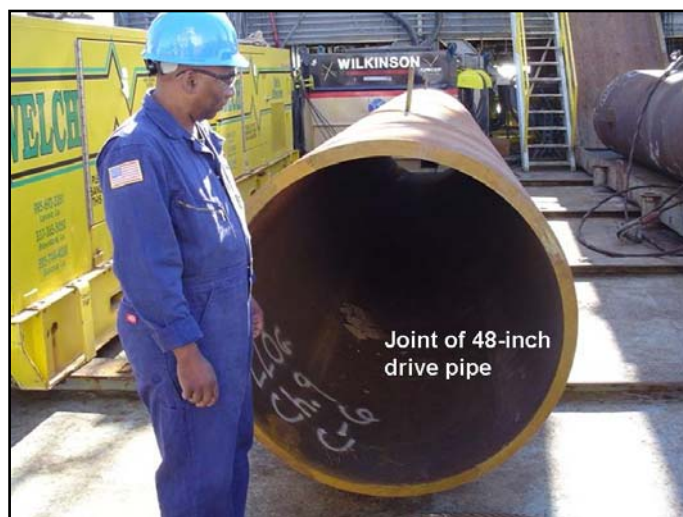
Figure 5: Example, 48-in drive pipe

15-16 Jul 2007, 1100 hrs - The Rig moved onto location, jacked-up to approximately a 55-ft air gap, skidded out, and commenced operations preparatory to drilling the Well. The 48-in drive pipe and welding equipment were taken onboard the Rig (*see figure 5*).

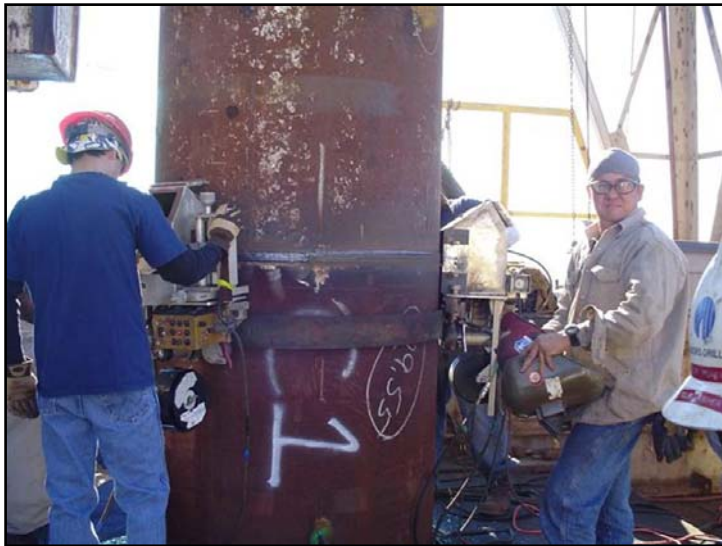
Figure 8: “UT”ing the welds, 48-in drive pipe

welds, and install the 48-in drive pipe string. The Wilkinson crew assigned to this Well consisted of 9 men, four per shift with one supervisor. Each 12 hour shift included two welders and two tool men. According to testimony, they worked with the regular Rig crew on tower. The Rig driller supervised operations on the rig floor and operated the draw works. The Nabors floor men and roustabouts assisted moving the joints of drive pipe into position as needed. The Wilkinson crew assured the proper alignment, welding, and UT scanning all the welds to check the acceptability of the welded connections (*see figure 8*).

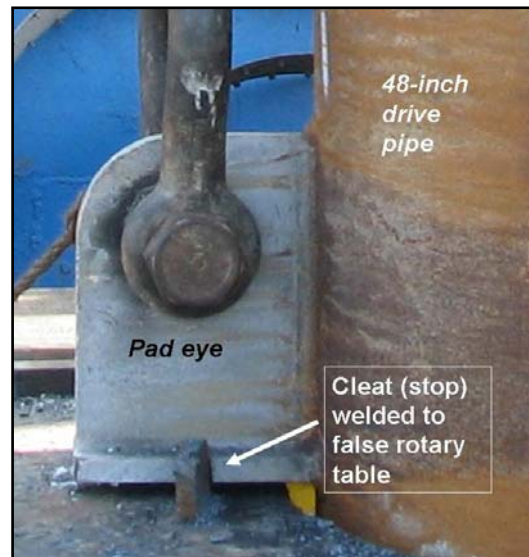
Figure 9: Positioning cleat (stop) for pad eye, 48-in drive pipe

- Cut the pad eyes off of joint #1.
- Lower the drive pipe assembly until the pad eyes on joint #2 contacts the false rotary.
- Rotate the drive pipe assembly until the pad eyes on joint #2 engage the pad eye stop to ensure alignment (*see figure 9*).

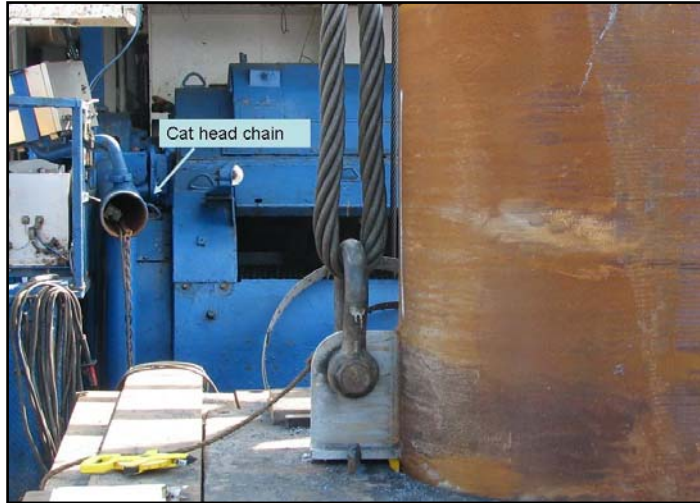
Figure 12: Cat head chain location

During testimony, it was noted that several other ways of rotating the drive pipe could have been employed. One such method would have been to “use the draw works.” Another would have been to use the cat head chain which has a much heavier chain and more powerful motor. The cat head was also located at a favorable angle to turn the drive pipe assembly (*see figure 12*). No supervisors or Rig
