Investigation of October 20, 2015 Fatality During Pipe Handling

Lease OCS-G 33531, Keathley Canyon Block 96
Drillship Pacific Santa Ana

March 3, 2017

U.S. Department of the Interior
Bureau of Safety and Environmental Enforcement

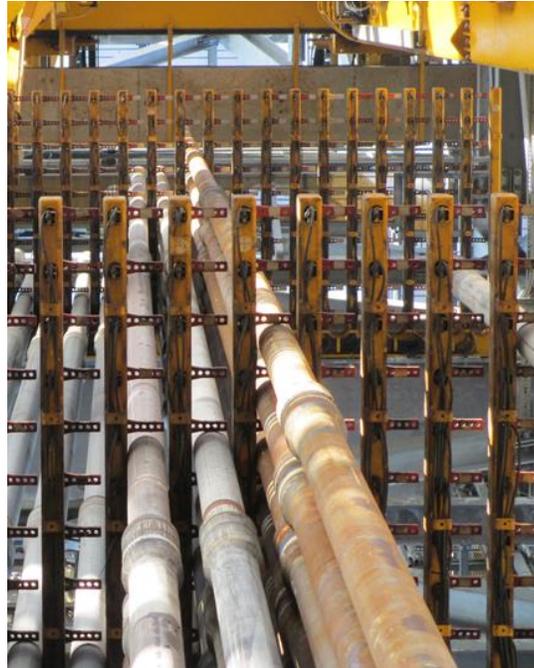
Figure 3- Looking upward from the deck. In the foreground is the lower fingerboard. Latches in closed position can be seen holding stands of pipe in place.

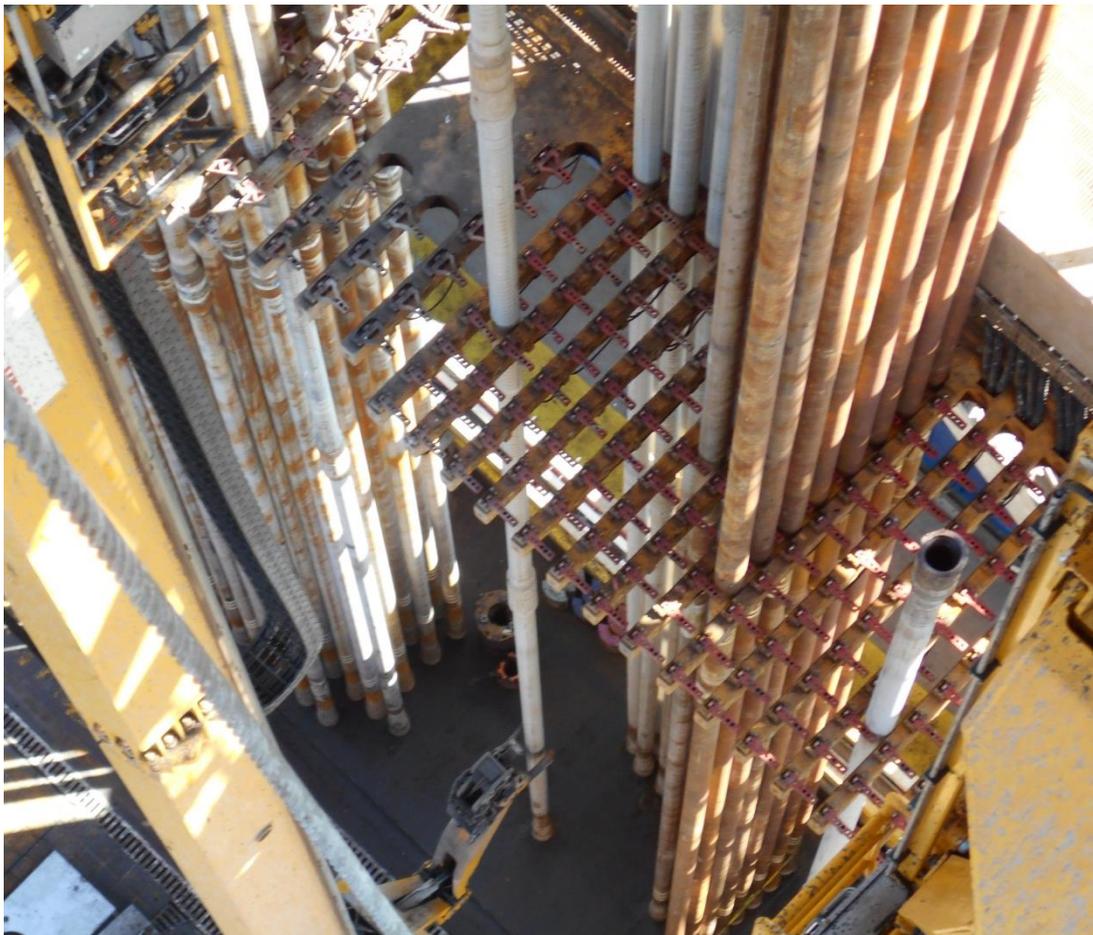
Figure 4- The MHR lower guide head is visible in its position around a pipe stand at the bottom of the photo.
