QC-FIT
EVALUATION of
FASTENERS
FAILURES
ADDENDUM II

Office of Offshore
Regulatory Programs

QC-FIT Report # 006
July 2017

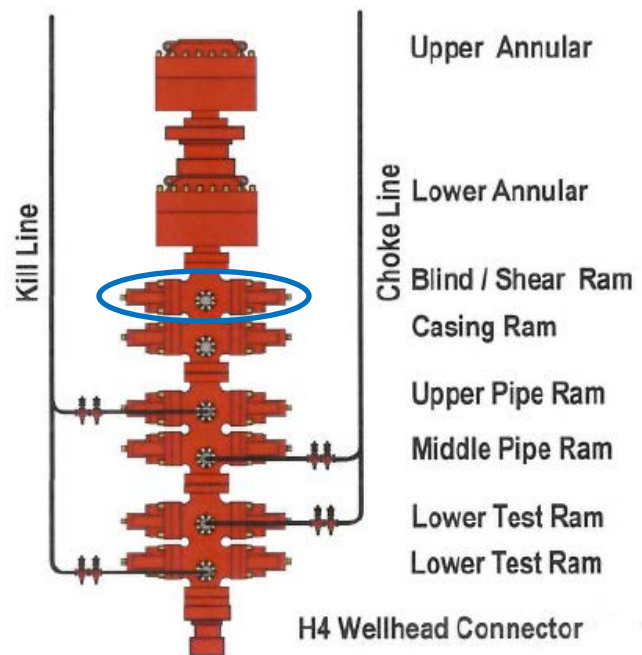
FIGURE 1: BOP SCHEMATIC

Figure 1 on the right is a schematic of a typical BOP with the BSR assembly circled in blue. Figure 2 shows a schematic of the BSR assembly which is located on the BOP that is secured by eight fasteners. Six of the eight fasteners fractured during BOP testing¹² allowing pressurized hydraulic fluid to leak to the sea. Figure 3 shows the BOP subsea with some of the fractured fasteners at the door interface. Figure 4 shows the BOP subsea with one of the eight fasteners fractured at the nut end. Figure 5 shows the BOP on deck and the upper BSR Assembly with fractured fasteners. Figures 6, 7, and 8 are images of the fractured fastener at the thread.
