QC-FIT EVALUATION OF SHEAVES FAILURES

Office of Offshore
Regulatory Programs

QC-FIT Report #005
May 2017

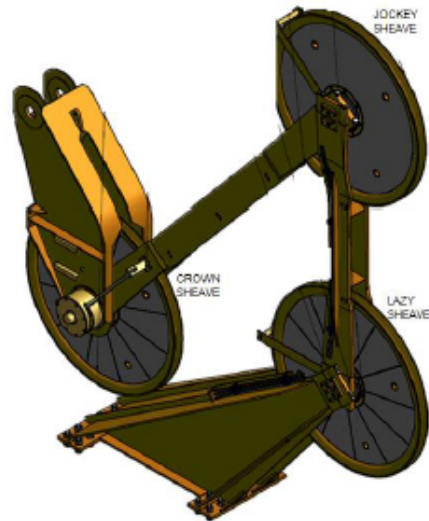
- Issue:** Hub weld cracking incidents have been reported for the CMC's 78" fastline jockey sheave (the middle of the three sheaves in the fastline linkage arm assembly). These cracks propagate from weld defects near the root of the weld between the web plates and the hub.

Illustrations: Above: Example of crack at hub of old fastline sheave. Right: Cross-section of typical sheave. The red arrows are pointing at the welds that supplier defines as "critical".

- Solution:** NOV recommends that the present fastline jockey sheave be replaced with a single-web sheave. Until replacement is performed, the critical welds of the sheaves in the fastline linkage arm assembly should be visually inspected for cracks on a weekly basis. The Critical Welds are shown in the Maintenance Instructions and in the figure below. Additionally, users should ensure that appropriate fastline stabilizers are installed, as these significantly lower the dynamic high-frequency side loading on the sheaves.
