QC-FIT EVALUATION OF WING VALVE FAILURES

Office of Offshore
Regulatory Programs

QC-FIT Report #004
February 2017

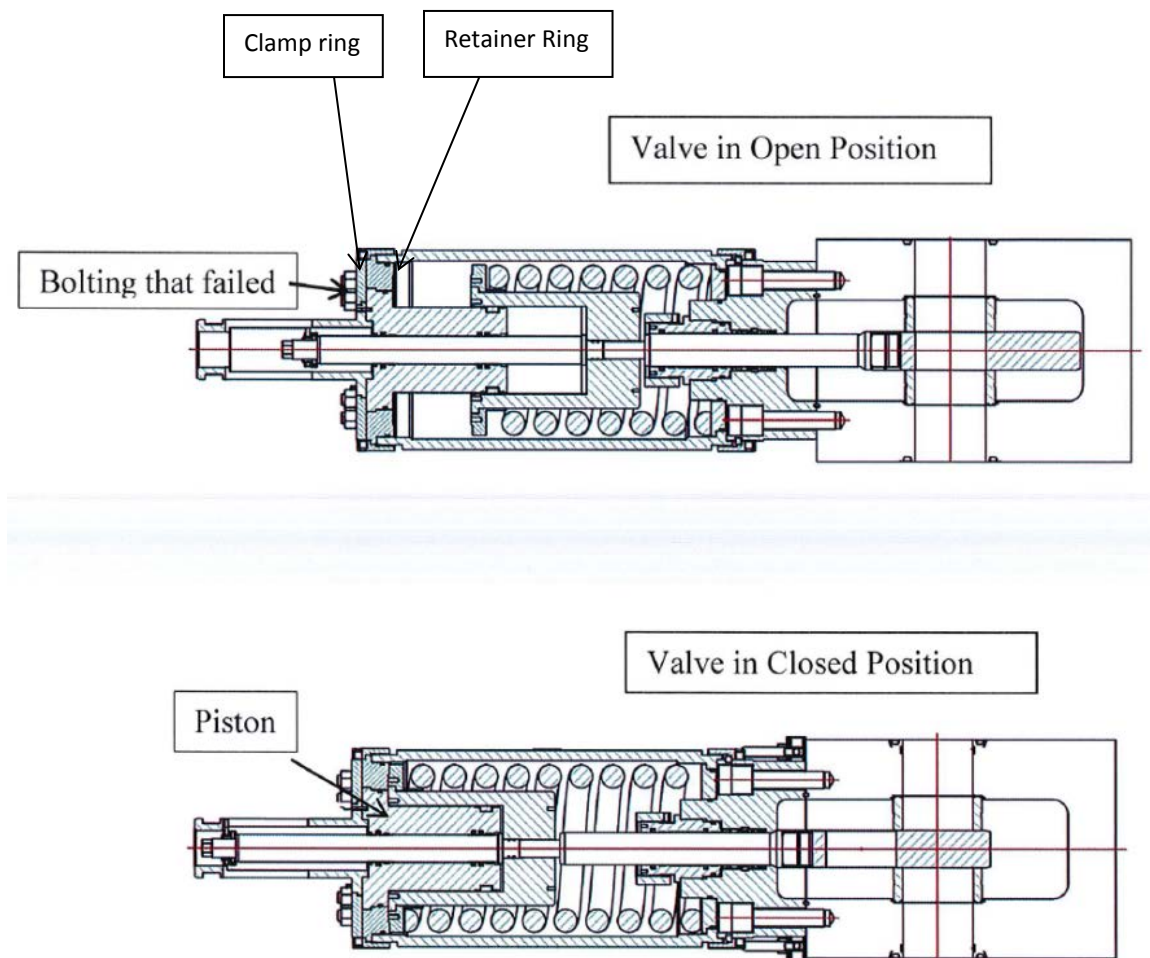
1. Housing
2. Retainer Ring
3. Clamp Ring
4. Nuts
5. Fasteners

The retainer ring fits into the housing, which has threaded holes where the fasteners engage at the bottom end. The clamp ring attaches to the end (top) of the housing with through holes, which allow the fasteners to pass through. The nuts are then screwed onto the fasteners, securing the clamp ring to the housing and simultaneously securing the retainer ring inside the housing. The figure below shows an enlarged schematic view of these components and the assembled view.
