Bureau of
Safety and
Environmental
Enforcement

QC-FIT EVALUATION OF CONNECTOR AND BOLT FAILURES SUMMARY OF FINDINGS

EXECUTIVE SUMMARY

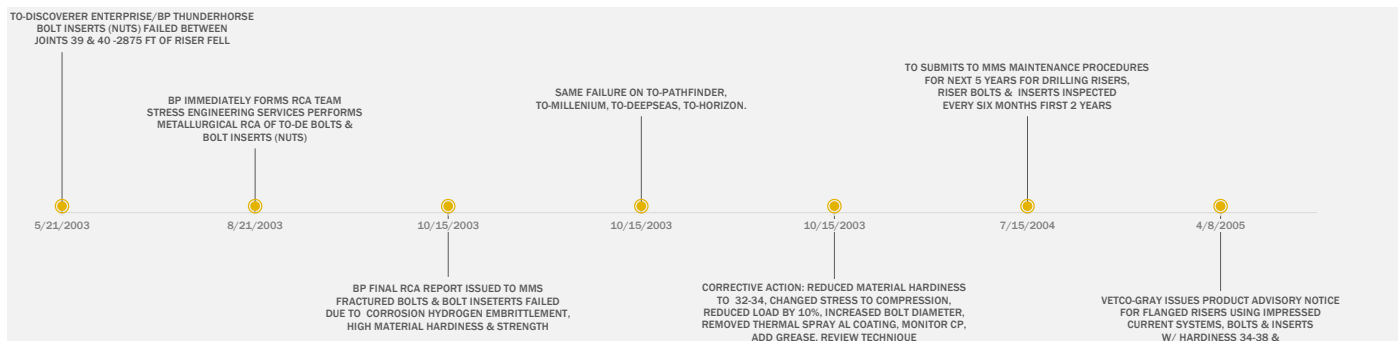
Figure H.1 - 2003-2005 Transocean–Discoverer Enterprise/BP Thunderhorse and Affected Vessels Timeline

A bolt insert failure occurred on May 21, 2003 on Transocean's Discoverer Enterprise (TO-DE) drilling riser (BP-Thunderhorse) (see Figure H.1 for overview detail of TO-Discoverer Enterprise Bolt Event Timeline). The bolts' inserts (nuts) that secure the drilling riser failed between joints 39 and 40 resulting in the riser parting to approximately 3,200 feet below sea level and the release of 2,450 bbl of Accolade synthetic based drilling fluid. The bolt insert and bolt fractured due to severe, accelerated, environmentally assisted corrosion. The 2003 TO-DE bolt insert/bolt failure impacted five TO rigs: Discoverer Enterprise, Pathfinder, Horizon, Millennium, and Deepseas.

On October 15, 2003, an RCA report on the TO-DE riser inserts (and bolts) failure was issued to the Minerals Management Service (MMS). A third party performed the metallurgical RCA for the inserts and the bolts that were also AISI 4340 with a material hardness design specification 34-38 HRC. The inserts and bolts for TO-DE and TO-Discoverer Pathfinder (examined for comparison) had yield strength values of 135 ksi for inserts and 145 ksi for bolts. The material hardness values were in the range of 34-40 HRC for the inserts and 34-38 HRC for the bolts that did not fail. For the failed inserts the hardness values were 34-39 HRC, and 35-37 HRC for the failed bolts. The RCA stated the immediate cause for failure was due to the identified failure mechanism of environmentally assisted cracking fracture of the AISI 4340 inserts. This report also identified several factors as potential correlated factors contributing to the cause of hydrogen-related failure, as follows: high material hardness, high material yield strength of the inserts (and bolts), seawater salinity, fluid, thermal spray aluminum coating, potential stray direct current (DC) induced electrical currents, type of cathodic protection system, material compatibility (use of dissimilar metals in close proximity), and combined charging effects.

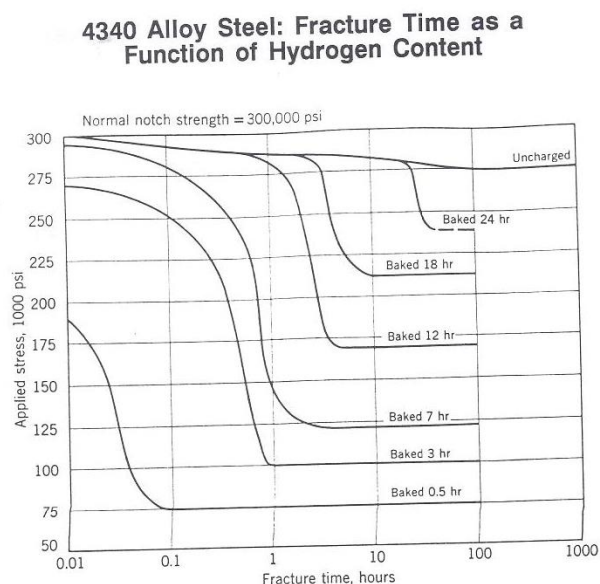
Based on curve above, when bolts are subjected to stresses in the range of approximately 28,000 to 35,000 psi with diameters in the range of 2.5-4 inches, and hardness 34-38 HRC, they will likely fracture due to stress corrosion cracking. For example, bolts with a hardness of 34 HRC, will likely fracture due to stress corrosion cracking (SCC) at approximately 35,000 psi. When subjected to an applied stress of approximately 28,000 psi. Bolts with a material hardness value greater than 38 HRC, will likely fracture due to SCC. Therefore, the higher the bolts' material hardness value, the lower threshold stress they can withstand before fracturing due to SCC. The lower the bolts' material hardness (more ductile its material strength properties), the higher the threshold stress they can withstand before fracturing due to SCC.

Delayed fracture times and minimum stress for cracking of 0.4% carbon steel as a function of hydrogen content. Specimen initially charged cathodically, baked at 150 °C for varying times to reduce hydrogen content.

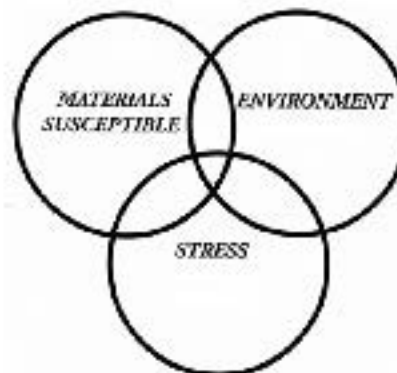
Fig. 1 — Factors contributing to hydrogen embrittlement.

Of these, hydrogen embrittlement is responsible for a surprising number of delayed failures and problems with products produced from wrought materials. If they undergo secondary processing operations such as plating. The factors (see Figure 1) responsible for this type of failure include having a susceptible material, an environment conducive to attack and the presence of stress (internal or applied). Once two of these three factors are present, failure is inevitable.

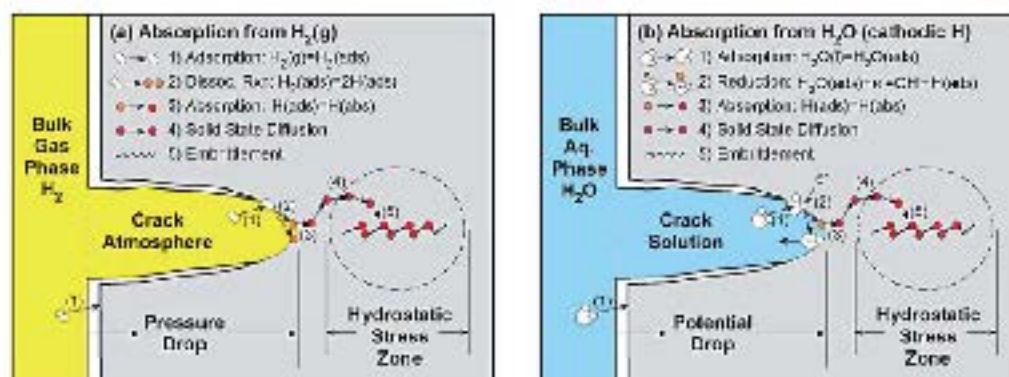
Fig. 2 — Hydrogen embrittlement mechanisms.

Hydrogen embrittlement is also known as hydrogen induced cracking or hydrogen attack. Materials that are most vulnerable include high strength steels, titanium and aluminum alloys and electrolytic tough pitch copper. Hydrogen embrittlement mechanisms (see Figure 2) can be aqueous or gaseous and involve the ingress of hydrogen into the metal, reducing its ductility and load bearing capacity. Stress below the yield stress of the susceptible material then causes subsequent cracking and catastrophic brittle failures (see Figure 3).

It is generally agreed that hydrogen, in atomic form, will enter and diffuse through a metal surface whether at elevated temperatures or ambient temperature. Once absorbed, dissolved hydrogen may be present either as atomic or molecular hydrogen or in combined molecular form (e.g., methane). Since these molecules are too large to diffuse through the metal, pressure builds at crystallographic defects (dislocations and vacancies) or discontinuities (voids, inclusions or interfaces) causing minute cracks to form. Whether this absorbed hydrogen causes cracking or not is a complex
