BSEE Panel Report 2021-001

Investigation of May 29, 2019, Fatality

Lease OCS-G02116, Eugene Island
Area Block 331

March 11, 2021

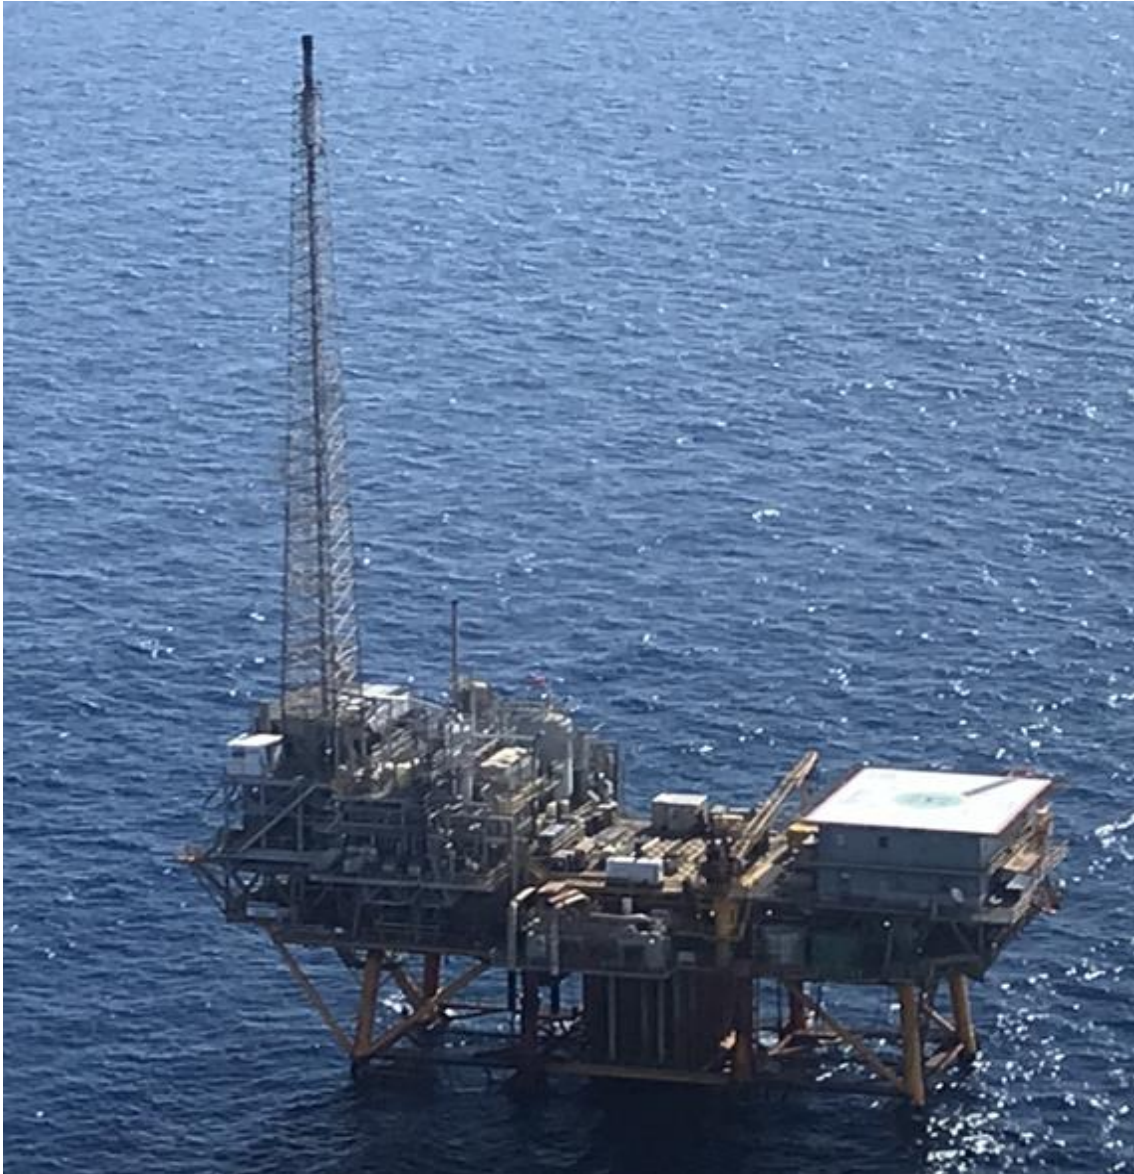
Figure 2- Aerial Photograph of EI-331 Platform "B"

EI-331 "B" Platform is a twelve-pile (eight main pile, four skirt), fixed steel structure with 41 well slots and conductors (*see Figure 2*). Shell Offshore Inc. originally installed the platform in 1972. The water depth at the platform location is approximately 240 feet, and the distance from shore is approximately 80 miles. Forty of the 41 well slots have been drilled, with 8 wells producing but offline at the time of the incident.
