BSEE Panel Report 2019-002

# **Investigation of October 11, 2017 Flowline Jumper Failure**

Lease OCS-G 24055  
Mississippi Canyon Block 209  
Gulf of Mexico Region,  
New Orleans District

December 30, 2019

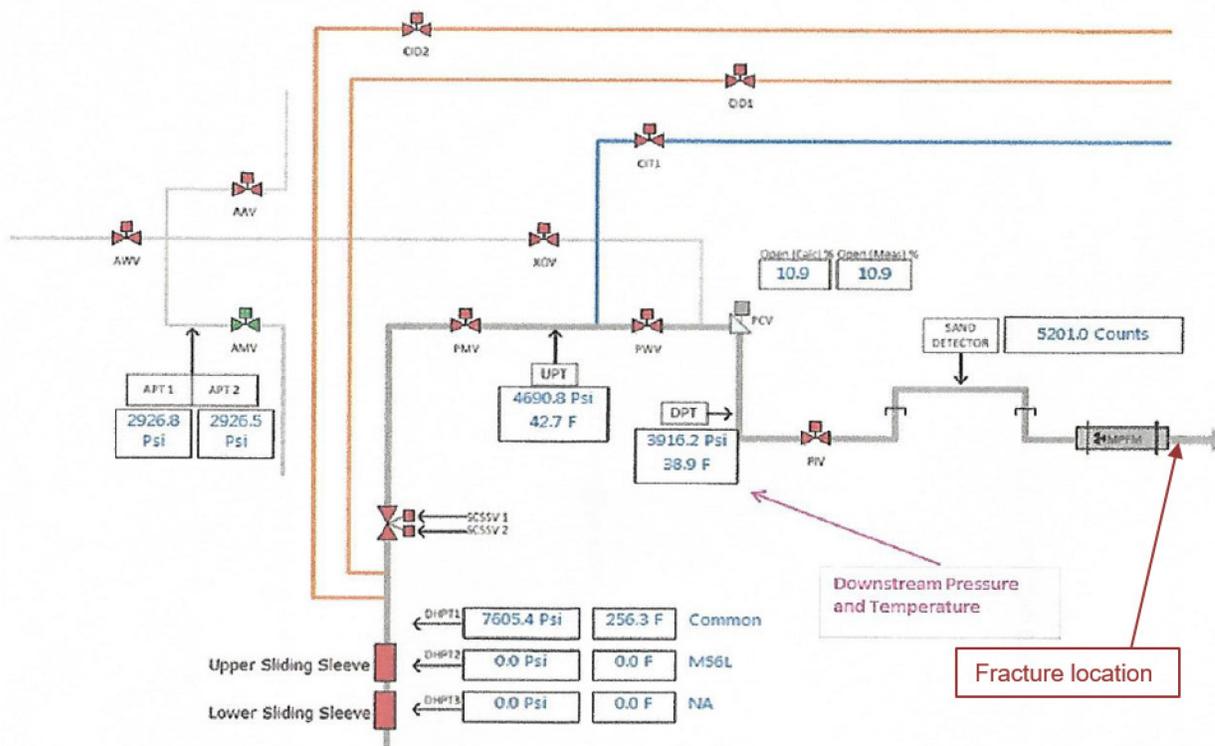
Figure 8 - MC 209 flow schematic.

In Figure 8, the Downstream Pressure Transmitter (DPT) is located downstream of the Pressure Control Valve (PCV), which is commonly referred to as the subsea choke. The subsequent trend (Figure 9) provided in this report refers to DPT pressure as either “Flowline Pressure” or “MC 209 1: DOWNSTREAM PRESSURE.” The location of the leak is immediately downstream of the MPFM flange shown on the right side of the drawing. When the Production Isolation Valve (PIV) is in the open position, the DPT has an accurate reading of the flowline pressure at the location of the leak.
