Addendum to Final Report  
for  
**UNITED STATES DEPARTMENT  
OF THE INTERIOR**  
BUREAU OF OCEAN ENERGY MANAGEMENT,  
REGULATION, AND ENFORCEMENT  
WASHINGTON, DC 20240  
**FORENSIC EXAMINATION OF DEEPWATER  
HORIZON BLOWOUT PREVENTER**  
CONTRACT AWARD No. M10PX00335

Report No. EP030842  
30 April 2011

Forensic Examination of Deepwater Horizon  
Blowout Preventer

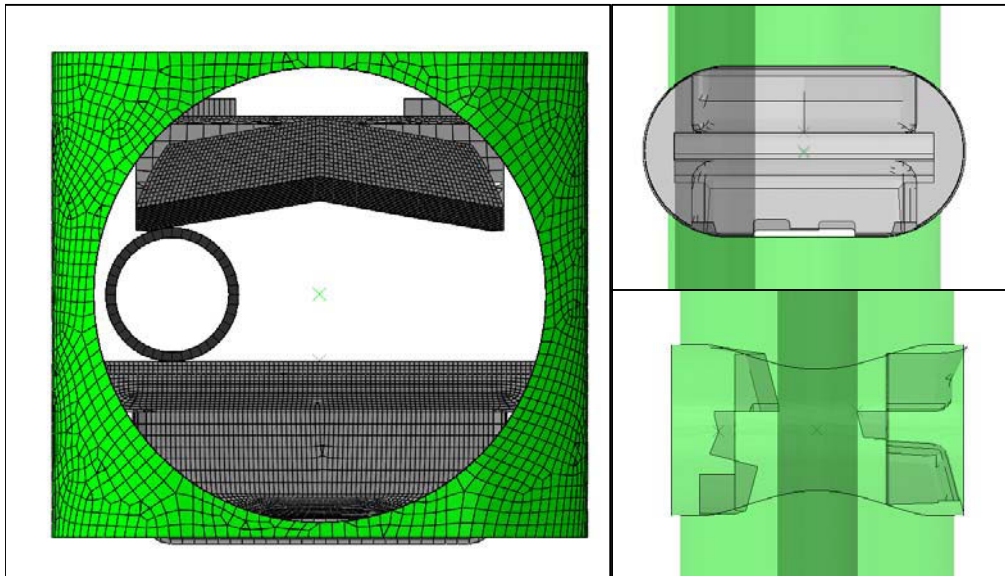
**Revised Figure 134 FEA Model of BSR Blade Surfaces and Off-Center Drill Pipe**

The progression of the shear cut for the model with off-centered drill pipe is shown in Revised Figure 139 and Revised Figure 140. With the pipe off center in the wellbore (displaced 0.5 inches from the inside wall of the wellbore as illustrated in Figure 134), the corner of the upper blade made the initial contact with the drill pipe (Frame 6). In Frame 12, the corner of the upper BSR blade has pierced the drill pipe and shearing has initiated. Because part of the pipe is outside of the upper BSR blade surface, only approximately 75% of the pipe is actually being sheared between the upper BSR and lower BSR blade surfaces (Revised Figure 141, Frame 23). Due to the shear initiation at the Kill Side end point of the upper BSR blade and the fact that less of the pipe was sheared between the upper and lower BSR blade surfaces, the calculated maximum shearing force / equivalent operating ram pressure was less than that calculated for the centered pipe model (1,882 psi equivalent pressure for the off-center pipe versus 2,408 psi equivalent pressure for the centered pipe).

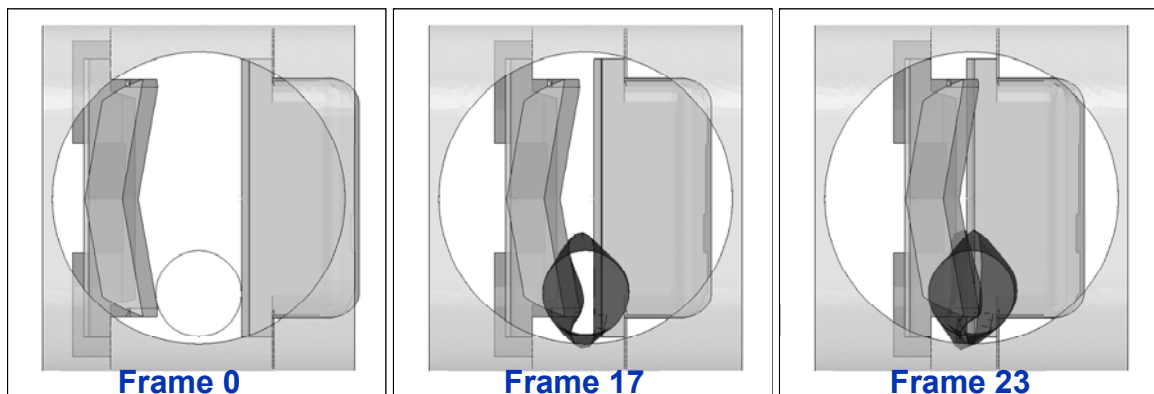
**Revised Figure 141 Top View Showing Deformation of Drill Pipe Outside of Shearing Blade Surfaces**

The configuration of the drill pipe for the condition shown in Frame 28 of Revised Figure 139 and Revised Figure 140 is referred to as the “final deformed” condition since it represents an operating ram pressure of 5,280 psi (greater than the available hydraulic pressure and thereby conservative for a maximum ram block displacement). Revised Figure 142 shows that, although the drill pipe was initially off-set 0.5 inch from the inside wall of the wellbore, the deformed pipe touches the wellbore surface both above and below the BSR cavity (Revised Figure 142). This is also the case for the lower operating ram pressures for Frames 23 and 27 (Revised Figure 139, Revised Figure 140,

and Revised Figure 141; equivalent operating ram pressures of 1,165 and 1,851 psi, respectively)

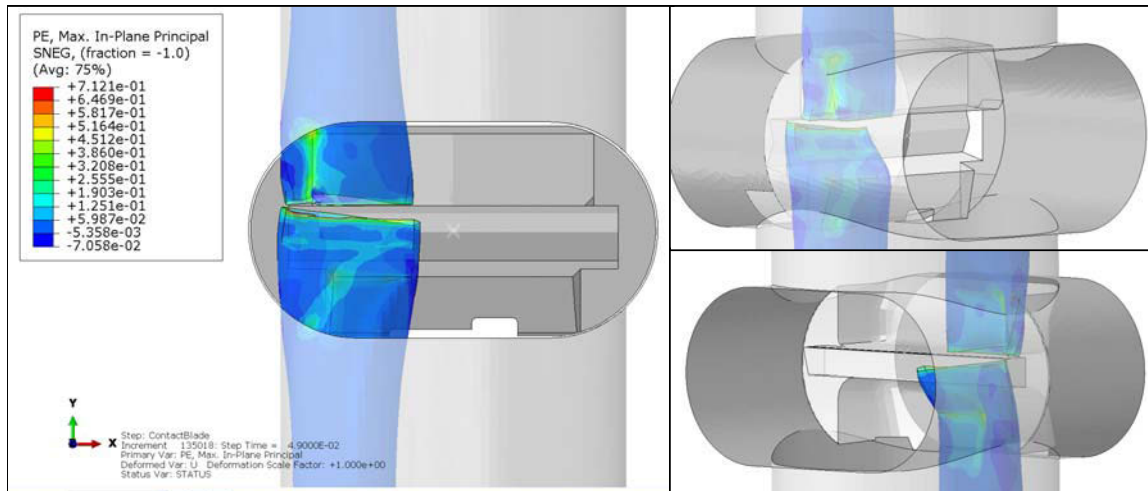
**Revised Figure 142 Final Deformed Configuration of Shear Cut Showing Strain Concentration at Inner Bend**

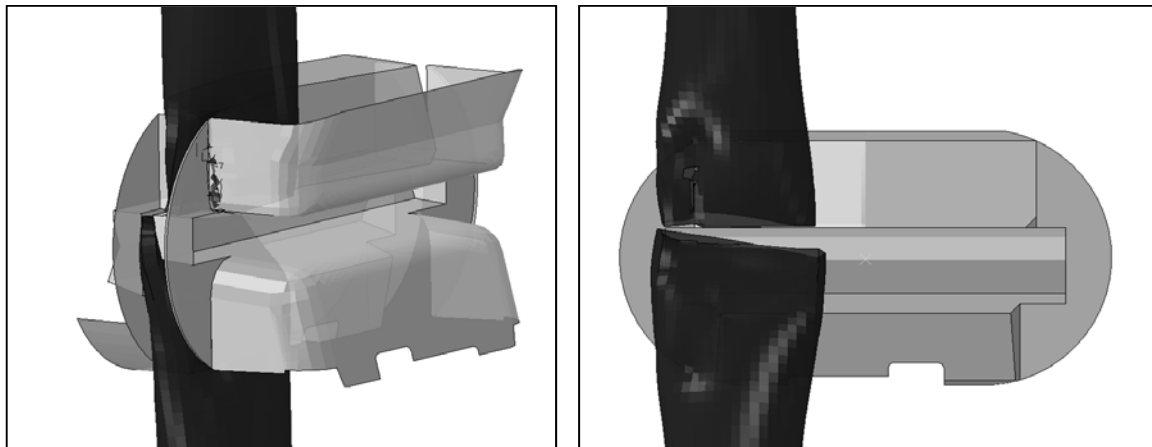
- For the FEA model, the ram block indentations on both the upper and lower segments of drill pipe were present and agreed with the recovered evidence (Revised Figure 143 and Revised Figure 145).

**Revised Figure 143 Final Deformation of the Drill Pipe as Predicted by the Off-Centered Pipe Model; Upper BSR Block Shown on the Right**

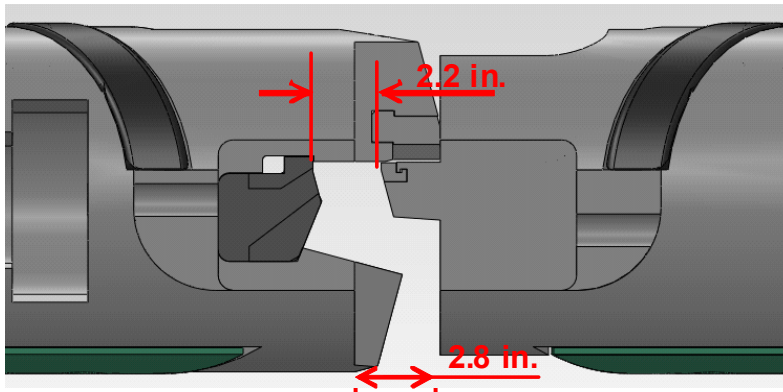
With an applied equivalent pressure of 5,280 psi (which is greater than the available hydraulic pressure), the upper and lower BSR blocks were 2.8 inches from being fully closed (Revised Figure 146 and Revised Figure 148). The side packers were 1.7 inches from making initial contact and sealing. The lower BSR blade was 2.2 inches from contacting the rear packers and sealing.

**Revised Figure 148 BSR CAD Models – 2.8 Inch Standoff between Blocks**
