# Investigation of Shell Offshore Inc. Hobbit Pipeline Leak Ship Shoal Block 281 January 24, 1990

Gulf of Mexico  
Offshore Louisiana

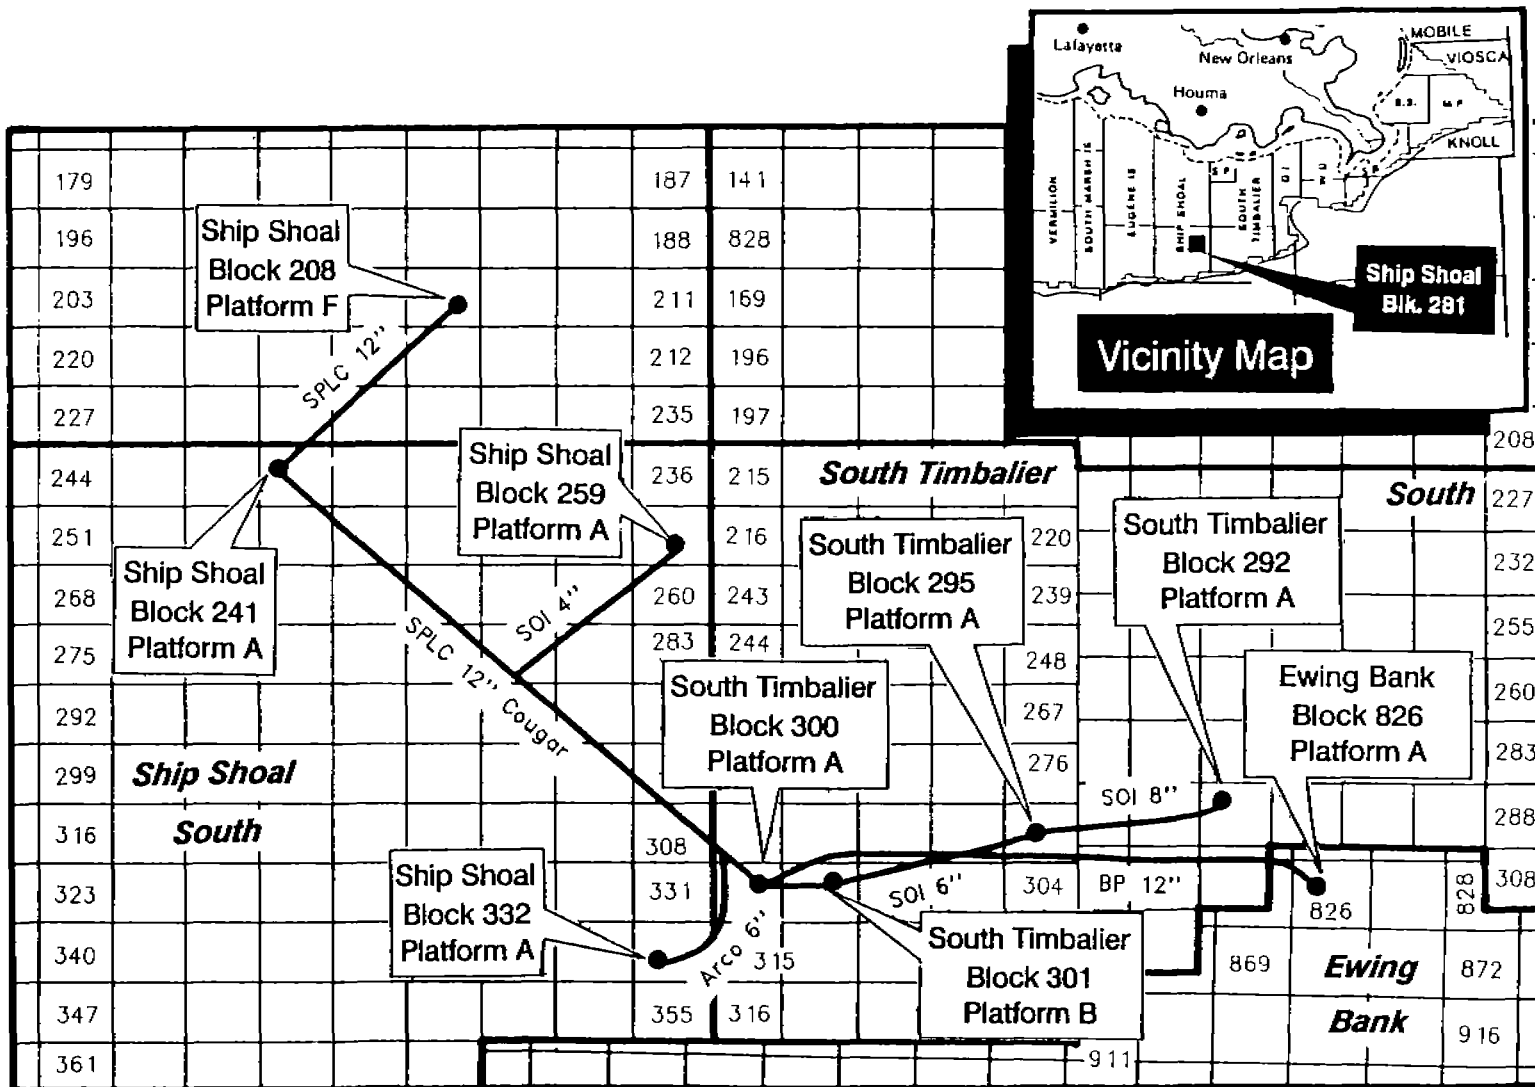
Attachment 1

Cougar Pipeline System
