UNITED STATES COAST GUARD

Report of Investigation into the Circumstances Surrounding the
Explosion, Fire, Sinking and Loss of Eleven Crew Members

DEEPWATER HORIZON

April 20 – 22, 2010

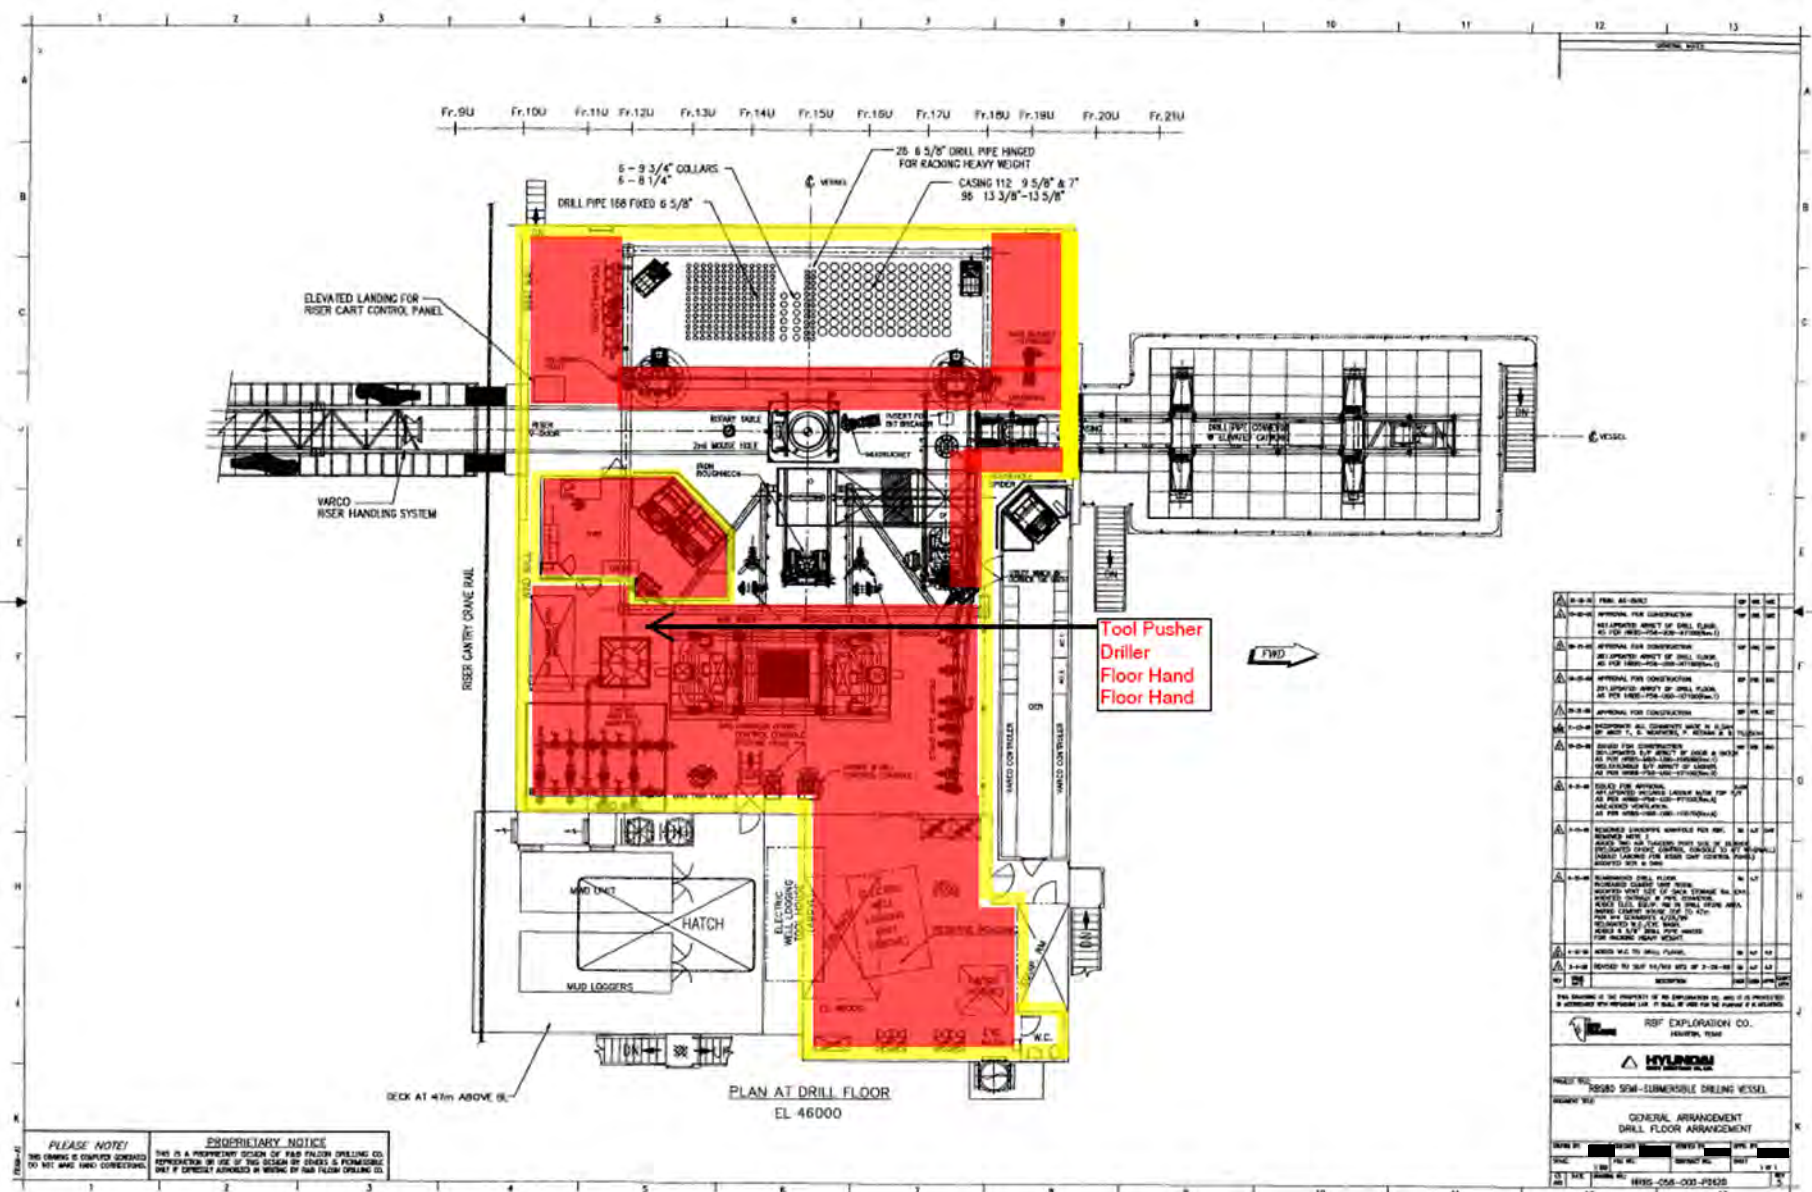
Figure 2 – Drill Floor Plan

On *DEEPWATER HORIZON*, the Drill Floor at elevation 46 m (151 ft) was classified as a Zone 2 area. All electrical equipment in this area was classified safe for such a location except for the electrical equipment in the Drill Shack, the Drilling Equipment Room (DER), and the mud logging and the measurement while drilling (MWD) units. These areas were not equipped with classified electrical fixtures, but were maintained under positive pressure in accordance with safeguard 3, explained below. All other areas on the Drill Floor that were within the wind walls and intermediate levels of the Moon Pool⁴⁴ directly beneath the Drill Floor from elevation 33 m (108 ft), up to the drawworks blowers on the starboard side, and up to approximately elevation 66 m (216 ft) on the port side, were classified as either Zone 1 or Zone 2 areas. In addition, the mud gas separator (MGS) vent at the very top of the derrick was classified as a Zone 1 area for a distance of 1.5 m (4.9 ft) from the outlet, and as a Zone 2 area for an additional 1.5 m (4.9 ft) beyond that point. The extent of the electrically classified areas is shown in yellow in Figures 2 through 5.

The locations of the missing and injured crew members are shown in Figures 2 through 4. Areas highlighted in green are the locations of injured personnel; the areas highlighted in red depict the last known locations of the missing. A-class bulkheads are shown as heavy black lines.

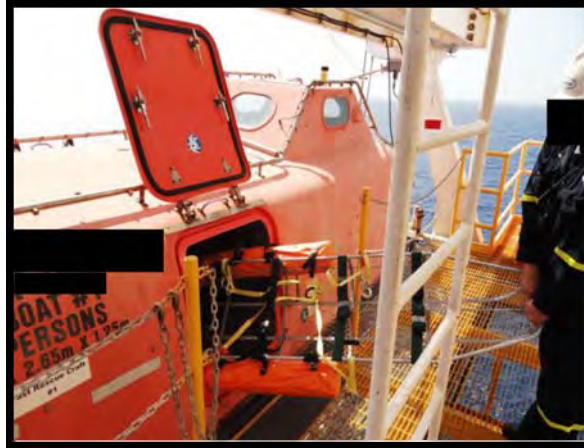
Figure 8 - Typical Stretcher Loading

The lifeboat design was not conducive to receiving an injured crew member on a stretcher. As illustrated in Figure 8, when loading a stretcher via a side loading door, crew members must maneuver it past the threshold. As shown in Figures 9 and 10, once loaded, the positioning of a stretcher in the lifeboat significantly impedes egress and reduces seating capacity by eight to ten occupants. Neither arrangement provides a means to secure a stretcher from shifting during operation of the lifeboat.

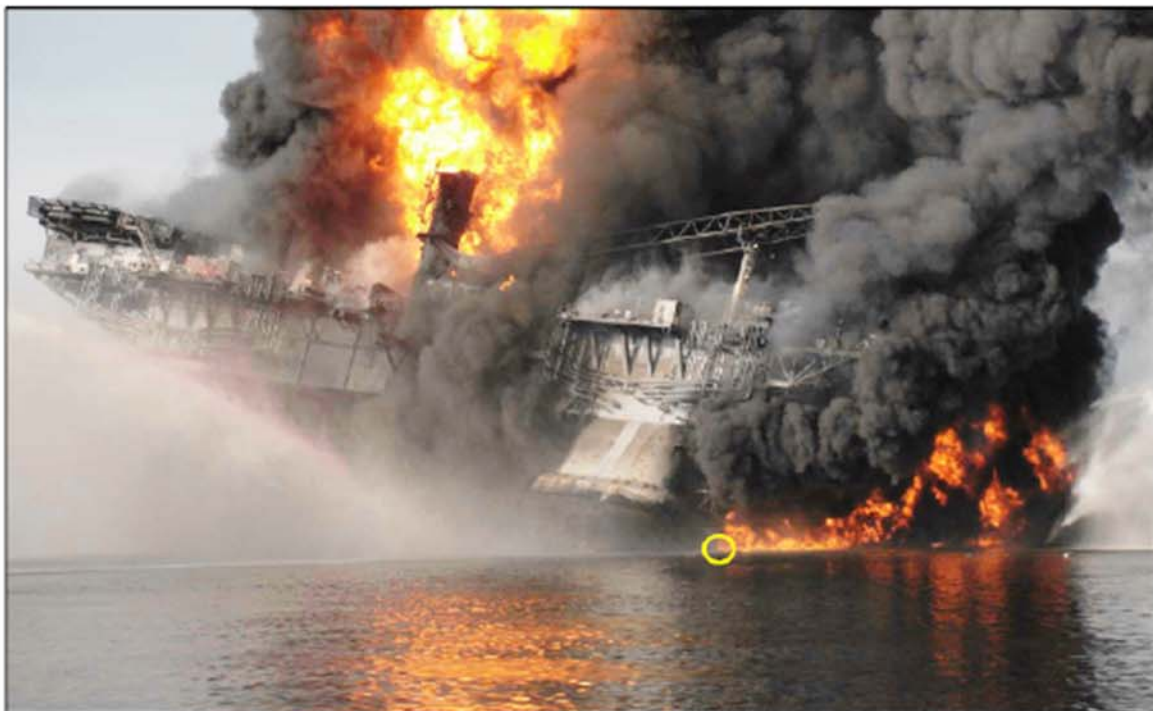
Figure 4: DEEPWATER HORIZON, Port Aspect (0612 on 22 April 2010)

Without information on the rig’s loading prior to the casualty, it is impossible to analyze specific damage scenarios. We also lack precise information regarding the rig’s draft, heel, and trim as the casualty progressed. However, using photographs of the *DEEPWATER HORIZON* during the casualty, we estimated her waterplane in the damaged, floating condition. To estimate the waterplane, we used photographs taken at known times and identified three recognizable hull locations that intersected the waterline. The hull locations at the waterline that we used are marked on the photographs (see below) with yellow circles. Figure 3 and Figure 4 were reportedly taken at 0612 on April 22, 2010. Figure 5 and Figure 6 illustrate how the waterplane estimated from these photographs looks when applied to our computer model. Figure 7 and Figure 8 were taken at approximately 1030 on April 22, 2010, just prior to the rig sinking. Figure 9 and Figure 10 illustrate how the waterplane that was estimated from these photographs looks when applied to our computer model. Although the extent of damage shown in Figure 7 and Figure 8 indicate that some hull deflection may exist, our waterplane estimates cannot account for deflection and necessarily assume that the hull was not deflecting in the pictures.

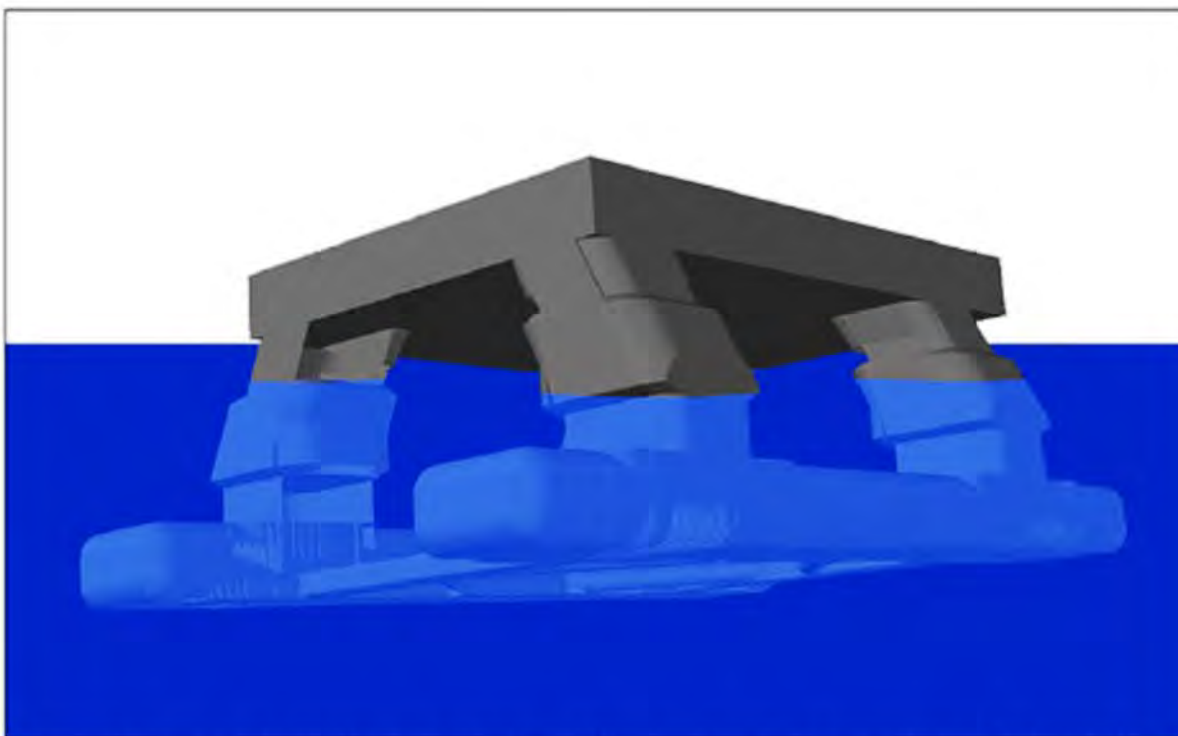
Figure 5: Computer Model Showing the Estimated Waterline, Port Bow Aspect (0612 on 22 April 2010)

Based on the waterplane estimates shown in Figures 5, 6, 9, and 10, we estimated the displacement, heel, and trim at two discrete times: 0612 and 1030 on 22 April 2010. The rig's attitude and displacement for these conditions, as well as the presumed 23 meter draft pre-casualty condition are shown in Table 2. These results show that the rig's displacement had increased by approximately 1500MT at 0612 and by 2300MT at 1030 on 22 April 2010. Changes in displacement describe the cumulative effect of added weight (or lost buoyancy) required for the rig to achieve its estimated waterline. The results shown in Table 2 indicate that the vessel must have experienced flooding, either as the result of damage to the watertight envelope, or as a result of downflooding caused by firefighting water and/or downflooding through preexisting openings, or some combination thereof. In other words, without any flooding, the shifting of on-board weights such as ballast, topside loads, and/or the toppling of the derrick, either alone or in combination, would not have been sufficient to place the vessel in the conditions shown in Table 2.
