**THE BUREAU OF OCEAN ENERGY MANAGEMENT,
REGULATION AND ENFORCEMENT**

**REPORT REGARDING THE CAUSES OF THE APRIL 20, 2010
MACONDO WELL BLOWOUT**

September 14, 2011

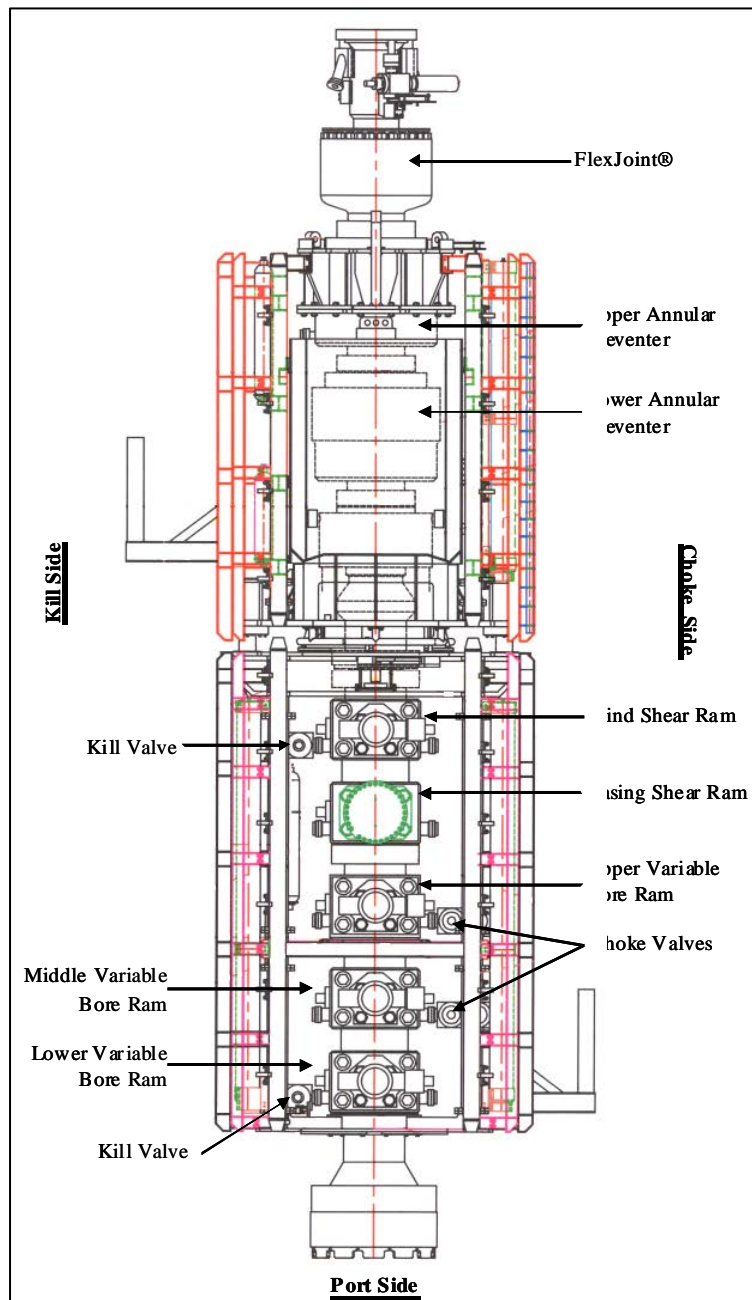
Figure 10 – Schematic of the *Deepwater Horizon* BOP Stack

The *Deepwater Horizon* BOP assembly consisted of two major sections: the stack and the lower marine riser package (see Figure 10). At the time of the blowout, the major components of the *Deepwater Horizon* main stack consisted of the following:
