Final Report
for
UNITED STATES DEPARTMENT
OF THE INTERIOR

FORENSIC EXAMINATION OF DEEPWATER
HORIZON BLOWOUT PREVENTER

VOLUME II APPENDICES

Report No. EP030842
20 March 2011

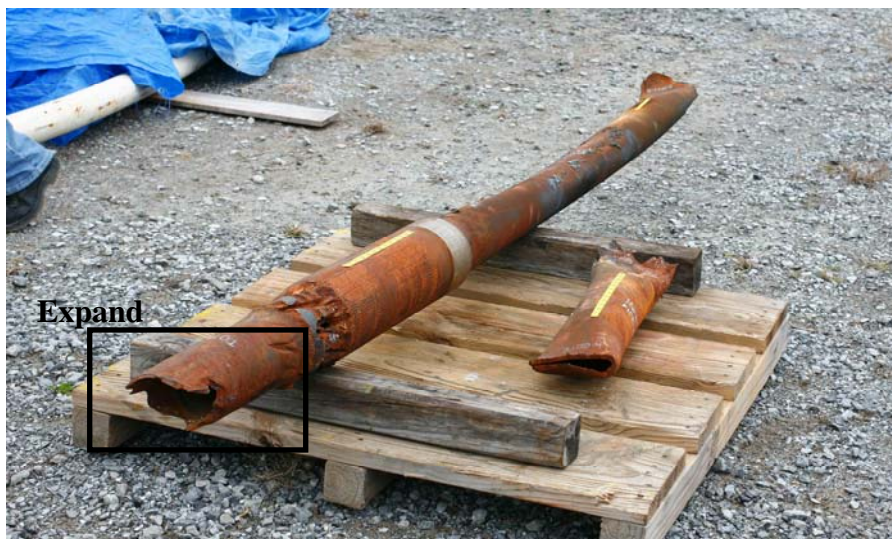
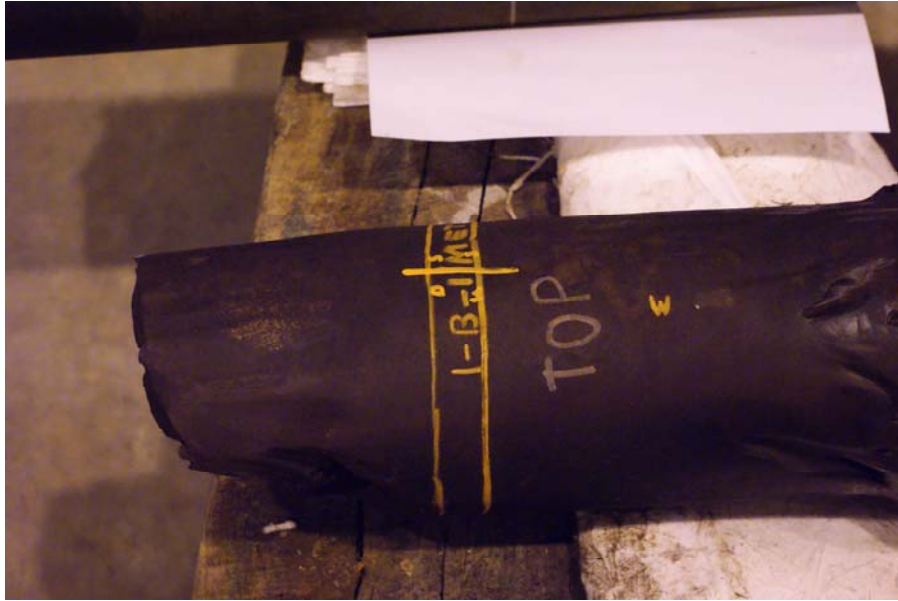
Figure 5 – Area to cut Item No. 1-B-1.

Because of the constraints posed by the fracture / sheared surface and the corresponding friction weld at the pipe joint, a one-inch metallurgical ring sample (as opposed to typical 3-inch sample) will be selected for the downstream end of Item No. 1-B-1 (Table 3). Figure 5 shows the location on Item No. 1-B-1 from which the one-inch metallurgical sample will be removed.

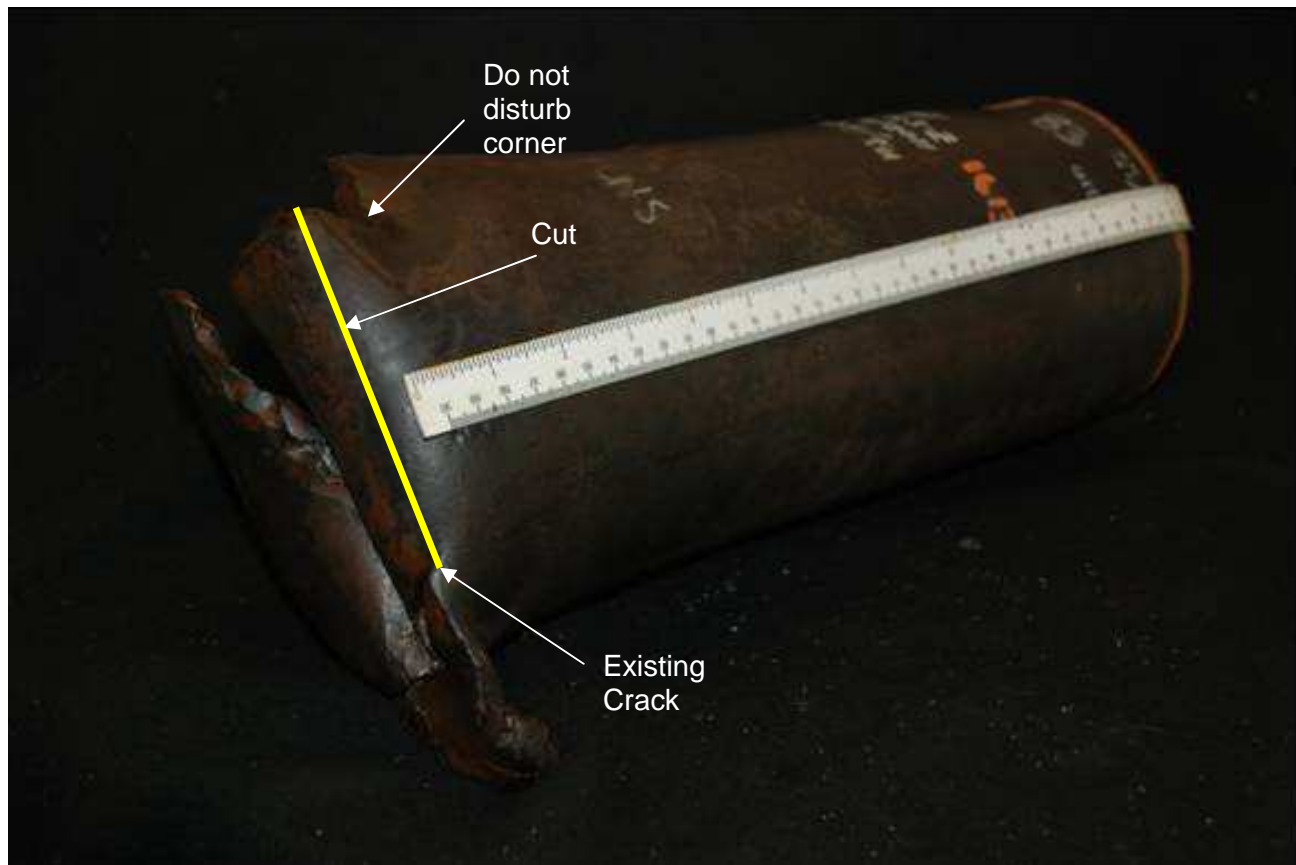
Figure 1 – Documentation of the proposed cut on Item 83 on the side without the “flat”

2. Examine surfaces using a stereo microscope where appropriate.
3. Cut Item 83-Z to reveal the surfaces that are curled into the ID of the pipe (see Figure 1 and **Error! Not a valid bookmark self-reference.**).

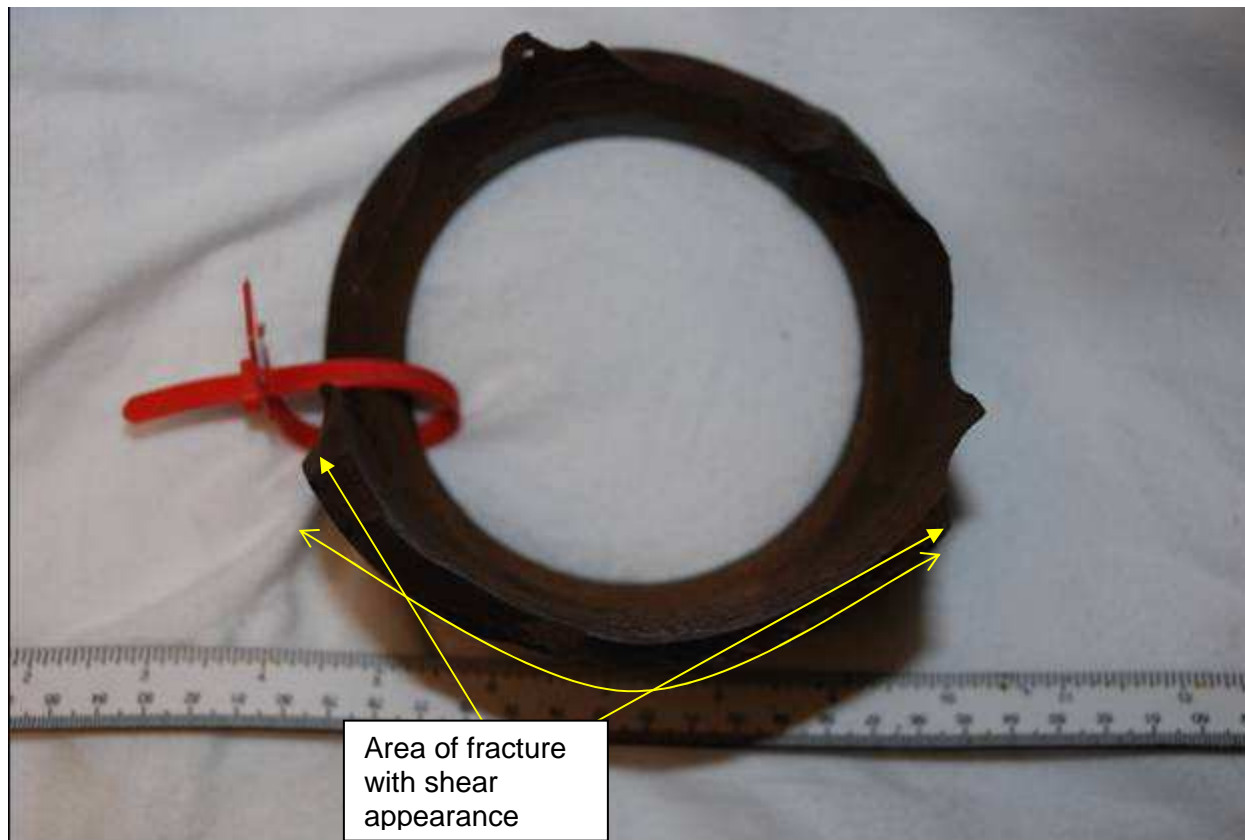
Figure 3 – Top view of Item 1-B-1-Z

4. Examine and photograph the cut surfaces from both sides of the pipe section Item 83-Z.
5. Cut fracture surface area from Item 1-B-1-Z (see Figure 3 and Figure 4).
