Investigation of H₂S Gas Release Platform Hermosa, OCS-P 0316 Pacific OCS Region

August 3, 1999

Prepared By

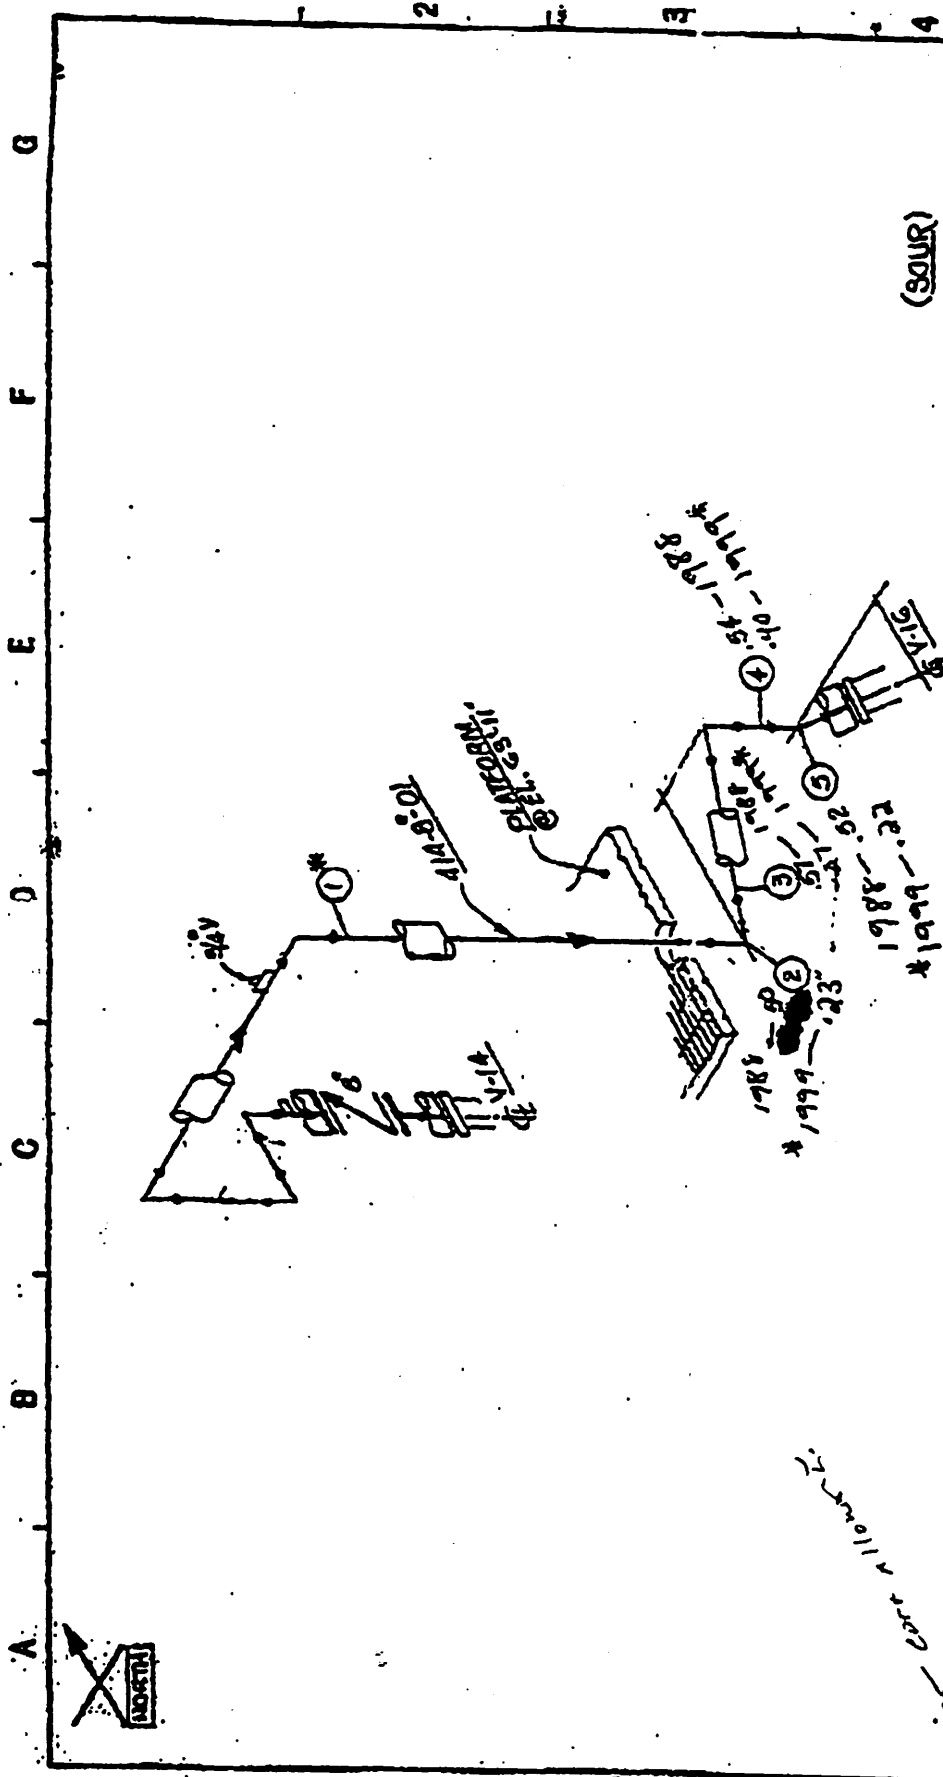
G.I. PRODUCED GAS (SOUR)

5 TEST POINTS.
* 1 HOLE TO BE CUT IN INSULATION.

Injection point by V-02. This area has severe corrosion on the bottom and has a remaining wall thickness of .10". These are the same readings has last year. The quills on the injectors have been replaced and are not creating any further wall loss

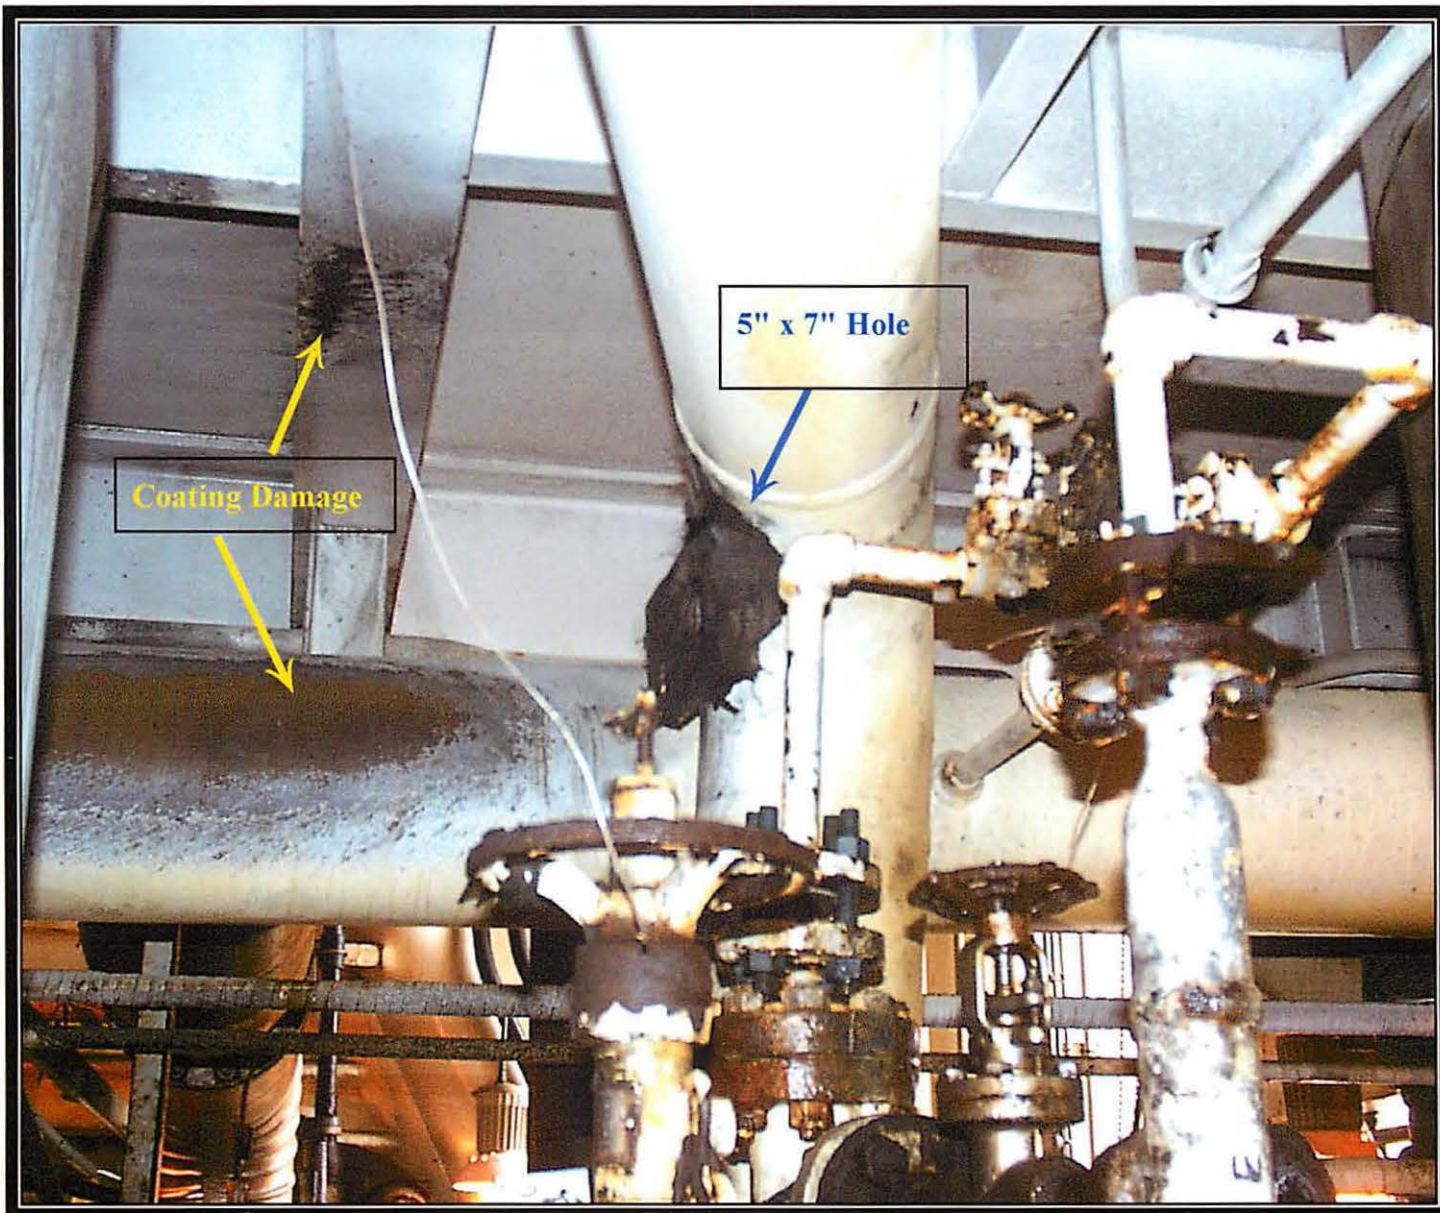
Appendix A.5-Ruptured Elbow and Surrounding Damage

The flowline failed due to internal corrosion, which reduced the wall thickness until it could no longer support the normal operating pressure. Corrosion was caused by condensed liquid water reacting with H₂S gas to form a corrosive acid gas.

The original nominal wall thickness of the flowline was 0.50 inch. The thickness at the rupture was 0.14 inch. Per ASME B31.3, the minimum allowable operating thickness for 1209 psi is 0.26 inch and the burst thickness is 0.11 inch.
