# Final Interpretive Report

## Acoustic Corer™ Survey to Identify Buried Conductors and Geo-Hazards at Mississippi Canyon Block 20 Gulf of Mexico

# Couvillion Group

## RPT-08387-5.0

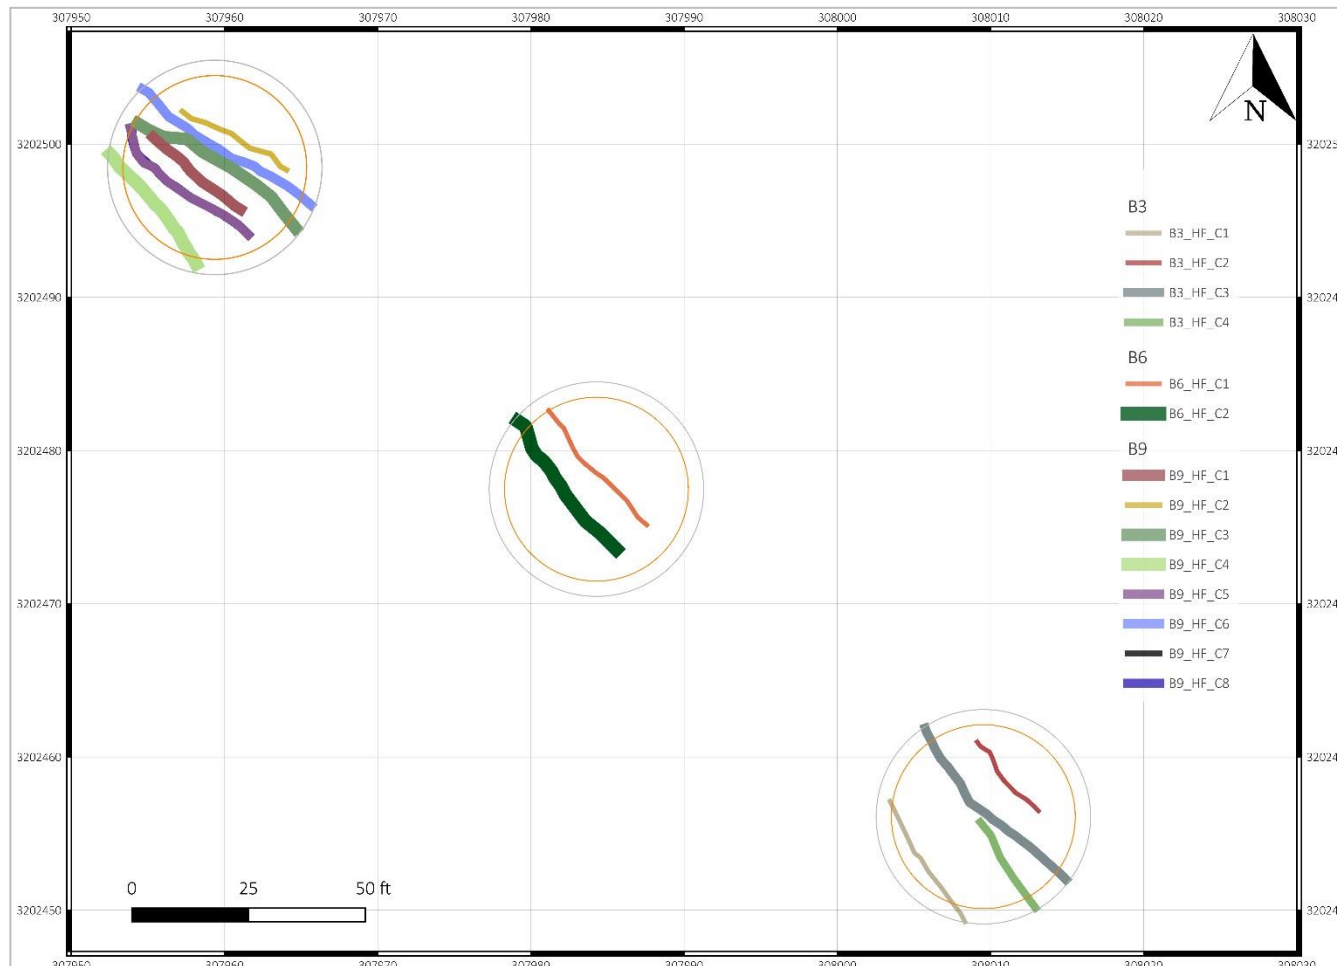
Figure 1 - Plan-View Map of the MC20 Survey Area showing Sites B3, B6, and B9 including identified Linear features (*NAD27 UTM 16N in meters*). Linear feature widths are not to scale. Note: this map includes only the linear features outlined in Table 4, not the anomalies in Table 5. B9\_HF\_C8 is shadowed by B9\_HF\_C5 and B9\_HF\_C7 is shadowed by B9\_HF\_C1 in plan-view. Refer to Section 7 for more information.

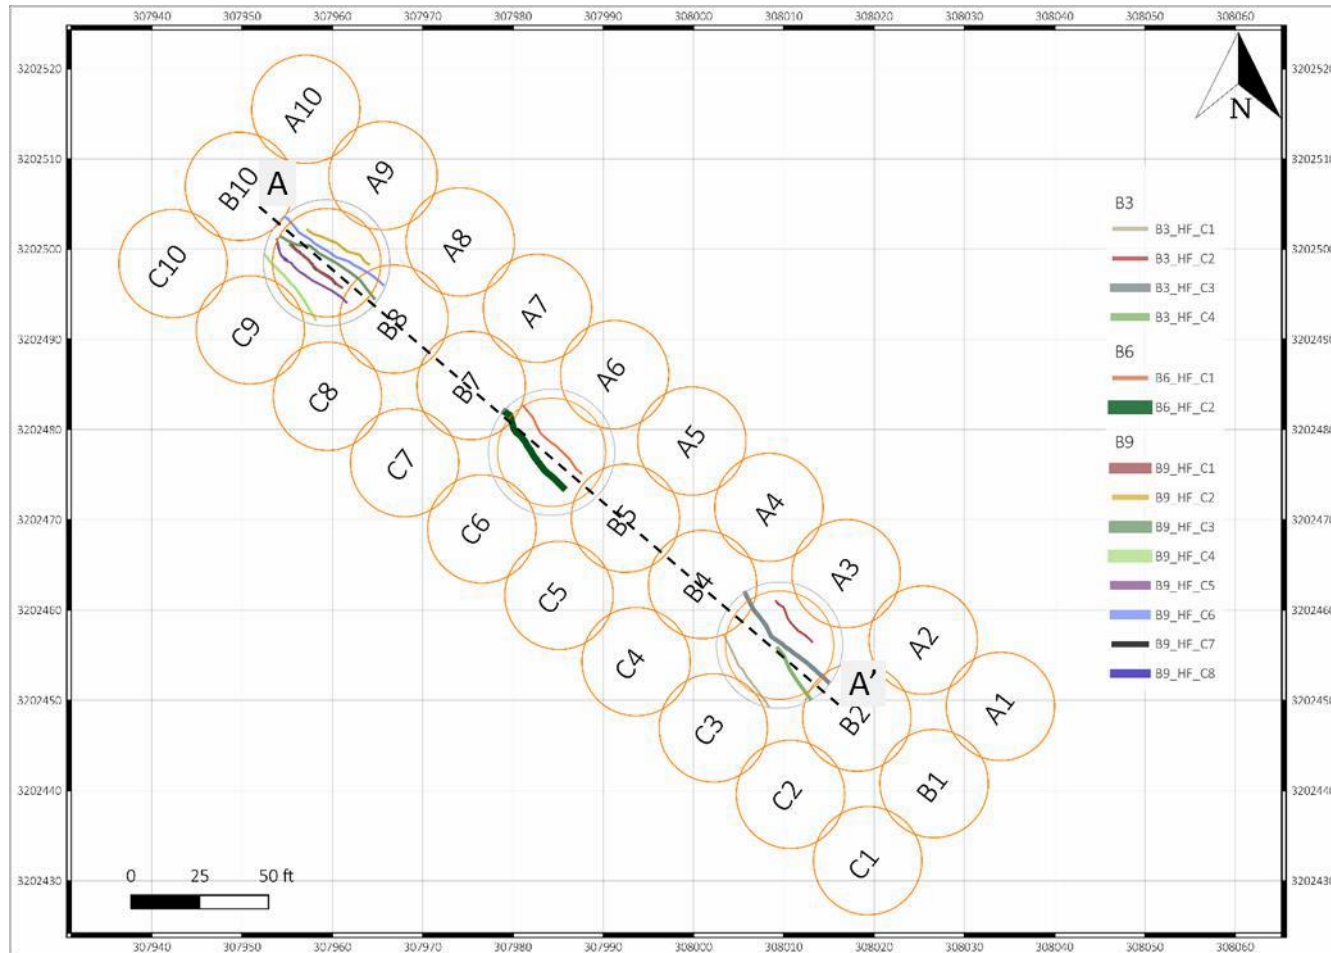
Figure 2 - Plan-View Map of the MC20 Survey Area showing other potential AC Sites including identified Linear features (*NAD27 UTM 16N in meters*). Linear feature widths are not to scale. Note: this map includes only the linear features outlined in Table 4, not the anomalies in Table 5. B9\_HF\_C8 is shadowed by B9\_HF\_C5 and B9\_HF\_C7 is shadowed by B9\_HF\_C1 in plan-view. Refer to Section 7 for more information.

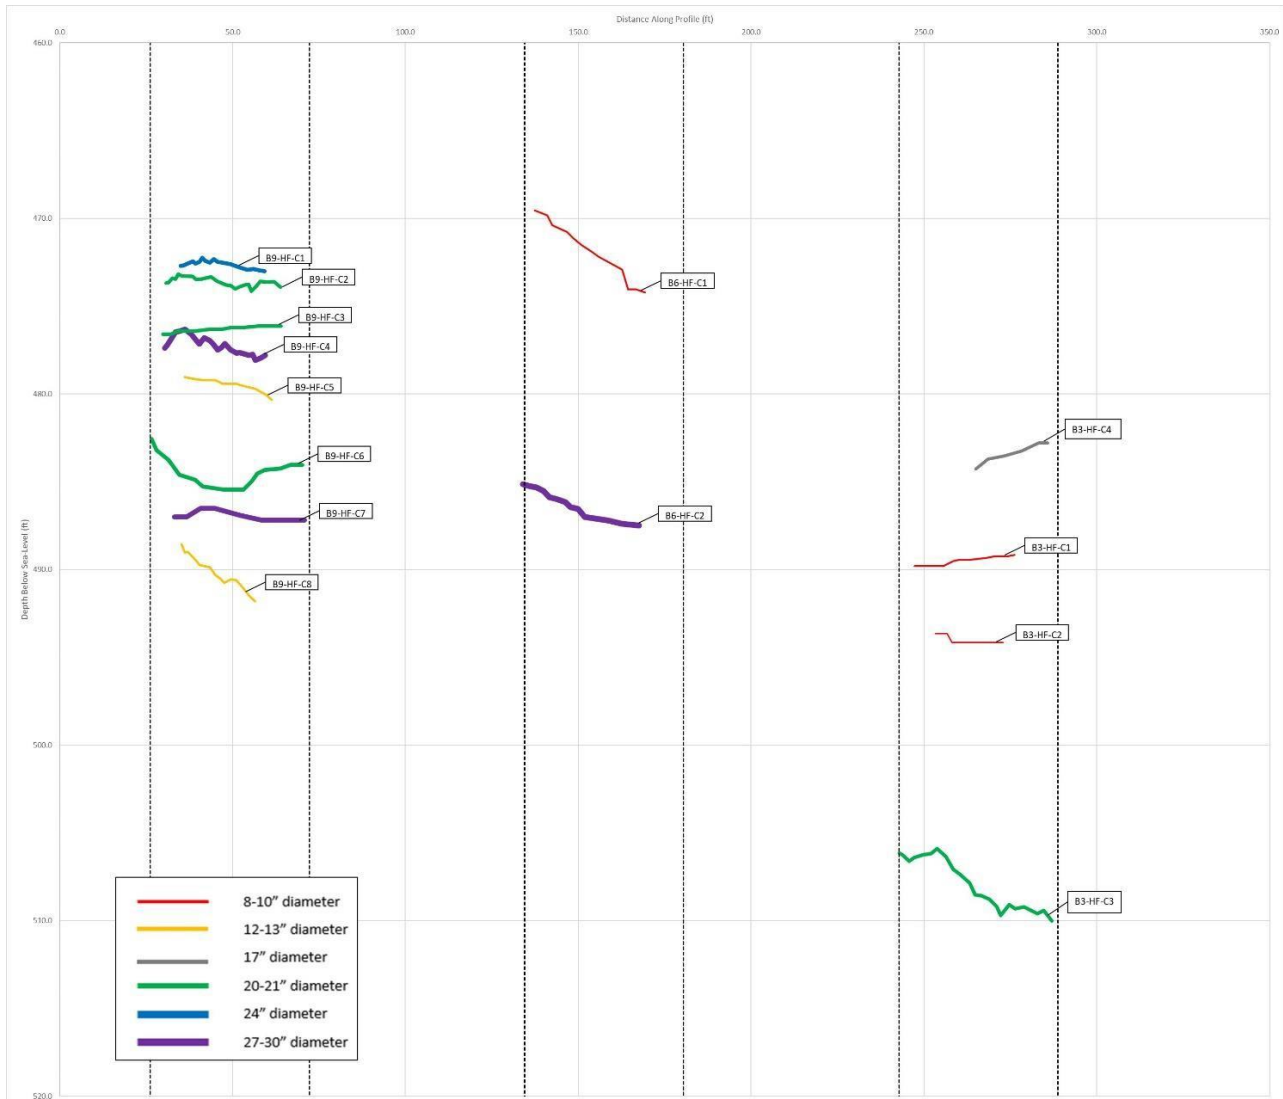
Figure 3 - Annotated Profile showing all linear features identified within the AC data. Profile A-A' is shown in Figure 2. The data shown is from sea-level and is not tidally corrected.

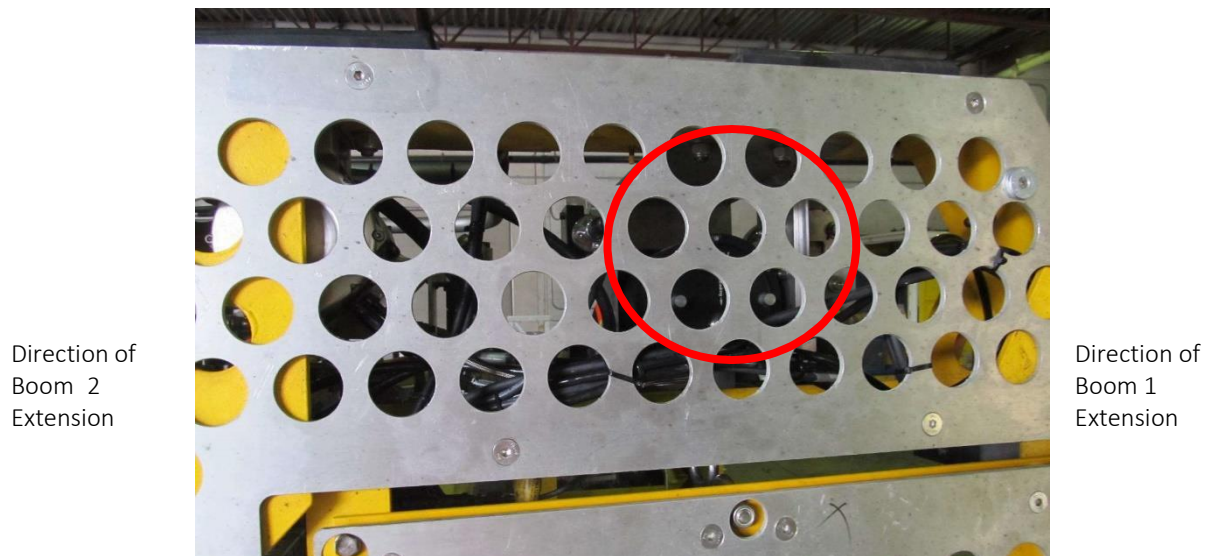
The “heading arrow” on the TOGS Gyro system should point toward the rear of the AC as per PanGeo engineering drawings. (Alignment Notch in direction of Boom Extensions). Prior to the MC 20 project the AC underwent a complete refurbishment. During the final stages of reassembly, PanGeo’s lead mechanical expert was absent due to personal reasons. The QC audit revealed that the onsite lead responsible for the AC maintenance program recalled orienting the arrow on the TOGS mounting flange to point toward Boom 1. This offset would cause a 90-degree shift in the heading reading.

*Figure: Image showing correct installation of TOGS, Husky Campaign 2014*
