**Investigation of Loss of Well Control and Fire  
South Timbalier Area Block 220, Well No. A-3  
OCS-G 24980  
23 July 2013**

**Gulf of Mexico  
Off the Louisiana Coast**

David Trocquet – Chair  
Jack Williams  
Marty Rinaudo  
James Richard  
Charles Arnold  
Michael Idziorek  
Michael Pittman  
Matthew Capon - USCG

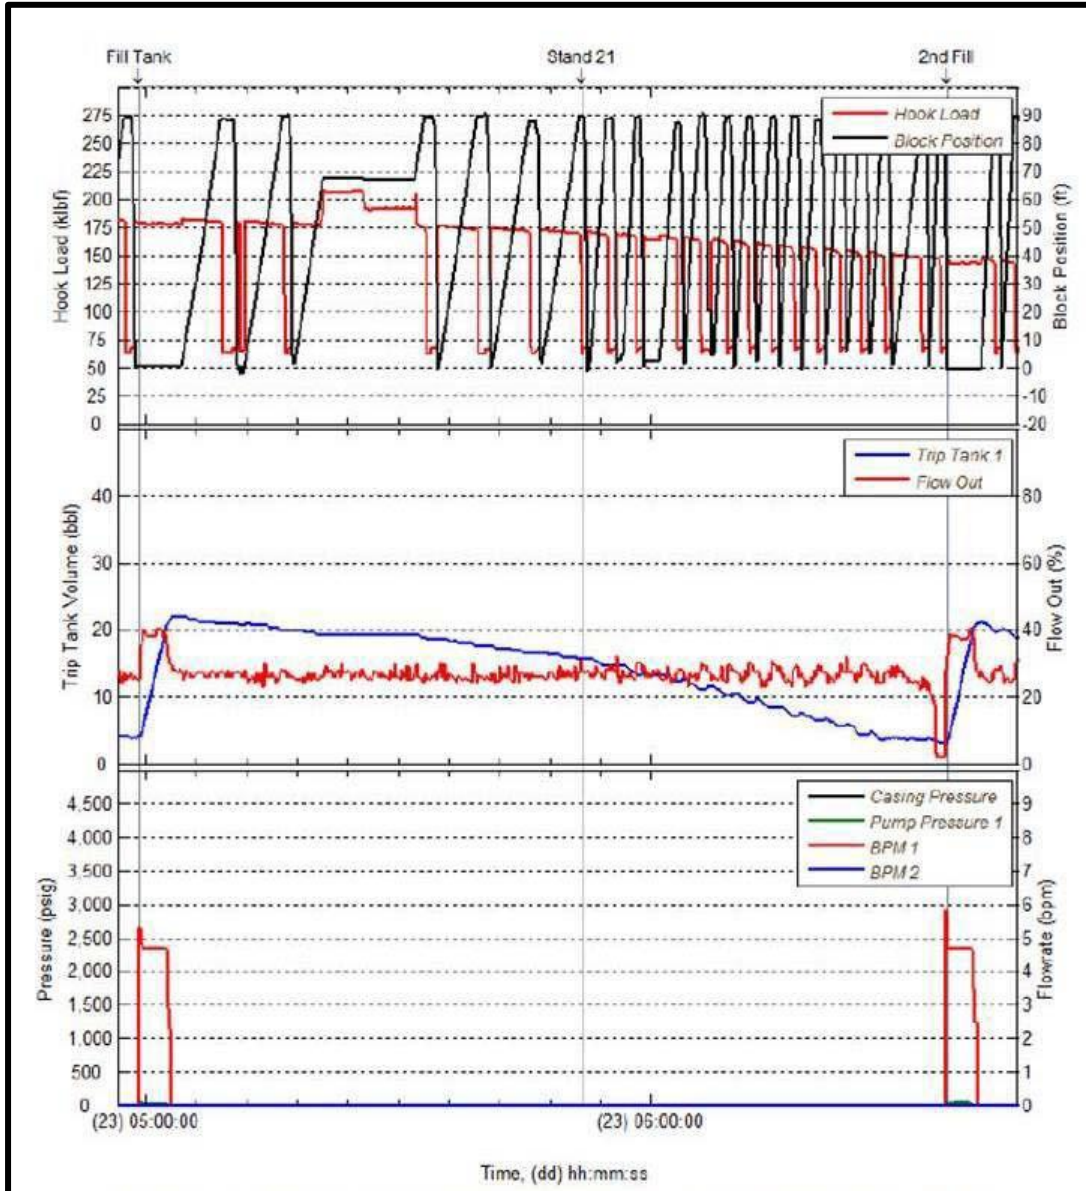
**Figure 14:** Summary plots of digital trip records for second trip tank fill-up (from SME Committee Report)

Figure 14 (above) shows a summary of the recorded digital data between the first trip tank fill-up and the second trip tank fill-up (stands 16 thru 35). The trip tank was re-filled for the first time during the trip at 0459 hrs after pulling stand 15. The tank volume had decreased 19.5 bbl from an initial reading of 23.2 bbl to 3.7 bbl for 14 stands, which had a total displacement of 10 bbl. The SME Committee calculated from this data an apparent seepage loss of 9.5 bbl over the first 52 minutes of the trip, approximately a 10 bph seepage loss rate. It was noted by the SME Committee team that no swabbing tendency was observed in the trip tank volume though some sticking seemed to be associated with stand 18.

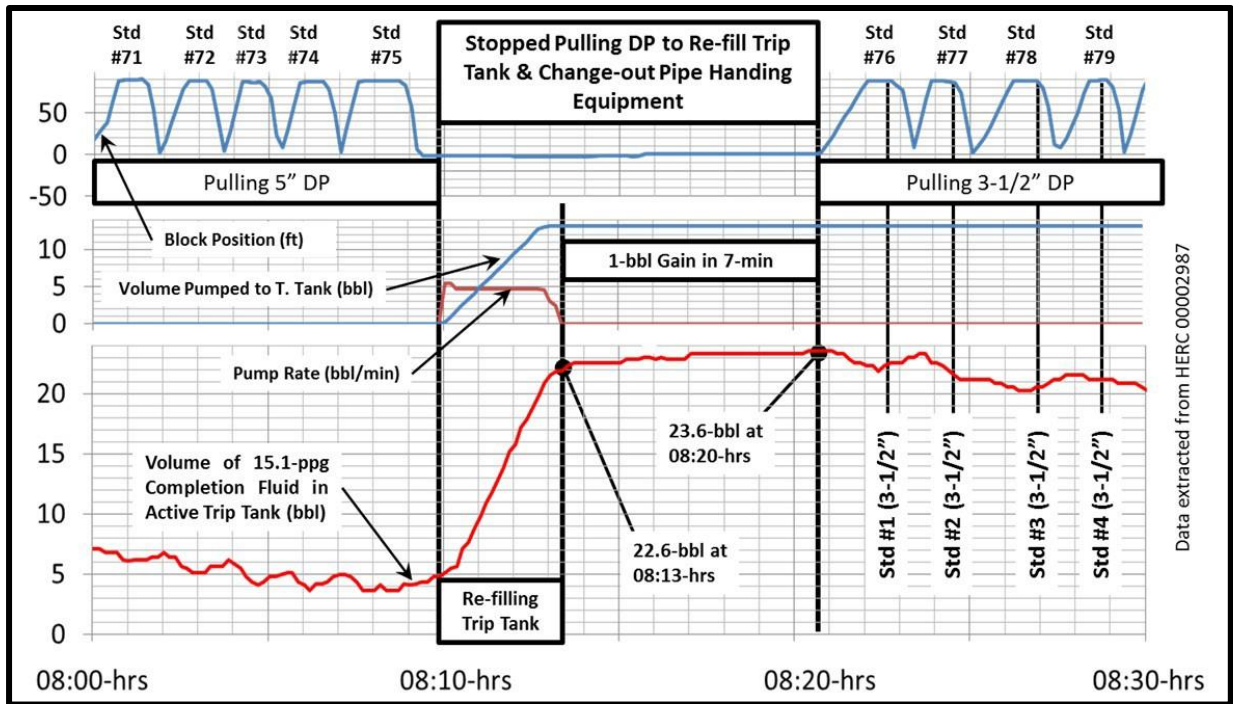
**Figure 17:** Digital plot: first indication that Well could be flowing (from SME Committee Report)

Figure 17 (above) graphically shows the time period when tripping operations were stopped to change the pipe handling equipment. About 12 minutes elapsed between racking the last stand of 5-in pipe and latching to pull the first stand of 3 ½-in pipe. From the SME Committee Report: “While the pipe was stationary, the trip tank volume increased from 22.6 bbl at 08:13 to 23.6 bbl at 08:20. Either this was not noticed or it was not thought to be significant, because the trip tank pump was never turned off to check visually for flow. Had the trip tank gain been investigated further and acted upon at this time, securing

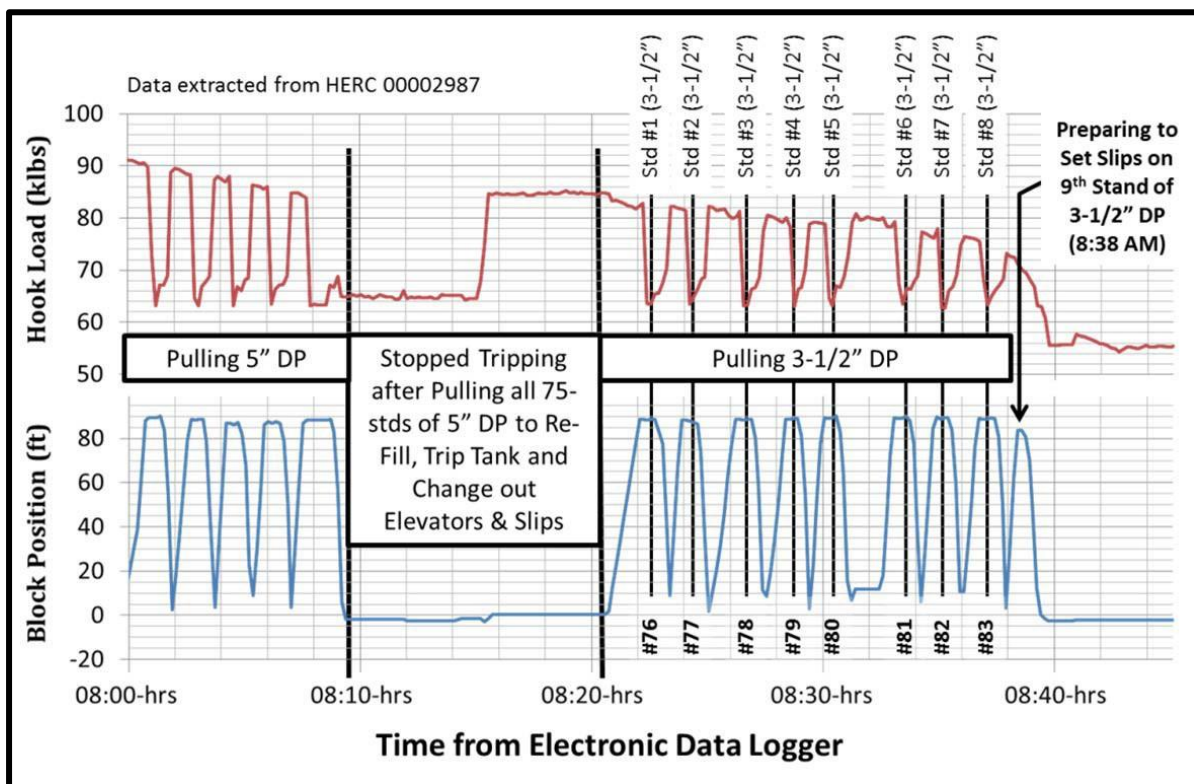
**Figure 19:** Hook load and block position history just prior to the attempted shut-in (from SME Committee Report)

Based on the 23 July 2013 electronic data log, the 9th stand of 3½-in drillpipe was in position to set the slips at about 0838 hrs. Hook load and block position data just prior to the rig crew taking steps to control the Well at that time is shown in *figure 19*.

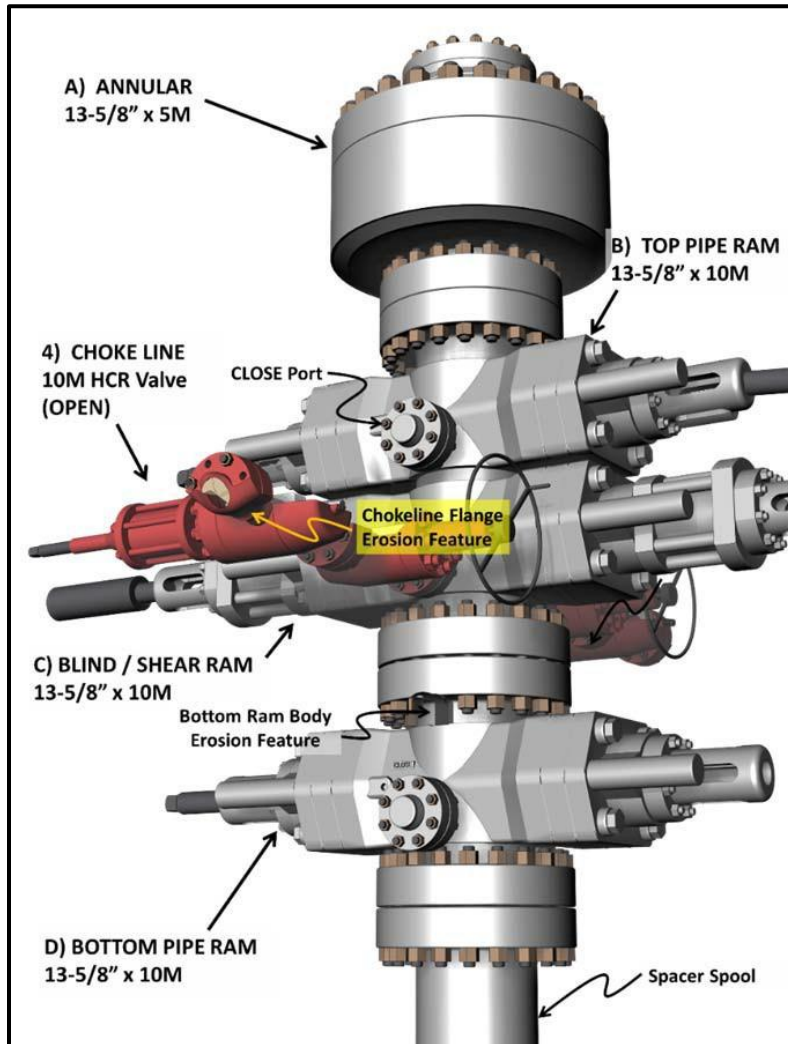
**Figure 23:** Blowout preventer (from SME Committee Report)

Closing the annular preventer before the safety valve was stabbed in the top of the work string is not in accordance to the Hercules Well Control Procedure. Such action could cause the pressure to be increased on the work string, forcing it out of the hole. It could also increase the force of the ejecta exiting the end of the work string making it more difficult to stab the safety valve. The Driller stated that he first attempted to position the work string so that the safety valve could be stabbed but that the flowing

pressure of the Well, operating on the end of the drillpipe and packer, was already forcing the pipe out of the hole up into the top drive bell guide making it impossible to position the pipe so that the safety valve could be stabbed. So he then closed the annular. It remains unknown if closing the annular early contributed to the inability to stab the safety valve.

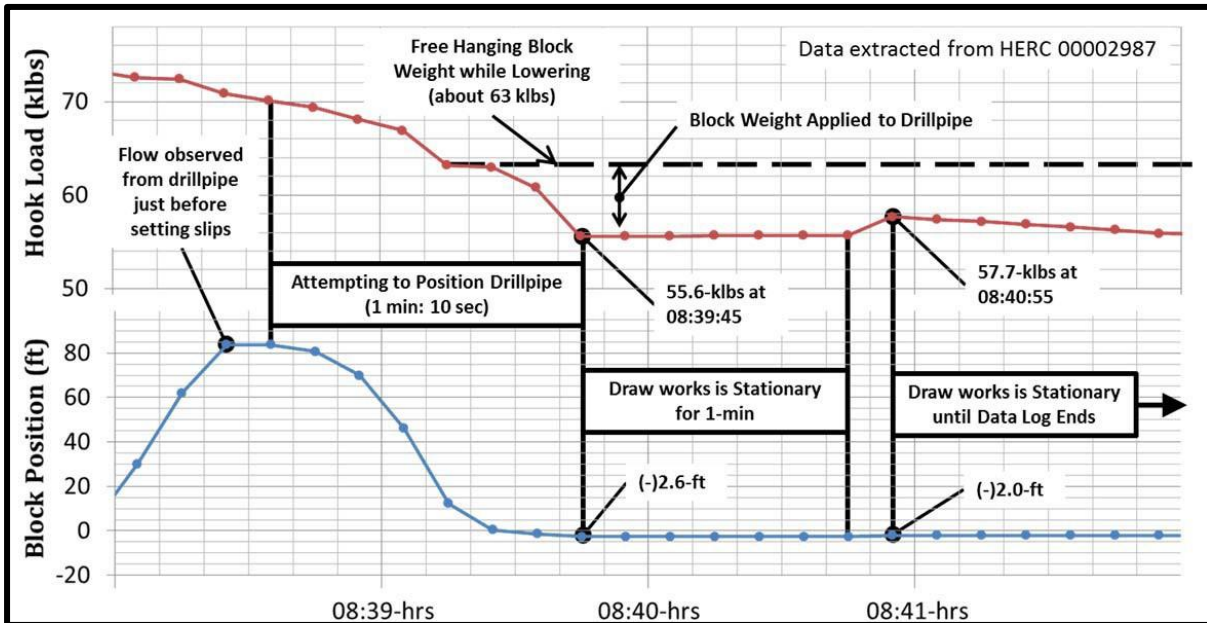
**Figure 24:** Initial kick response to install a drillstring safety valve (from SME Committee Report)

*Figure 24* is from the SME Committee Report. It depicts hook load and block position on an expanded time scale during the critical period when control of the wild well may still have been possible. The SME Committee Report states the following:

*“...hook load falls about seven thousand pounds below the normal hanging weight of the traveling block / top drive and that the block position goes slightly below zero to -2.6 ft. According to multiple witness accounts the drillstring safety valve could not be installed because the 3-1/2” drillpipe had shifted up relative to the elevators and 3-1/2” drillpipe box connection was up inside the top drive bell guide. Approximately 1,140 feet of drillpipe and was still in the well. The estimated total weight of the remaining work string was about 19,000 pounds in air or 14,600 pounds when submerged in 15.1 ppg completion fluid...”*

*“...there is an indication in the data log [see figure 24] that there was an attempt to reposition the block ending by 08:40:55. It is likely that this was an attempt to make space for the drillstring safety valve. The driller’s account indicates that the drillpipe followed the top drive up during this attempt and that the drillpipe box connection remained inaccessible.*

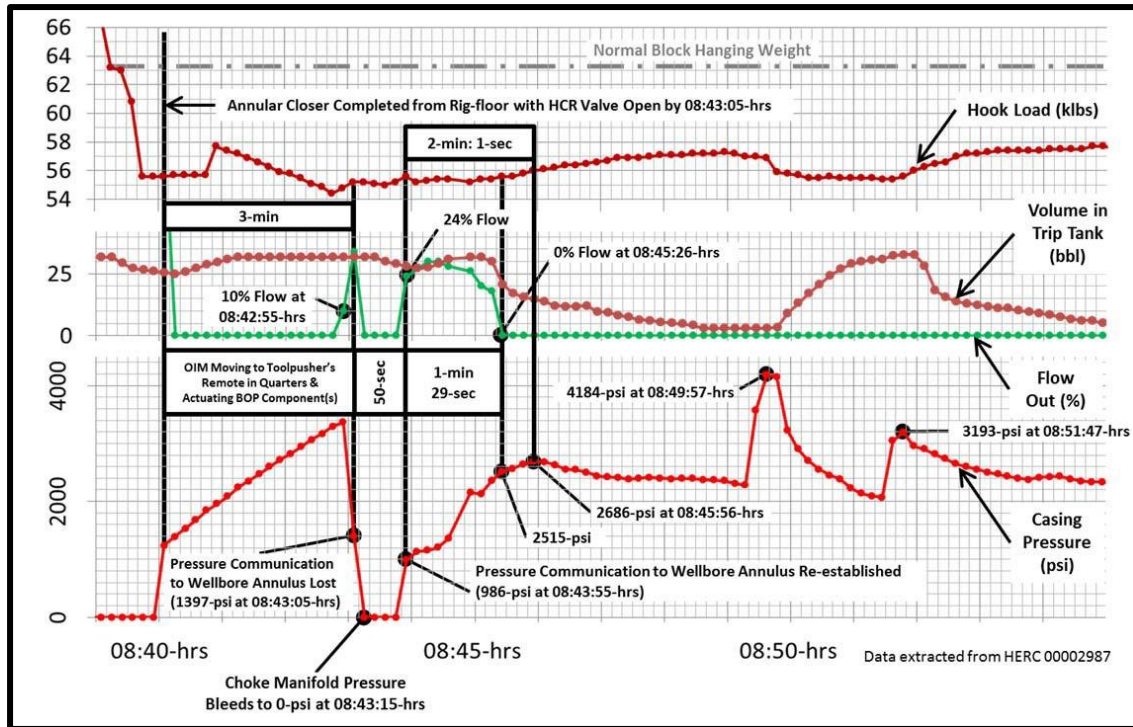
**Figure 25:** Data recorded after kick was detected: 0836 hrs to 0855 hrs (from SME Committee Report)

*“Once it became imprudent to continue efforts to install a drillstring safety valve, the only remaining barrier to a blowout through the inside of the drillpipe available was closing the blind shear rams. The data log indicates that the blind shear rams were not actuated for another three minutes at 08:43:55 [see figure 25].*

Figure 25 shows electronic data presentation created by the SME Committee for their report. It covers the period from the initial observation on the rig floor of the loss of control, through the abandonment of the Rig. This data was recorded over a 20 minute period beginning just before the indications of impending loss of well control became evident and were acted upon.

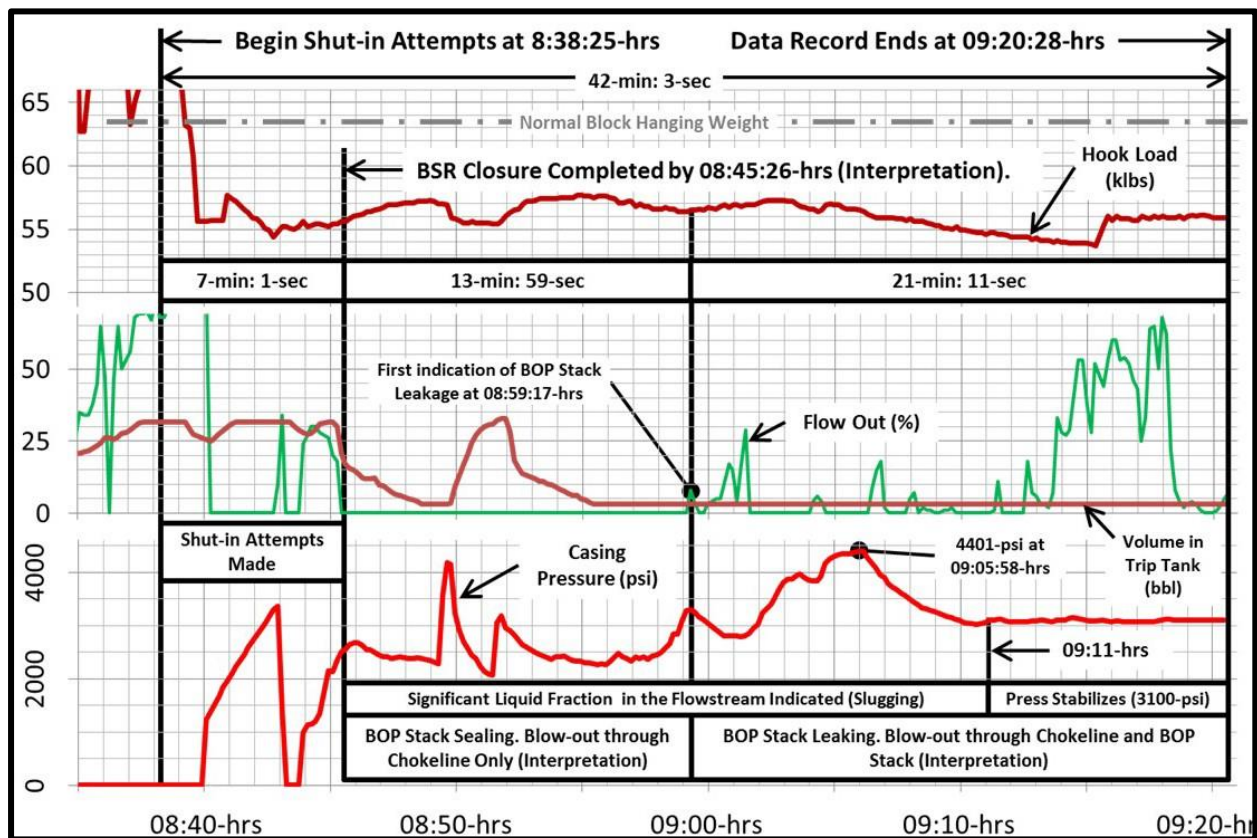
Figure 26: Data recorded during and after attempted shut-in (from SME Committee Report)

*“The upper pipe rams could have also been closed immediately prior to this action in an attempt to prevent upward pipe movement. It is unlikely that the upper pipe rams would have stopped upward pipe movement because a tool joint was spaced-out above the upper pipe rams. The block position sensor showed only 0.6 ft of movement, (figure [26]), so the amount the driller picked up would have to be on the order of inches and not feet.”*

0900 hrs – From SME Committee Report, first indication from the flow-out sensor of leakage through the BOP stack was recorded.

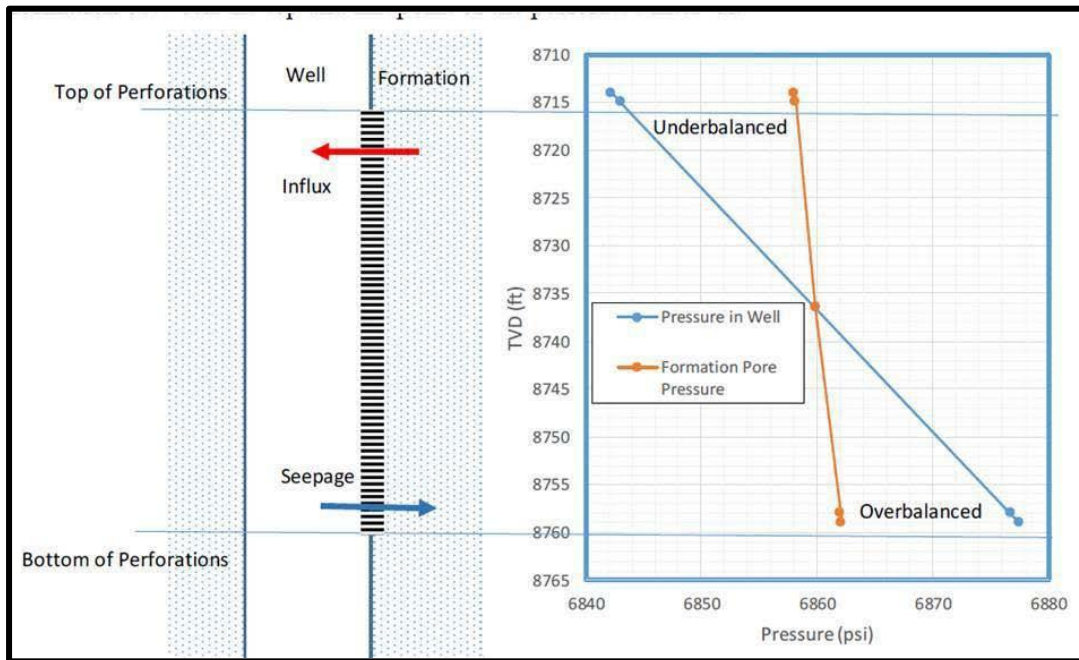
**Figure 39:** Pressure conditions for balance at perforation midpoint (from SME Committee Report)

*“The blue line [in figure 39] was originally shifted about 90 psi to the right for a full column of 15.3 ppg brine. After opening the bypass around the packer at 00:17 prior to starting out of the well, it is likely that not all of the 3.6 bbl of gas trapped below the packer had been swept down into the formation during the short periods of a high flow rate. If one barrel of gas remained and was released when the bypass was opened, it is estimated that the upward migrating dispersed gas would be capable of reducing the bottom-*

hole pressure by about 68 psi. This would have shifted the blue curve back to the left so that the overbalance at the midpoint of the perforations would then be  $90 - 68 = 22$  psi.”

“At 02:08, the trip tank was drained and the fluid level in the well was allowed to fall until 02:45 when the well was refilled with the rig pump. If the actual loss rate exceeded 2.9 bbl/hr such that more than 1.8 bbl was lost during this time interval, the bottom-hole pressure would have fallen by more than 22 psi and allowed additional gas to trickle into the bottom of the well until the well was filled back up at 02:45. After 02:46, the fluid level was again allowed to fall until the well and trip tank were filled with the rig pump at 03:05. Again, this could have resulted in additional gas bubbles entering the bottom of the well prior to refilling the well.

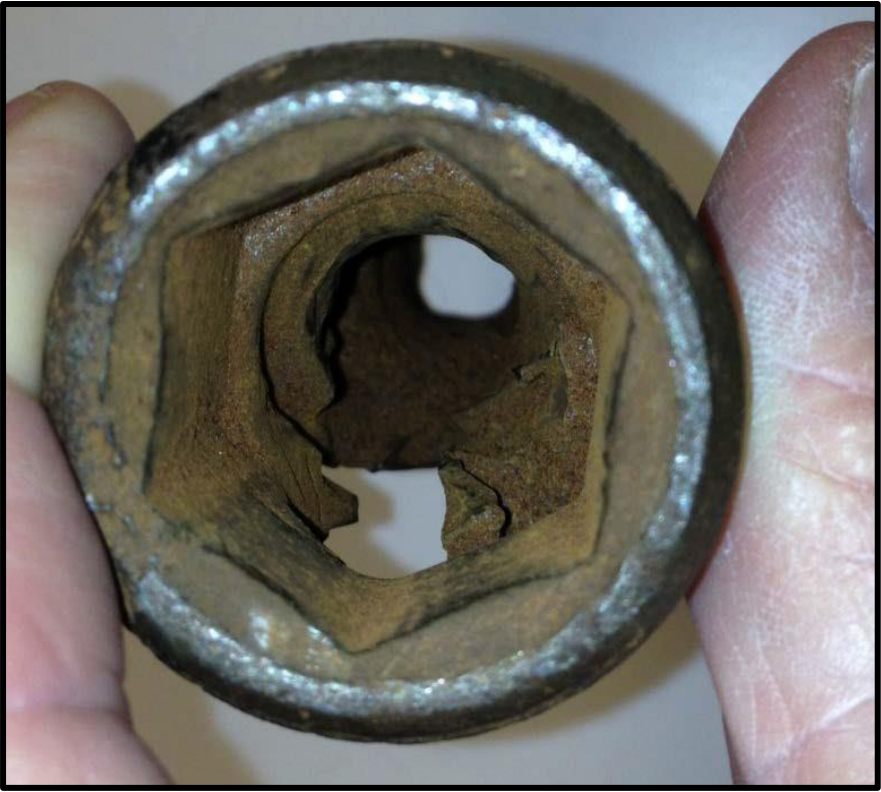
**Figure 44:** Choke body eroded from high delta P and micro-fines

The King Engineering review presented pictures of erosional damage that can occur from micro-fines in the stream and other damage that can result from a high delta P ratio. Those pictures include eroded choke bodies and flanges, and a schematic of the turbulent flow path that helps cause such erosion. *Figures 44 and 45* are examples (not from the King Engineering presentation) of a choke body eroded by cavitation and/or fines in the well stream, and a delta P ratio over 0.6.

The damage to the choke body shown in *figures 44 and 45* bears passing similarity to the damage observed to be sustained by the BOP on the Well during the Incident (*figures 46, 47*).

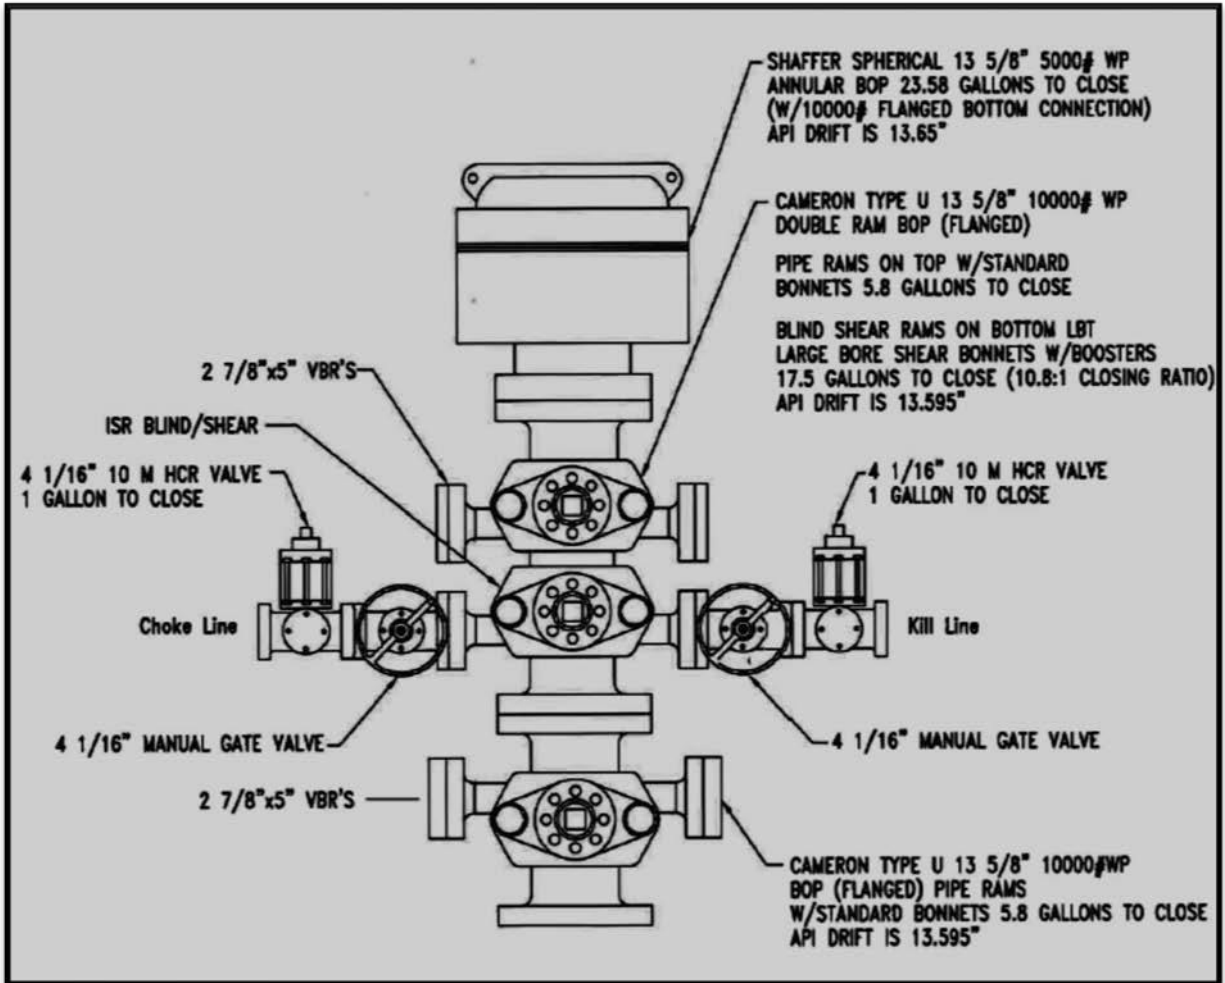
*Figure 49: Schematic of Hercules 265 BOP stack*

Cameron manufactured the BOP stack used during well-related activities by the Hercules 265 in compliance with API specifications. The subject stack was designed and tested in accordance with API Specification 16A. BSEE's information management system confirmed the BOP stack for the Hercules 265 had an API RP 53 Certification on 5 April 2013.
