**MANAGEMENT OF HUMAN ERROR
IN
OPERATIONS OF MARINE SYSTEMS**

**A GORDIAN KNOT:
INTO WHICH SAILED
THE *EXXON VALDEZ***

**Karlene H. Roberts
&
William H. Moore**

**Report No. HOE-92-1
January, 1992**

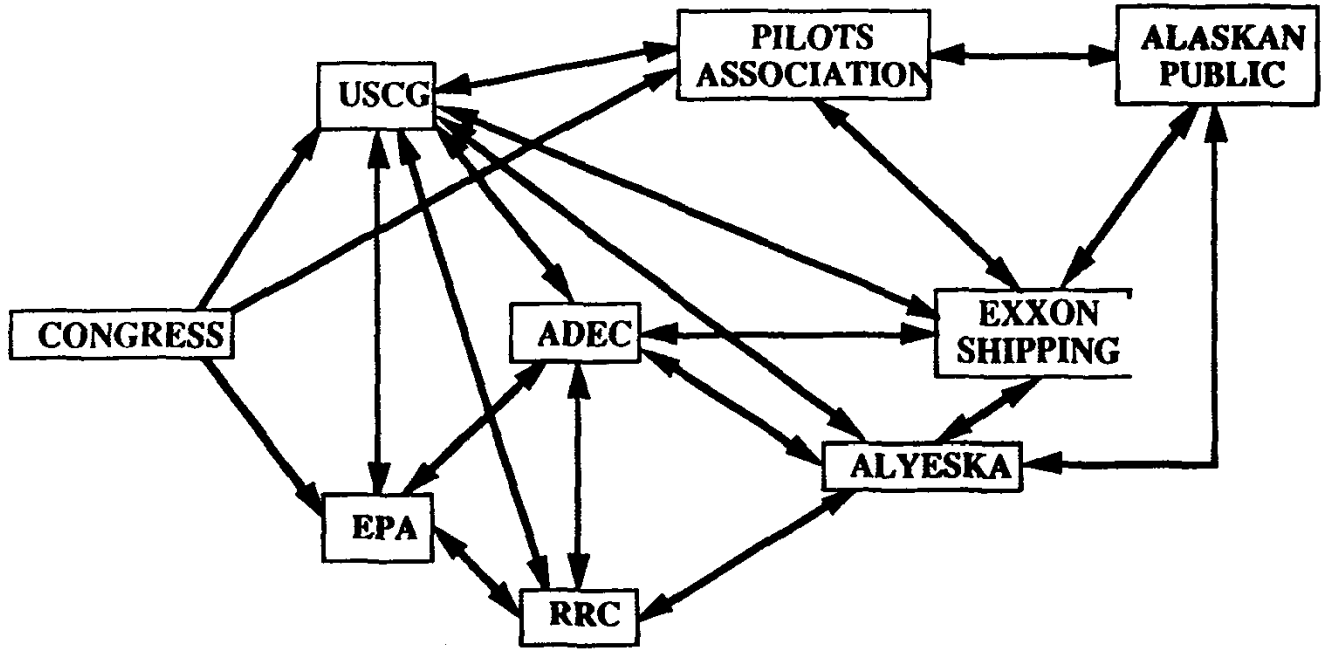
Figure 3: Organizational relationships for the Exxon Valdez incident

Another factor operating in the Valdez situation were initial paralyzes exhibited by many of the players due to fears about what would happen to them in later litigation. Figure 3 demonstrates the relationship between the organizations for maintaining operations and spill contingency planning. At some macro level (state or federal government) legislation should be drawn that minimizes the potential for paralysis. Something needs to be done to change the reinforcement contingencies from those that reward inoperativeness to those which favor engaging in strategies to ameliorate the problem. One model writ larger might be California's Good Samaritan law. Another would be a super agency that watchdogs those participating in clean up operations. ADEC could do this if ADEC had any teeth and knew what it was supposed to do.
