Post Mortem Failure Assessment of Jack-up MODUs During

Hurricanes Katrina & Rita

August 2005 & September 2005

Minerals Management Service

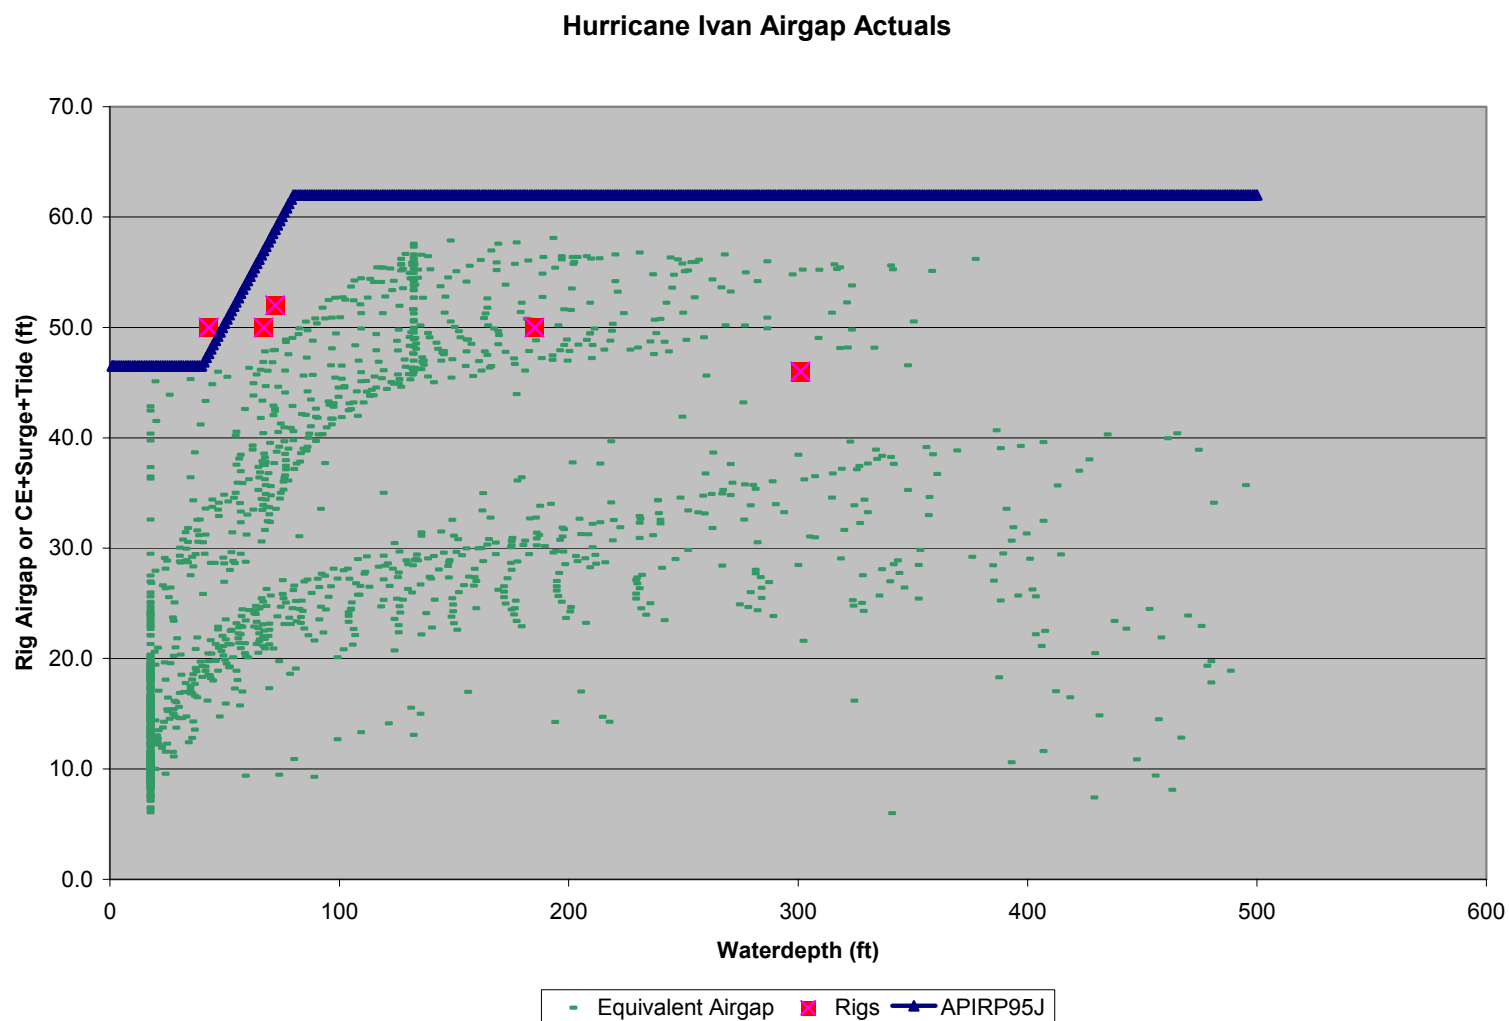
given (the dark blue line) as is the jack-up rig positions that were in the designated hurricane (the red squares). The jack-up rig at the 300 ft point depicted in the Hurricane Ivan chart is the Ensco 64 which was toppled. The other rigs in Hurricane Ivan survived.

Figure 5.1: Hurricane Ivan hindcast required airgap, API RP 95J criteria and actual jack-up airgaps

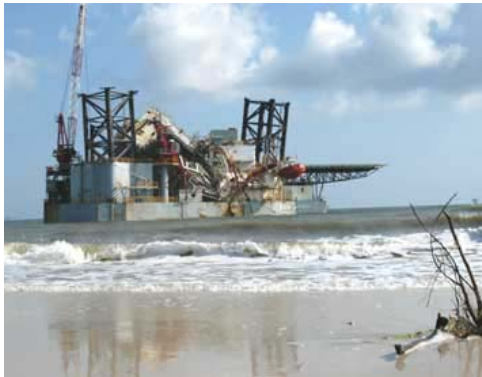
**66 miles NE (Katrina)
Ocean Warwick**

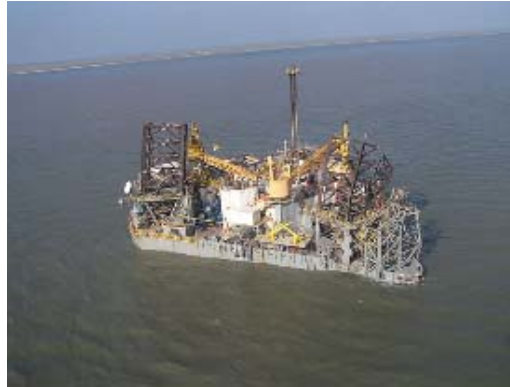
**118 miles NW (Rita)
Adriatic VII**

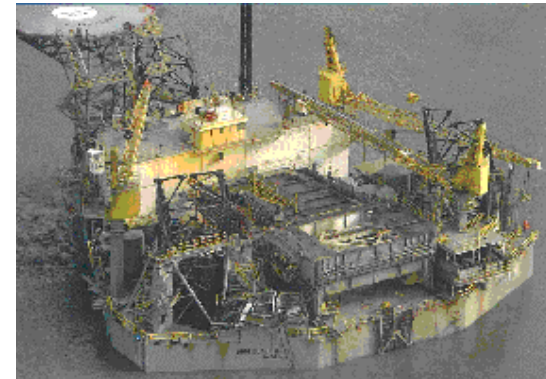
**108 miles NW (Rita)
High Island III**

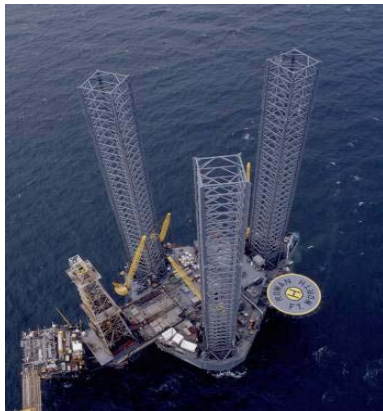
**Never Found (Rita)
Rowan Fort Worth**

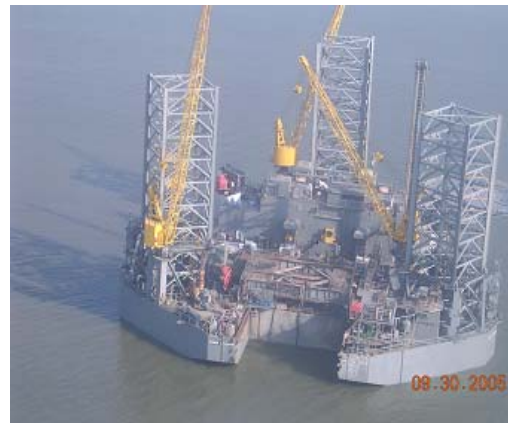
**103 miles NW (Rita)
Rowan Louisiana**

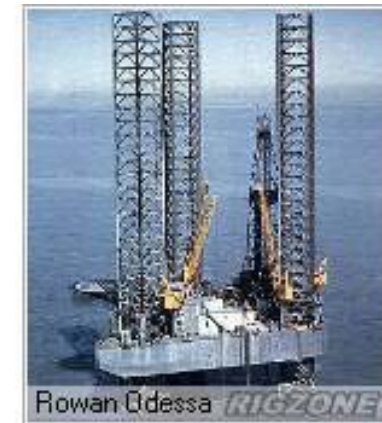
**6 miles NW (Rita)
Rowan Odessa**

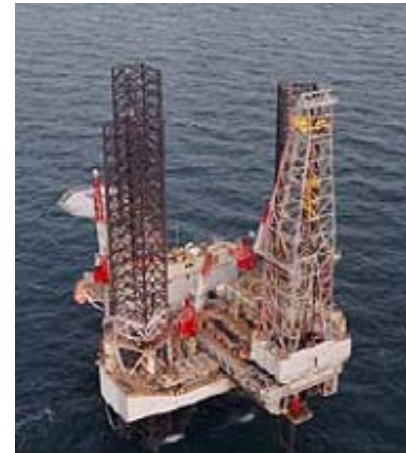
8.4	Ensco 74	Let-Super 116	Main Pass 270	205	86.9	1.5	1.5	2.0	72.2	49.3	Dominion E & P	52.9	50	62	-2.9	E	56.5	Central	195	511	21	1	Stbd. leg penetrated an additional 1ft. Jacking system (7 final drive units, 1 gear box) damage, two bottom shell plates 28A, 29A local damage, cracks in welds at gear unit brace beams backup structure at main deck. Deck plate buckled inboard and adjacent to port and stbd skid rails. Frames 18 & 19 port and stbd and at centerline for frame 19. 5 lights and minor wiring in derrick damaged, 2 deepwells grounded. Repaired on location and returned to service. Damage caused by waves contacting hull bottom. (100 kts wind, 50 ft waves, @45 ft airgap)

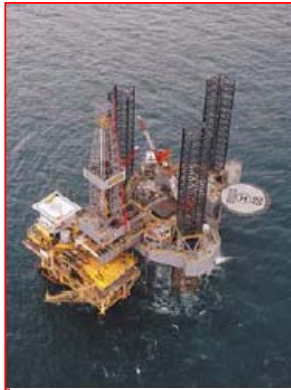
Enasco 68

9.5	Ensco 68	LeT 64 Mod	Vermillion 164	95	83.5	3.8	4.3	3.8	55.7	36.6	Exxon Mobil /Hunt	42.9	94	62		E	29.1	WC	85	511	56	0	Drill Package skidded to Port Leg. Minor damage to windwall of drill package Skidded package back to center and returned to service (100 kts wind, 40 ft waves)

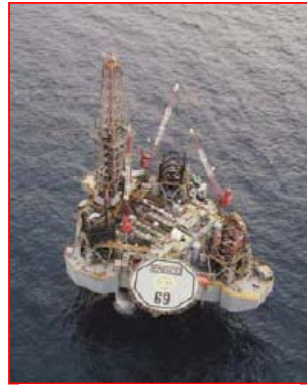
Enasco 69

9.6	Ensco 69	LeT 84-C Enhanced Leg	S Marsh 130	212	90.8	1.7	2.1	3.3	71.3	48.4	Energy Resource Technology	52.5	64	62		E	28.5	WC	112	511	66	Bow - 1 ft; Port 3.5 ft; Stbd 3.7 ft	Hull Plating Damage at Rake, Side Shell & Bottom due to hull contacting the skid-off package on the platform Electrical cables on all 3 deepwells damaged; stairways to rig floor from platform damaged; Control house A/C; Covers on electrical wires on legs blown off. Emergency lighting at lifeboats damaged; crane cab windows broken; satellite phone antenna damaged. Repaired and returned to service. (100 kt winds, 44 ft waves, @ 45 ft airgap) (w)

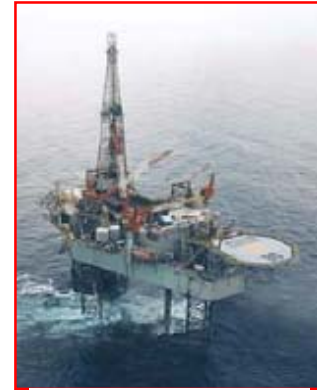
Enasco 90

9.10	Ensco 90	LeT82SD-C	Ship Shoal 204	110	74.7	2.0	2.2	3.1	57.8	37.9	Apache	42.1	77	62		E	72.6	WC	145	360	66	5 ft stbd	5 ft additional penetration resulted in 1 degree low on stern and 2.25 deg low stbd stern. No structural damage. Windows broken on stbd cranes bow and port; leg ladder damage stbd & port; 50 ft jet pipe damage on stbd leg incl. 6 clamps. Leveled rig and returned to service (100 kts wind 40 ft waves, 1 kt current @25 ft pen.)(w)

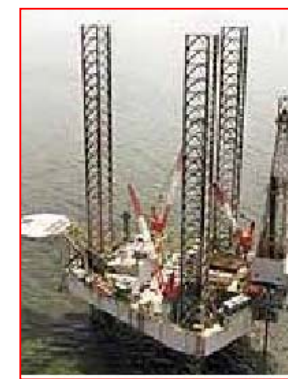
Enasco 98

9.12	Ensco 98	LeT82SD-C	West Cameron 540	194	70.9	1.7	2.0	2.2	54.6	37.2	Century Exploration	41.2	60	62		W	25.4	WC	337	360	32		Nav-Aid light missing; port & Bow crane windows missing. Several lights missing; Jet lines missing on stbd leg. Leg ladders missin and bent on all 3 legs. (100 kts wind 40 ft waves, 1 kt current @25 ft pen.)(w)

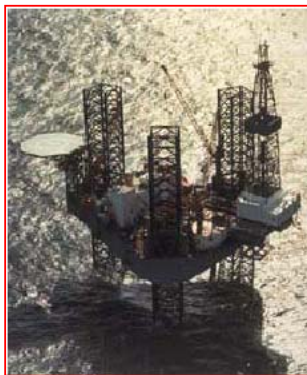
9.14	GSF Adriatic III	LeT116E	East Cameron 328	243	91.4	1.7	2.8	2.7	67.6	44.7	Arena Offshore	49.6	84	62		W	5.2	WC	64	477	53	3	Hull damage at stern (indentation) but no penetration. Possible contact with platform. Additional 3 ft penetration. Elevating System damage, Stern Shell damage Repaired at location. Took on additional 2-4 ft penetration. All 3 legs failed and the rig floated off location and beached. Derrick fell off. Numerous bottom and side shell penetrations. Legs and Heliport lost. Total Constructive Loss. (100 kts wind, 40 ft waves, 3 kt current @30 ft

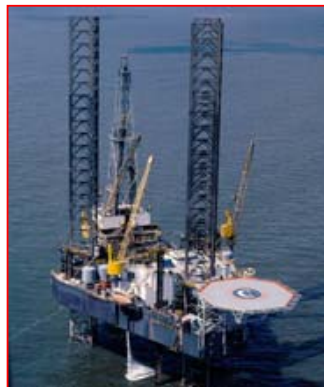
**GSF High Island
II**

9.17	GSF High Island II	LeT82SD-C	SMI 90	162	84.5	2.1	2.6	3.3	66.0	45.3	Chevron	49.9	74	62	24.1	E	34.4	WC	328	394	16	5	Additional 5 ft penetration. Leg Bracing Damage, lower and upper guide, required help from tug to straighten rig to permit jacking operation. May have bumped platform. Leg Bracing Damage, lower and upper guide, required help from tug to straighten rig to permit jacking operation. (100 kts wind, 43 ft waves @35 ft airgap & 25 ft pen.)

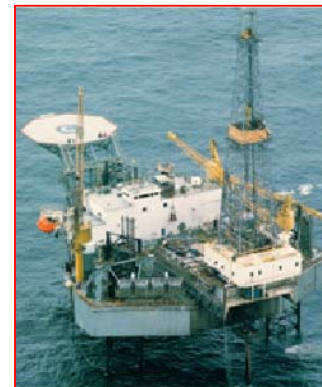
**GSF High Island
IV**

9.19	GSF High Island IV	LeT82SD-C	Vermillion 321	206	94.2	2.0	3.3	3.6	67.6	45.9	Nexen	51.2	70	62	18.8	E	4.4	WC	78	394	15	5	Initial penetration was 15' on all legs implying a sand layer. The additional penetration was nearly uniform (difference of 1' on one leg) further implying a sand layer with penetration due to shakedown. Breach of aft preload tanks, void tank, and transom. Cracks found in leg members. (100 kts wind, 42 ft waves @35 ft airgap & 25 ft pen.)

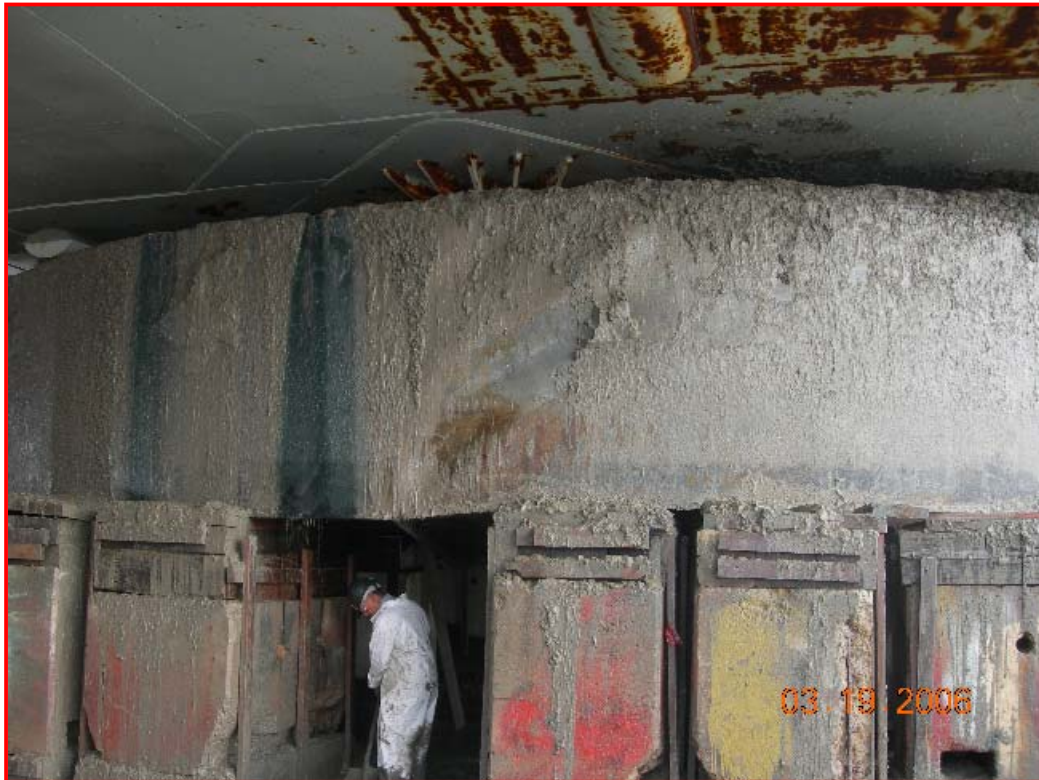
Figure 8.1.2: Spud Can Damage Locations. 1 photo from each spud can is shown superimposed on the Figure 8.1.1.

The Spud can damage pattern confirms it is as a result of the storm/hurricane.

- The Ocean Nugget was on a hard location with no “give” for rotation of the spud can.
- The damage is generally on the port side of the port chords with more damage on the port side of the port leg.
- The damage is a clear indication of an overload from the rig moving toward overturning in the direction of the worst part of the storm. Nothing except the rig being on its “tippee toes” could explain the character of the damage, resulting from being close to the overturning point of the jack-up.

While we are not aware of any similar spud can damage on an independent leg rig, it is not surprising that such an event took place. The leg on the Livingston III is very, very stiff (robust). This has the design feature that it can resist damage from rapid penetration situations very well, but it also attracts wave forces and thus is more subject to overturning in waves. The stiffness of the legs also allows the loads to be transferred into the spud cans. As is the case here the spud cans are bent up on their leeward side, and there are fractures in the top on the port side indicating an overload situation.

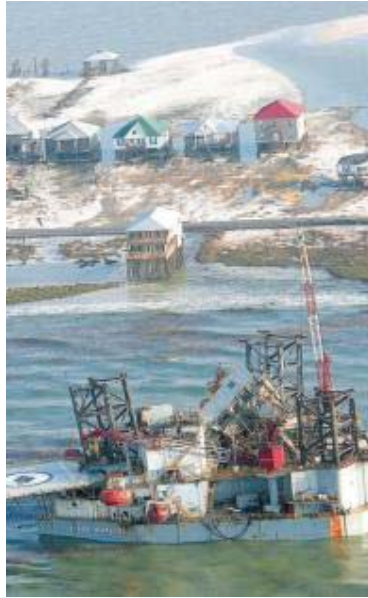
Photos 8.3.3: Different perspectives of Ocean Warwick, on the beach.

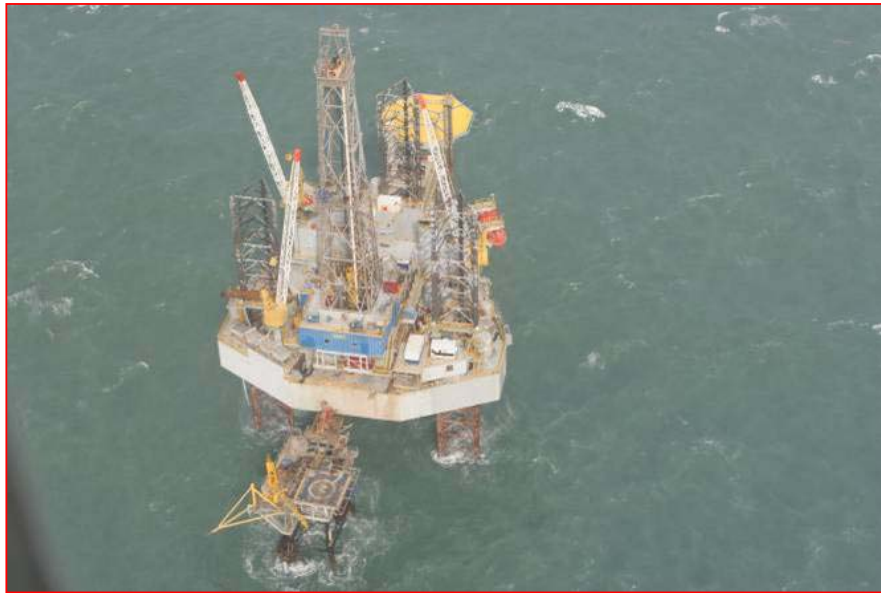
Photo 8.12.1 Noble Tom Jobe at South Timbalier Block 134

The Noble Tom Jobe was subjected to environmental loads somewhat greater than its design but less than its ultimate anticipated capability and thus the reader is referred to Table 7.1 and Table 10.1 for results. The Table 10.1 conclusion was that the rig was overloaded by a factor of approximately 1.7.

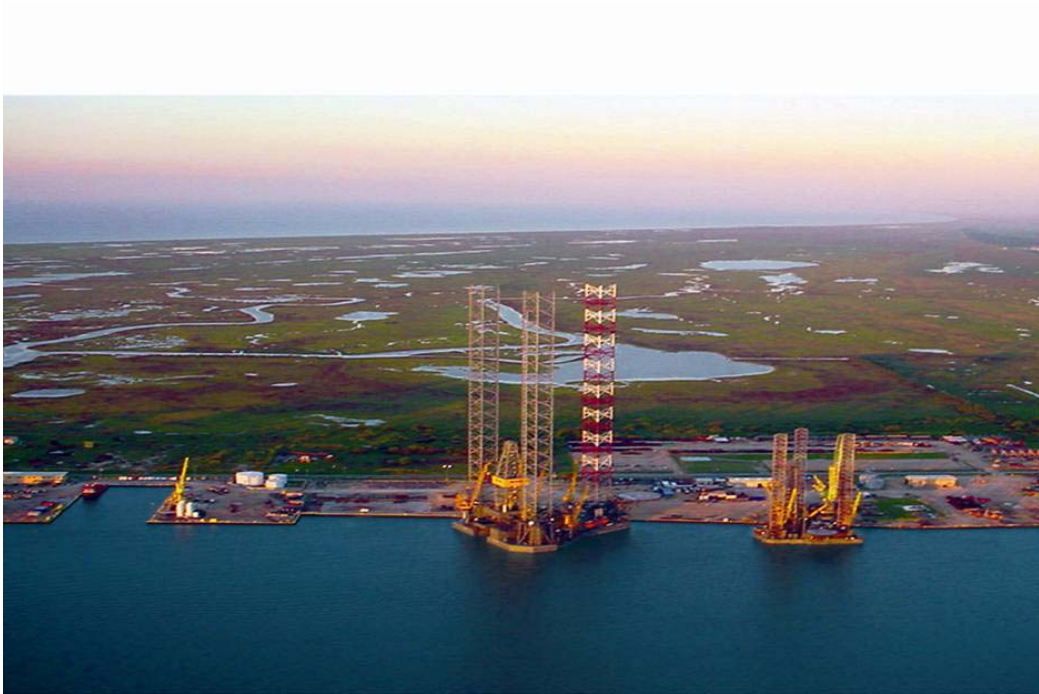
Photo 8.13.1 Bob Palmer vs Rowan Texas design in Sabine Pass, Texas

The Bob Palmer was at a location in South Pass 87 during Hurricane Katrina. Although it was at the standard airgap of the industry at the time 50 ft., the estimated airgap required to survive the storm was 57 feet. Although there was no evidence of damage to the hull, there was significant damage to walkways and platforms in the leg wells at the main deck level indicating green water coming up through the leg wells. It is generally assumed that any wave inundating the hull of the rig is quite likely to cause failure. All other parameters of the storm were within the design allowables.

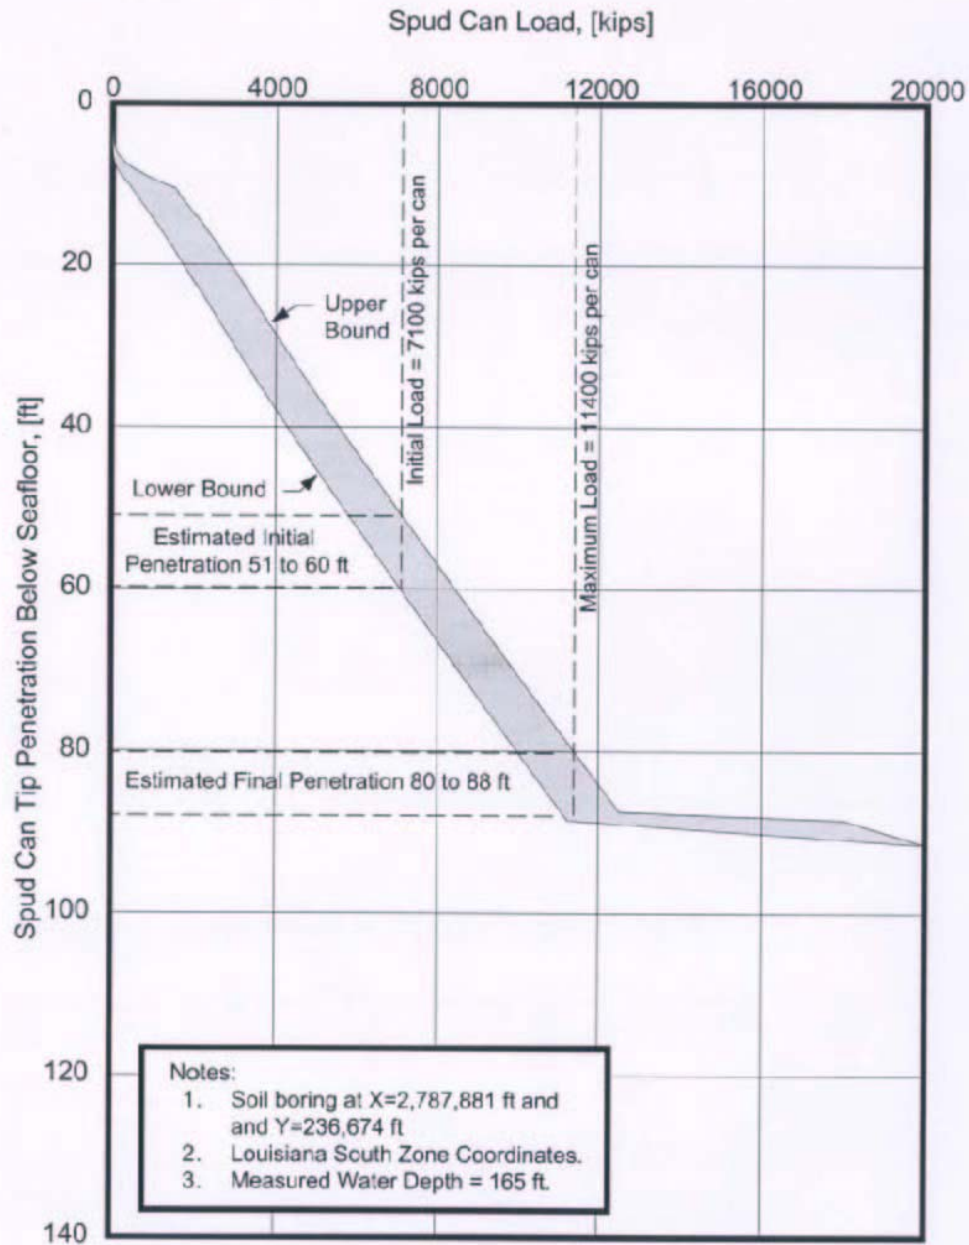
SPUD CAN PENETRATION CURVE

"The Rowan Paris was subjected to hurricane loading that dipped into its safety factor and reserve in strength. The combination of large (96 ft) penetration (high fixity), and high soil reserve strength contributed to the rig survival without damage.

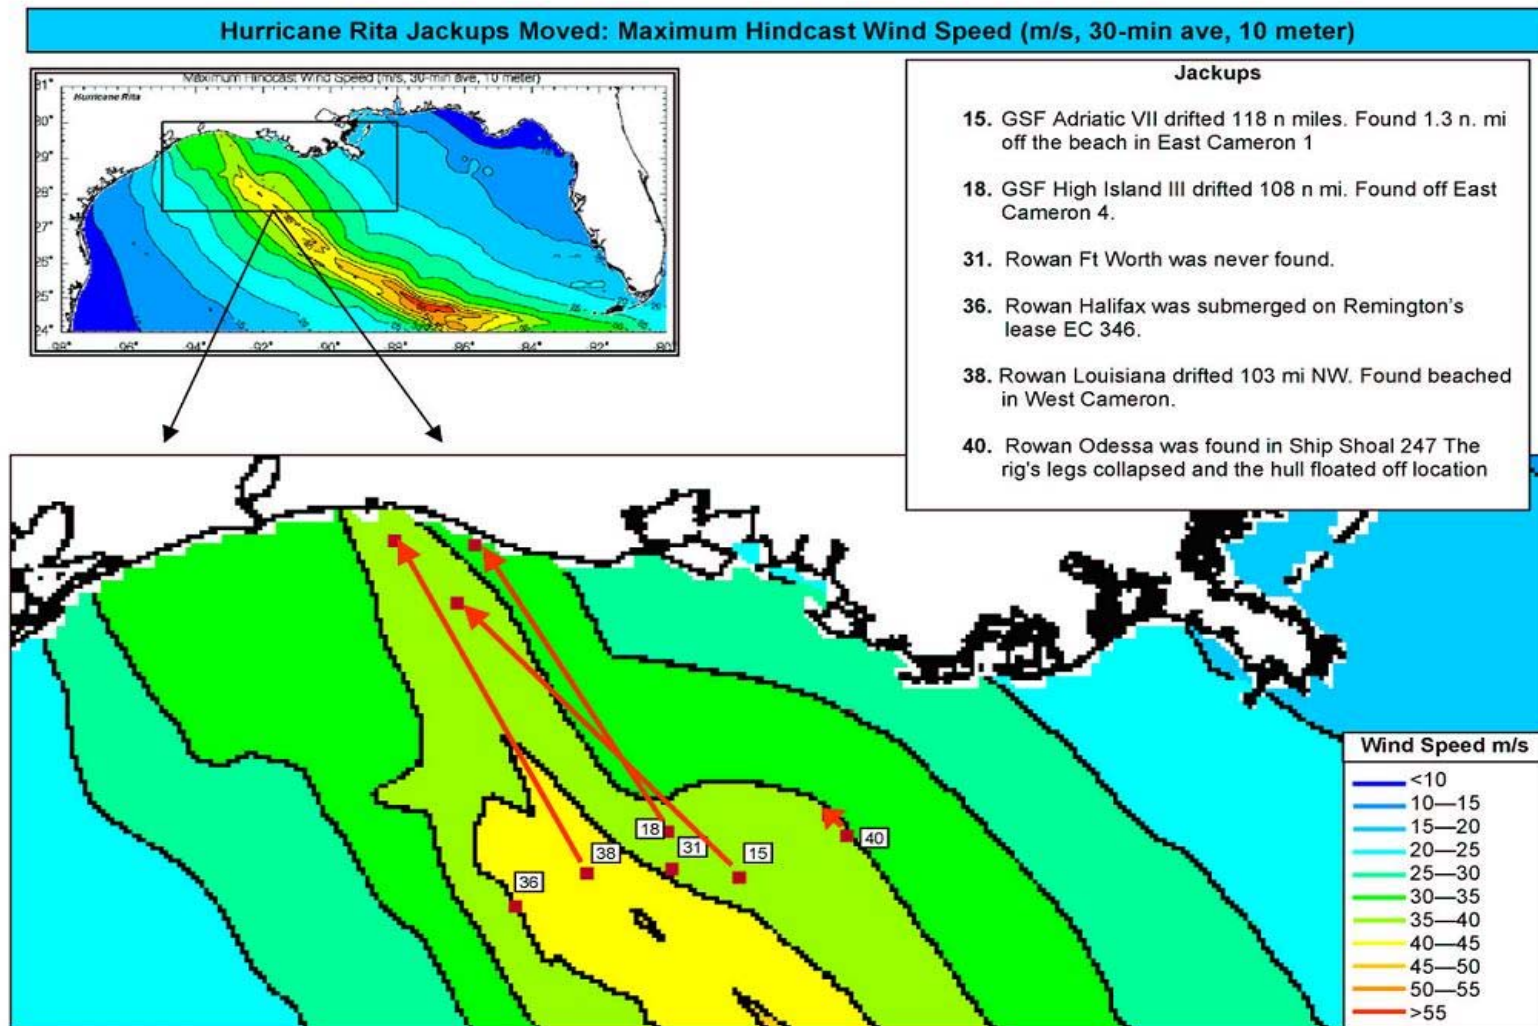
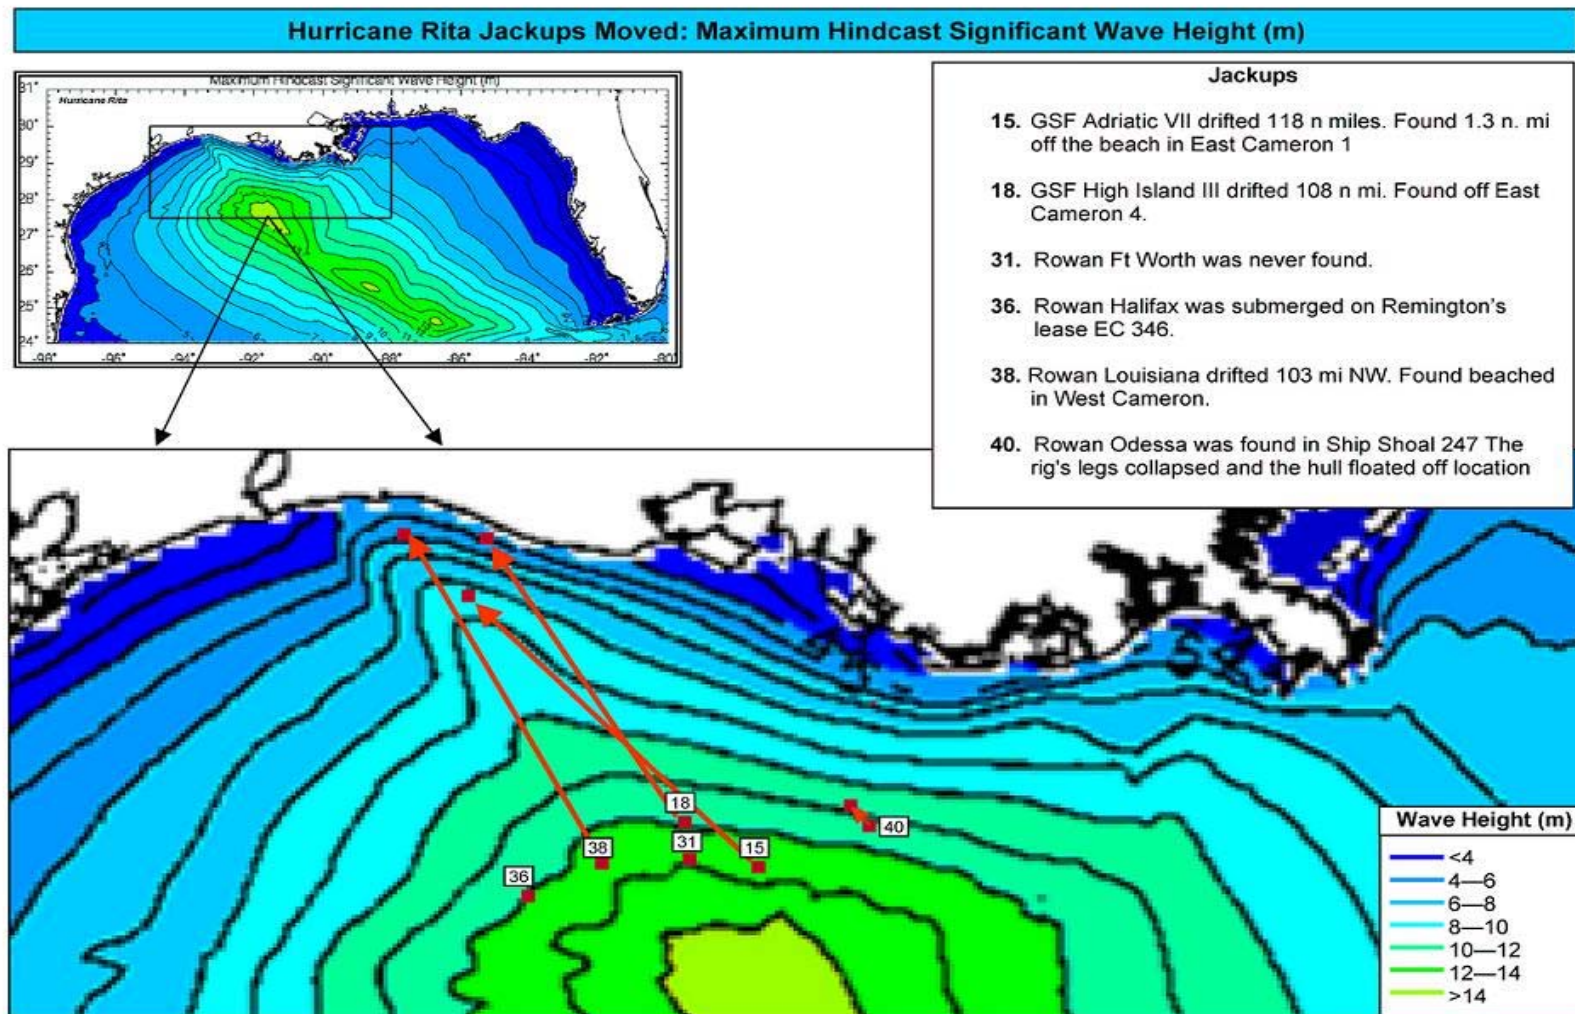
On Figure 9.3 and Figure 9.4 the jack-ups that broke away or sank are indicated and, where known, the position that the jack-up was after the hurricane. The routes are not known and thus are shown as straight lines.

The Rowan Louisiana was found 103 mi NW of its original location near Cameron Louisiana. The drift direction can be seen on the Figures 9.3 and 9.4.

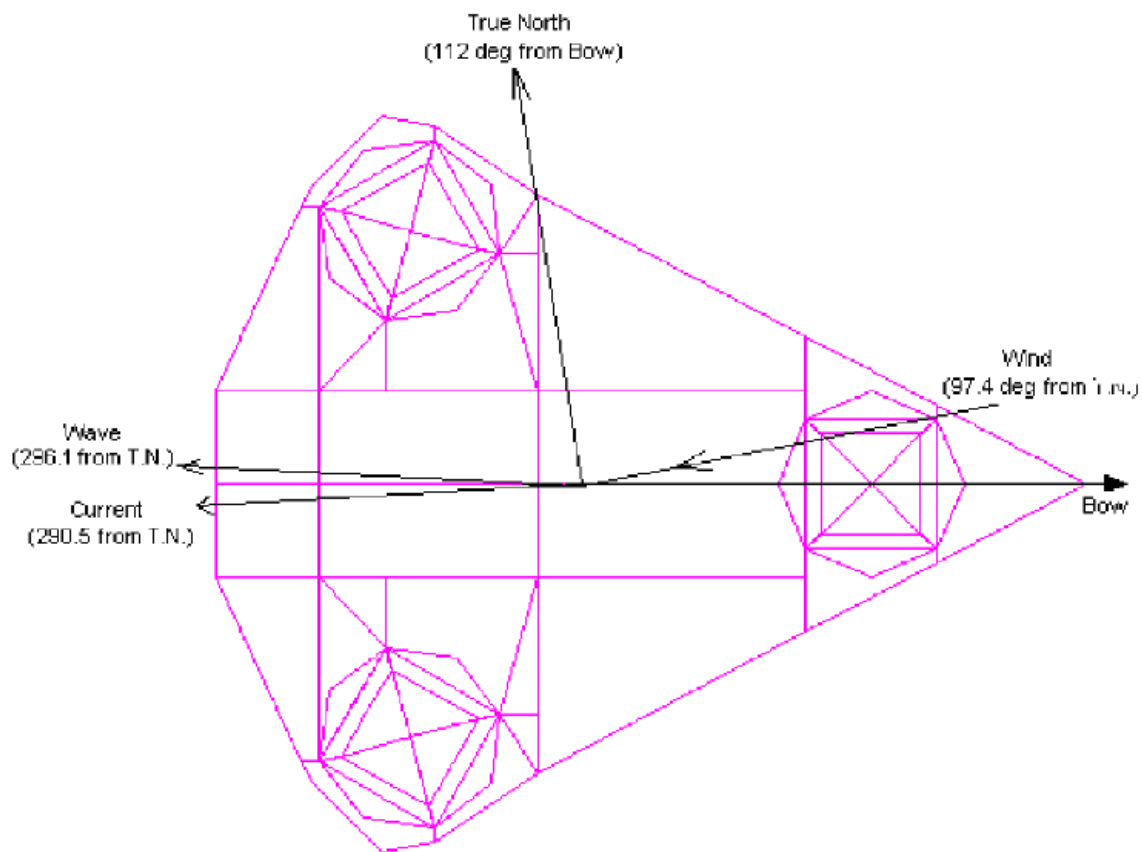
Additional remarks by the author were as follows: *"The Ensco 69 survived hurricane conditions that largely exceeded its original design conditions. Air gap loss was not an issue based on the hindcast data and the reported additional leg settlements of 3.5 ft and 3.7 ft (port and starboard respectively)."*

Likely reasons for the survival are the rig upgrades that enhanced its overall capability, the favorable environmental directions, and the favorable soil conditions with very high fixity and sufficient capacity to limit settlement.

Leg strength unity checks exceeded 1.0 with maximum values near the mudline. Reasons for the exceedence are the use of nominal yield strength and a conservative column curve (Ref 28).

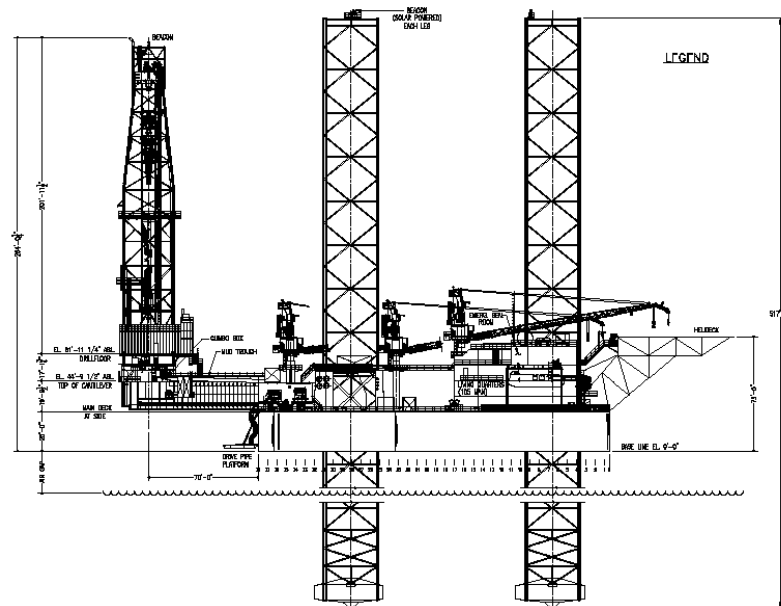
The following damage was reported: Port deepwell tower damaged; port crane front & side windows out & A/C unit damaged; starboard crane front & side windows out; A/C damage & door blown off; ladder damage on bow leg; satellite dish damage. Considering this minor damage, the Ensco 105 fared rather well in the Hurricane Rita, where the maximum wave height was 71.9 ft. The maximum wave at the location in Hurricane Katrina had been 36.8 ft. The average wind speed was less than the maximum design. Based on method used to estimate the ratio of the overload due to the environmental forces in Table 10.1 it is estimated that the rig was overloaded by a factor of 1.3 categorizing it as an "overload but expected survival" as the soil conditions were able to take further load without further penetration.

Photo 9.13.1 showing the deepwell pipe damage on the ENSCO 105.

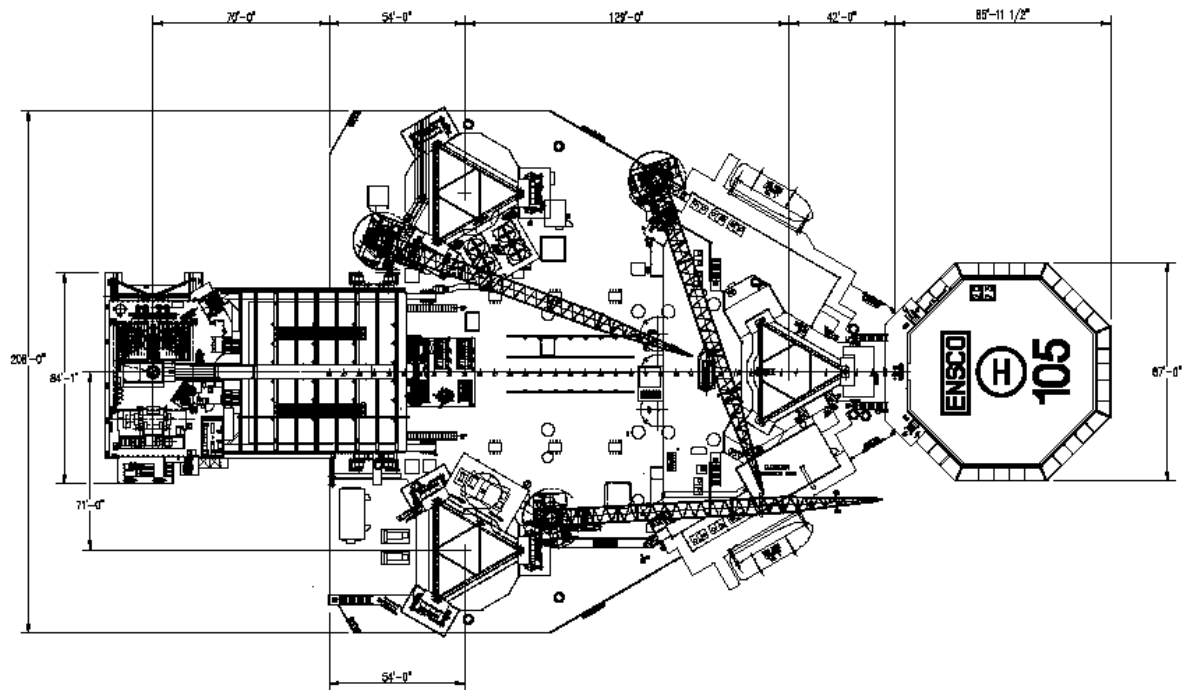
Photo 9.13.2 showing leg ladder damage on ENSCO

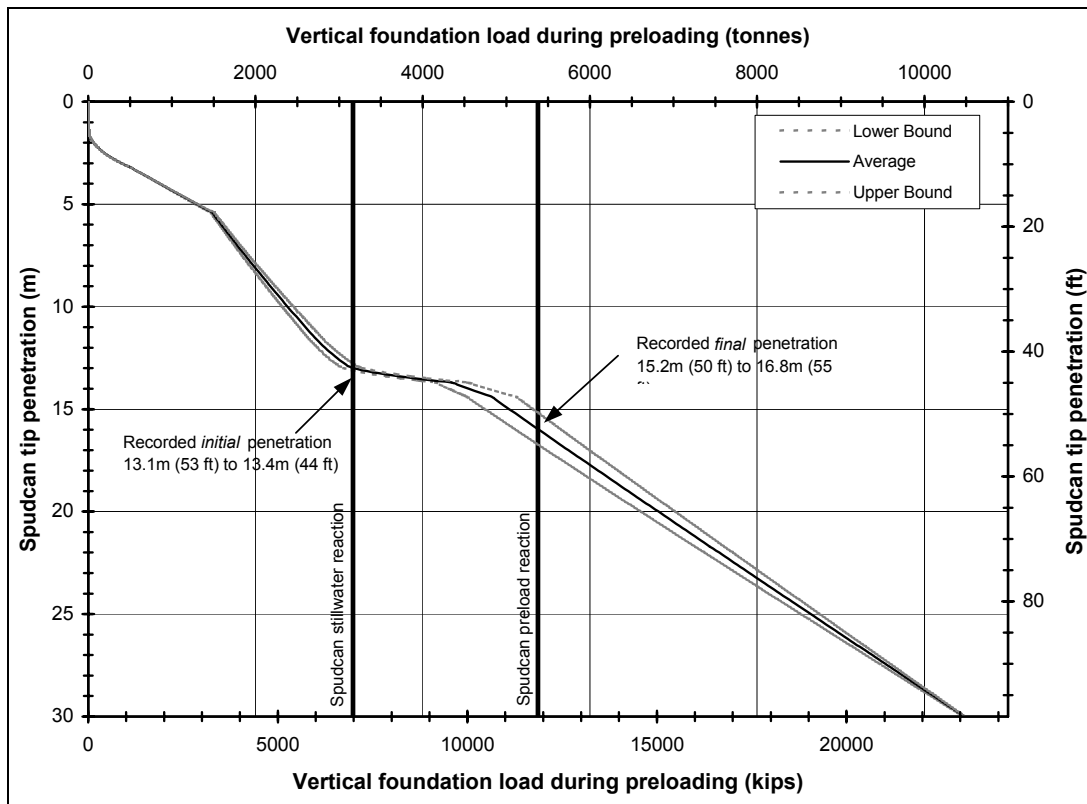
The above study also presented the spudcan foundation curves. The soil at final preload is described as a firm to stiff clay. As can be seen an additional 10-20% increase in load would anticipate a potential increase in penetration by a few feet only.

Figure 3 of Hoyle and Brekke showing potential increase in penetration with increased load

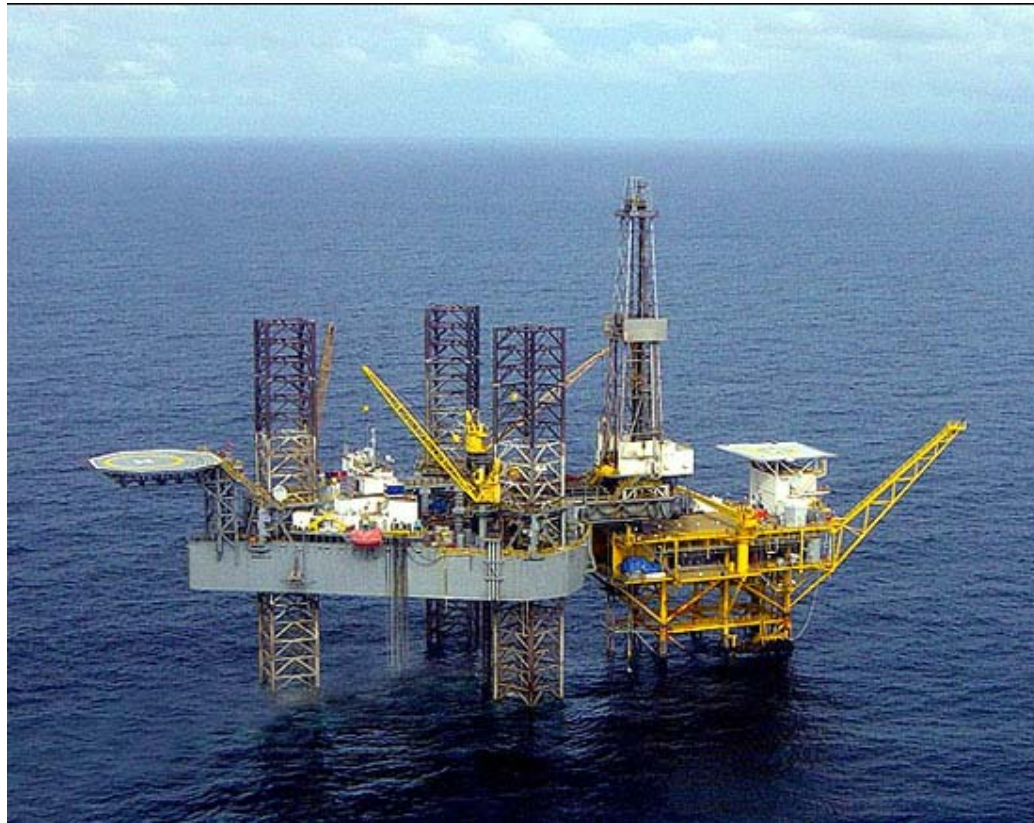
Photo 9.15.1: GSF Adriatic VII on location.

The hindcast maximum wave was 73 ft whereas the vessel's design was for a wave height of around 40 ft. depending on waterdepth, penetration, position on legs etc. It was thus subjected to over 3 times the loads it had been originally designed to. Additionally the

airgap was such that by computation, it is likely that the maximum waves at location hit the bottom of the hull. In the maximum wave situation, the vessel had a negative airgap of 2.3 feet although it complied with the industry standards at the time, 50 feet.

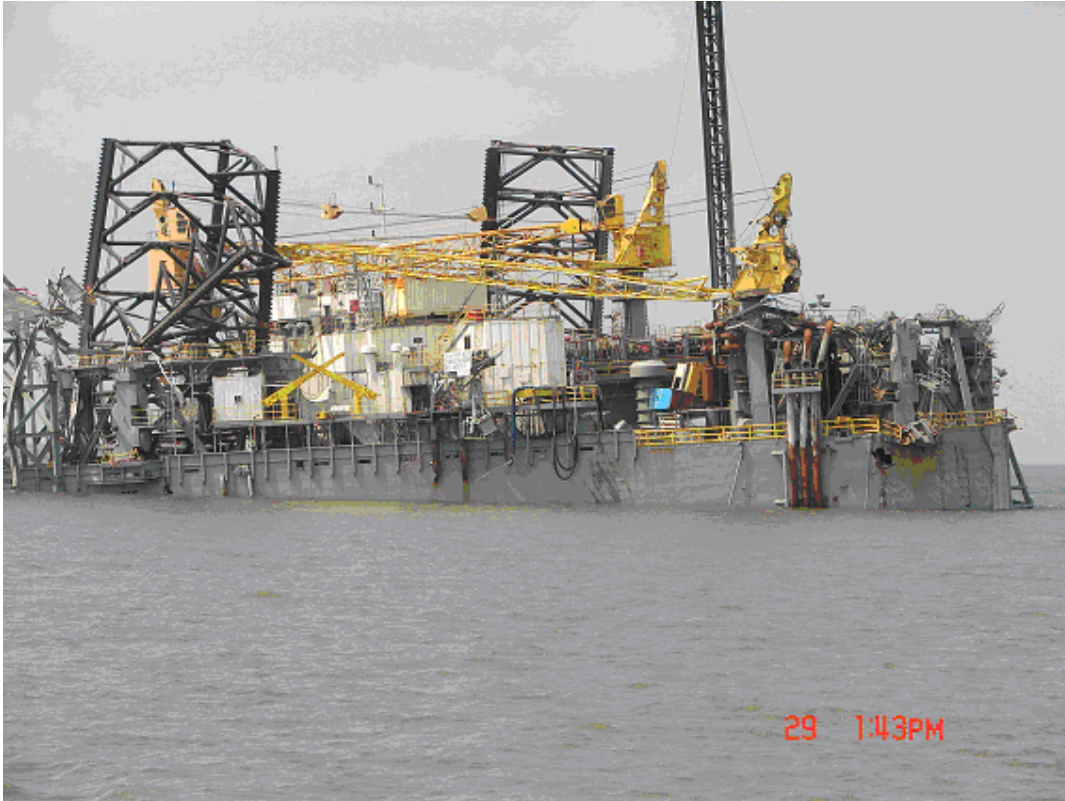
Photo 9.15.2: GSF VII as it lay grounded after the incident.

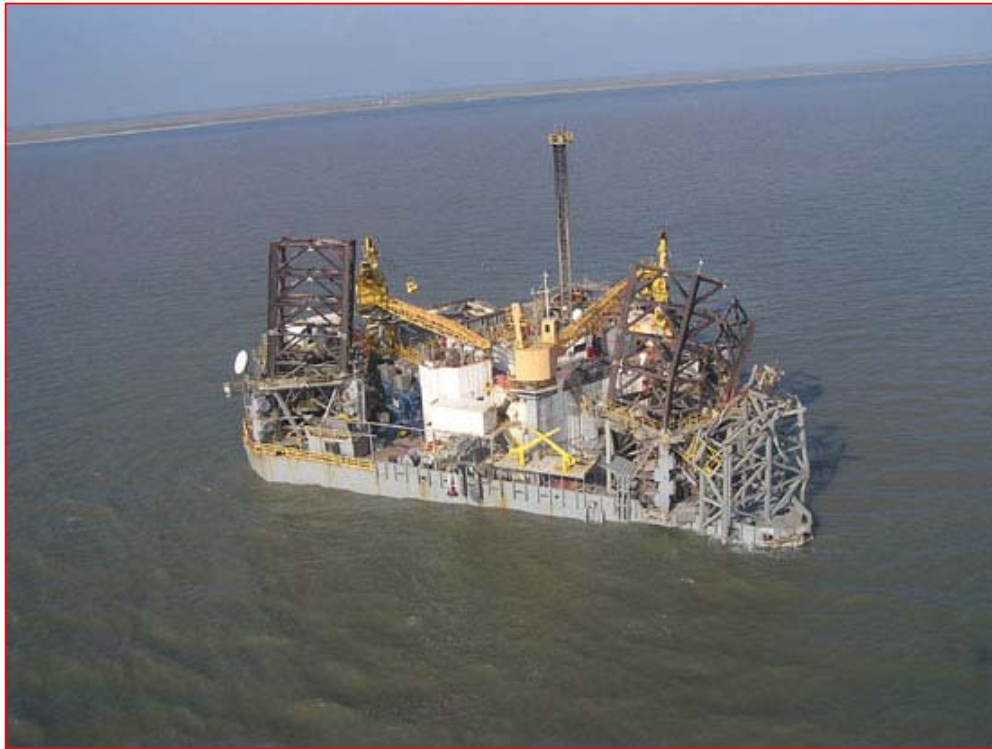
Photo 9.15.3: GSF VII off Cameron Louisiana with shoreline in the background

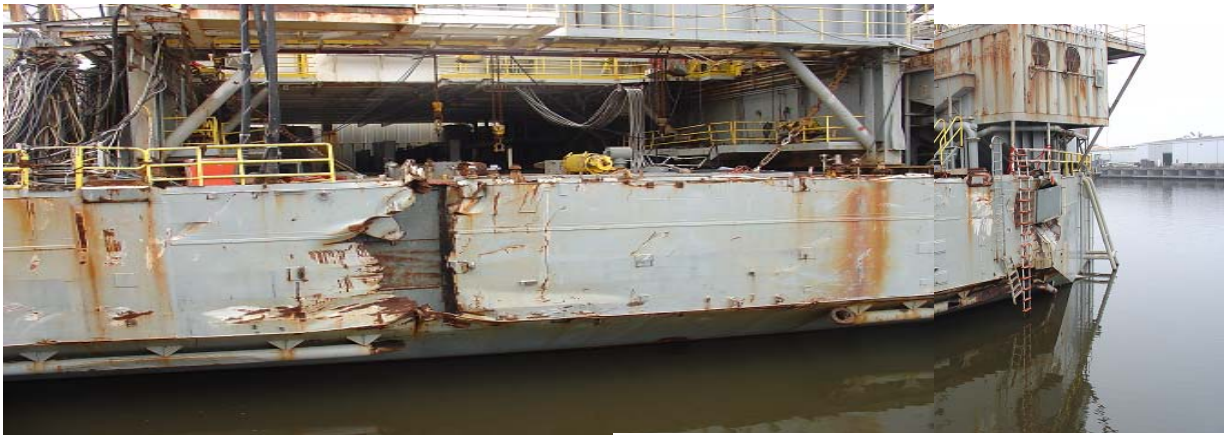
Photo 9.15.5: Composite photo of the stern of the vessel

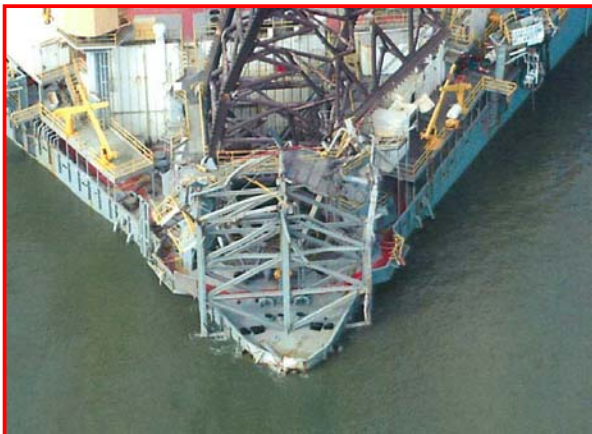
Photo 9.15.6 : Helideck support at bow.

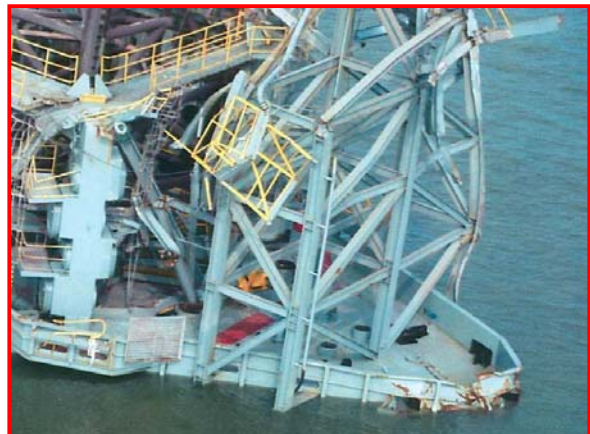
9.15.7: Helideck originally forward of the bow.

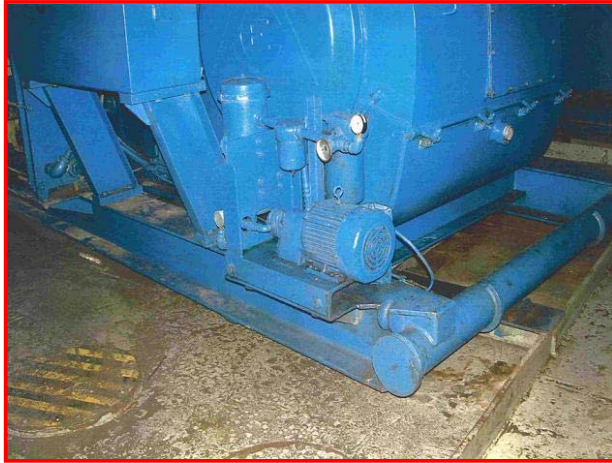
Photos 9.15.8: Mud Pump moved off foundation due to rig movement;

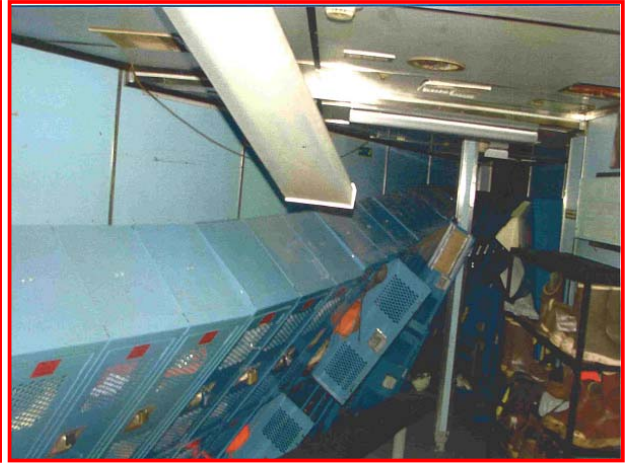
Lockers damaged due to movement

From the disarray in the quarters, it is apparent that the rig underwent a violent journey. Indications of significant amounts of water entering the quarters was evident.

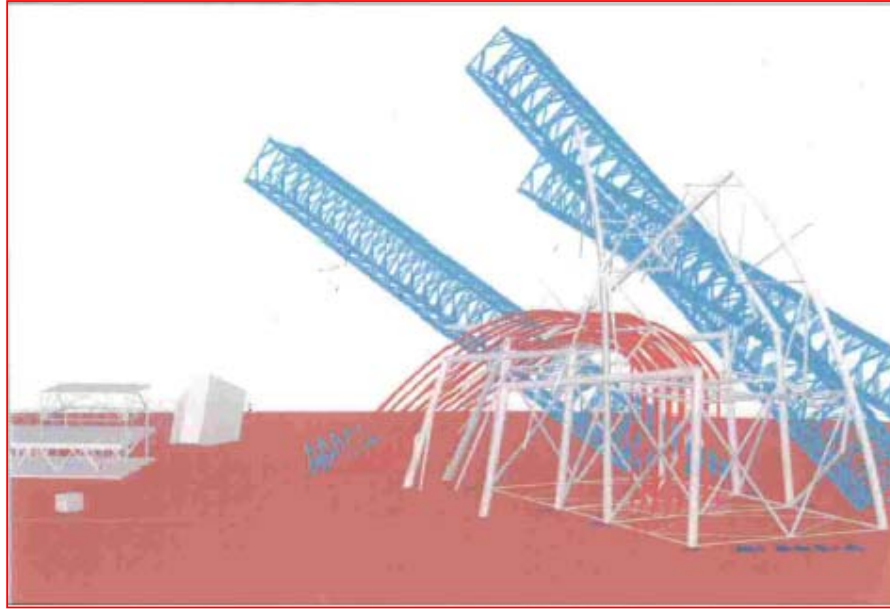
The legs and drilling package from the Adriatic VII remained on the sea floor at the location where the rig was prior to the storm. At the time the rig was working for Chevron Texaco adjacent to their Eugene Island 338A platform. As a result of the storm, the Chevron platform was toppled. One of the legs of the Adriatic VII came to rest on top of the Chevron platform debris. The legs, the starboard in particular, were in the way of plugging operations and had to be removed in order to gain access to the wells.

9.15.10 Artist's rendition shows the situation after the storm but at the pre-storm location.

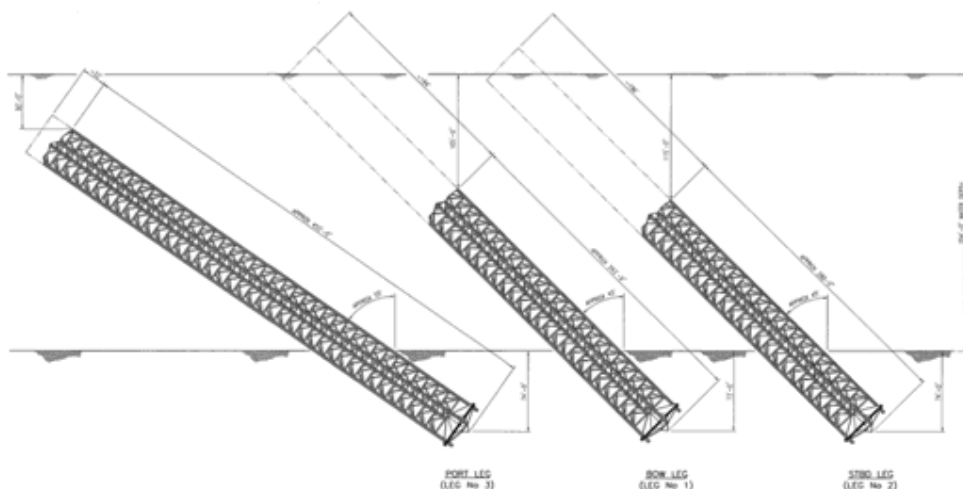
9.15.11 Artist's rendition shows the disposition of the legs after the hull had departed from location.

The soil on location were reported to be stiff clay, with medium dense silt to silty fine sand approximately 2 meters below the final penetration depth and according to the commissioned engineering study further load beyond that tested during the preload would have resulted in extra penetration. [Artist's impression above might then be somewhat misleading if this occurred].

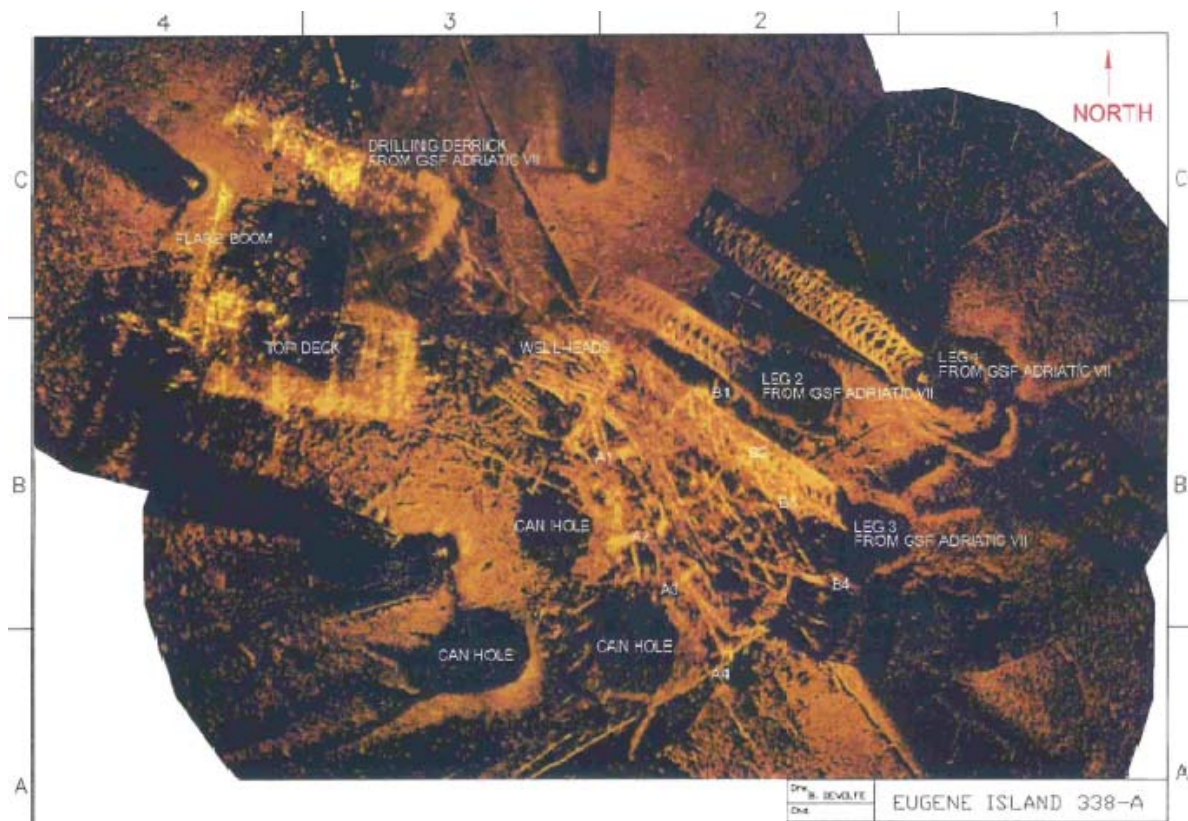
Figure 9.15.12 : Sonar Display of Eugene Island 338A after departure of the GSF Adriatic VII
