Post Mortem Failure Assessment of Jack-up MODUs During

Hurricanes Katrina & Rita

August 2005 & September 2005

Minerals Management Service

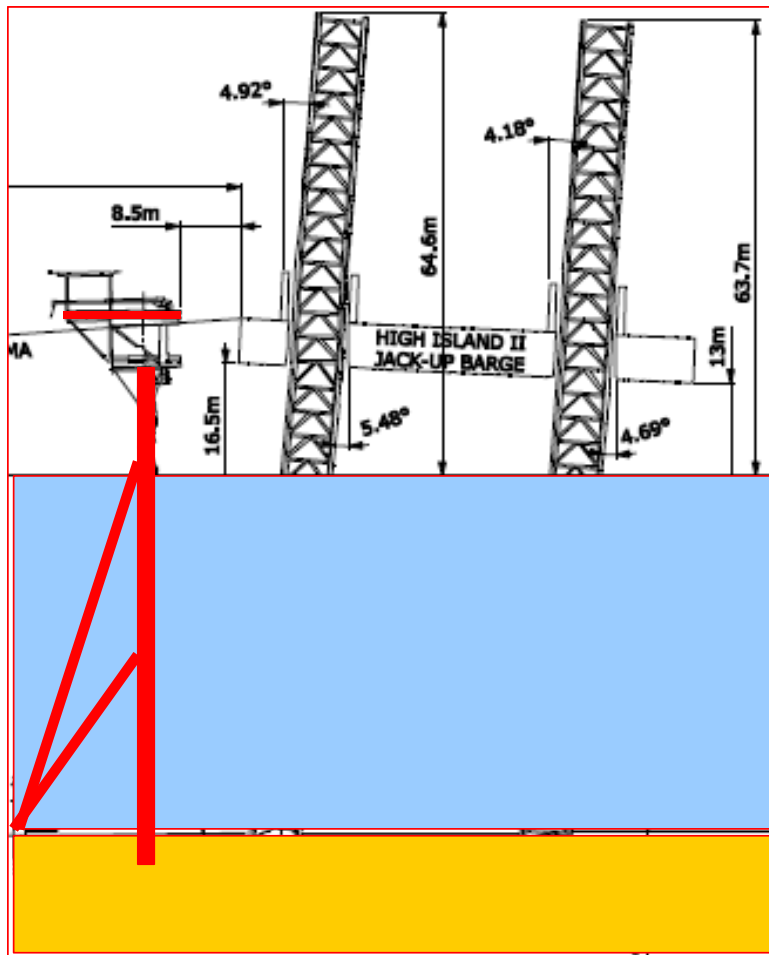
Figure 9.17.1 (Ref 36): Stoner, R.

Upon return after the storm it was noted that there was some cracking in the leg brace welds and some superficial damage but otherwise the jack-up was in good condition. The jacking equipment was all functional.”

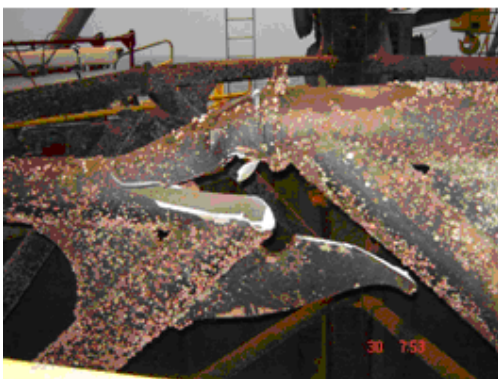
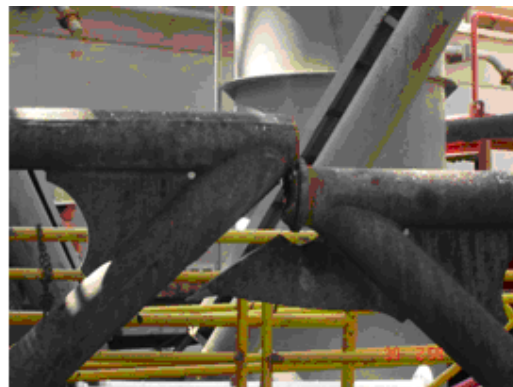
Photos: 9.17.5 Sheared Bracing.

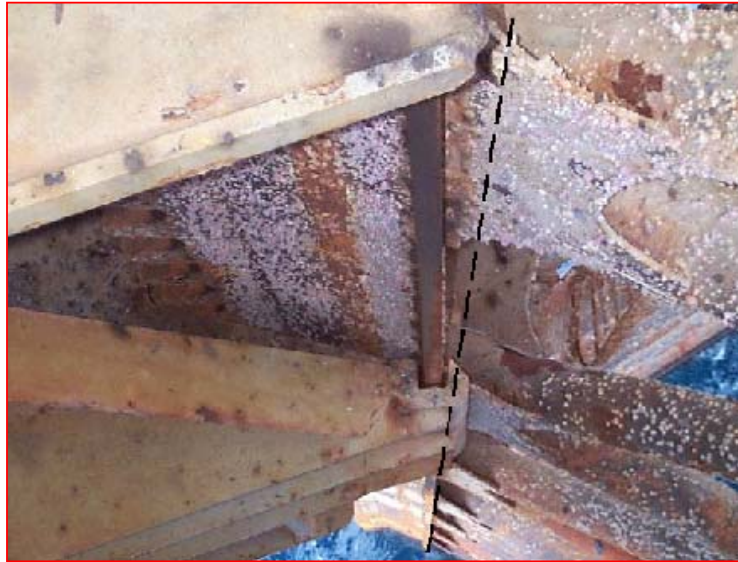
Photo 9.17.6 : Kink at the lower guide.

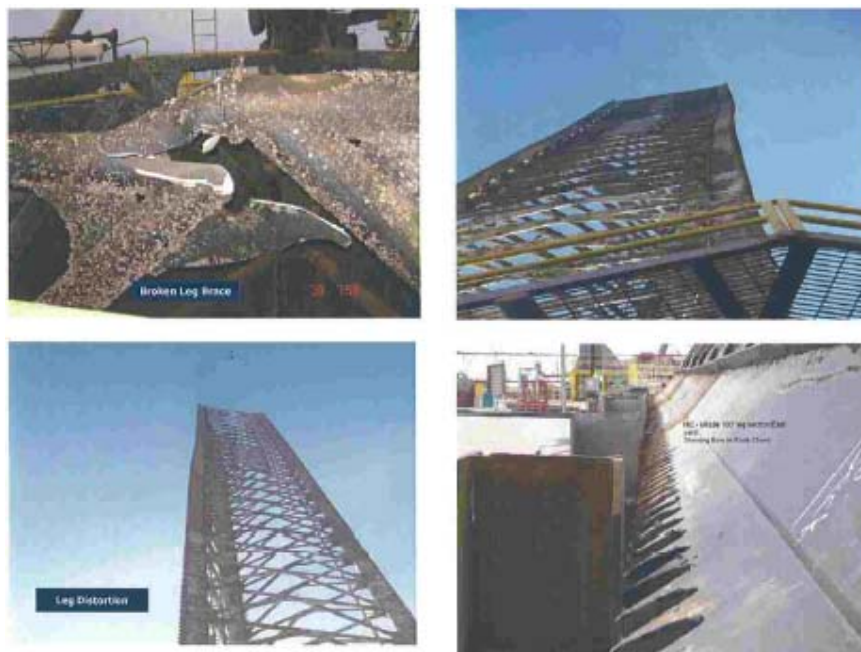
Photos 9.17.7: Miscellaneous Leg Photos

The Jacking system required some replacement parts. In addition the jack system bracing structure and attachments to the hull sustained some structural cracking. Some minor deck buckling in and around the jack frames was noted and to the lower and upper leg guides. All leg guides required replacement of the leg guide liners.

Due to the rocking motion and very high load cycles on the rig during the storm, significant damage occurred in the spud can to leg connection

assemblies. Review of the damaged indicated cracked welds and distorted /buckled plating and framing.

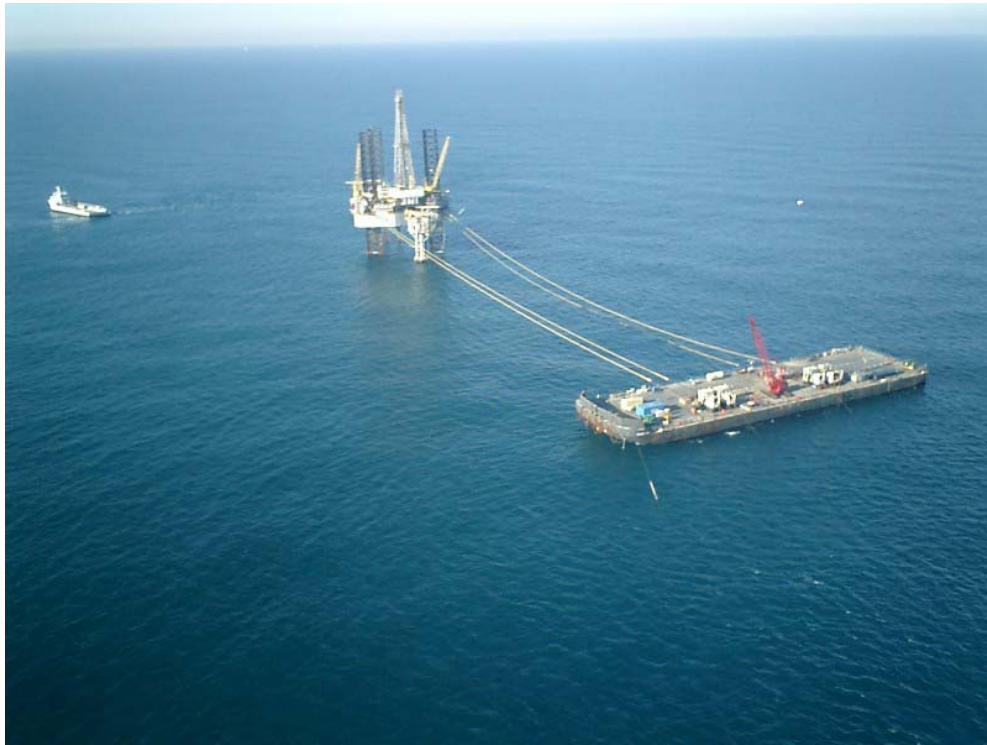
9.17.9 Photo: Overview of pullback barge

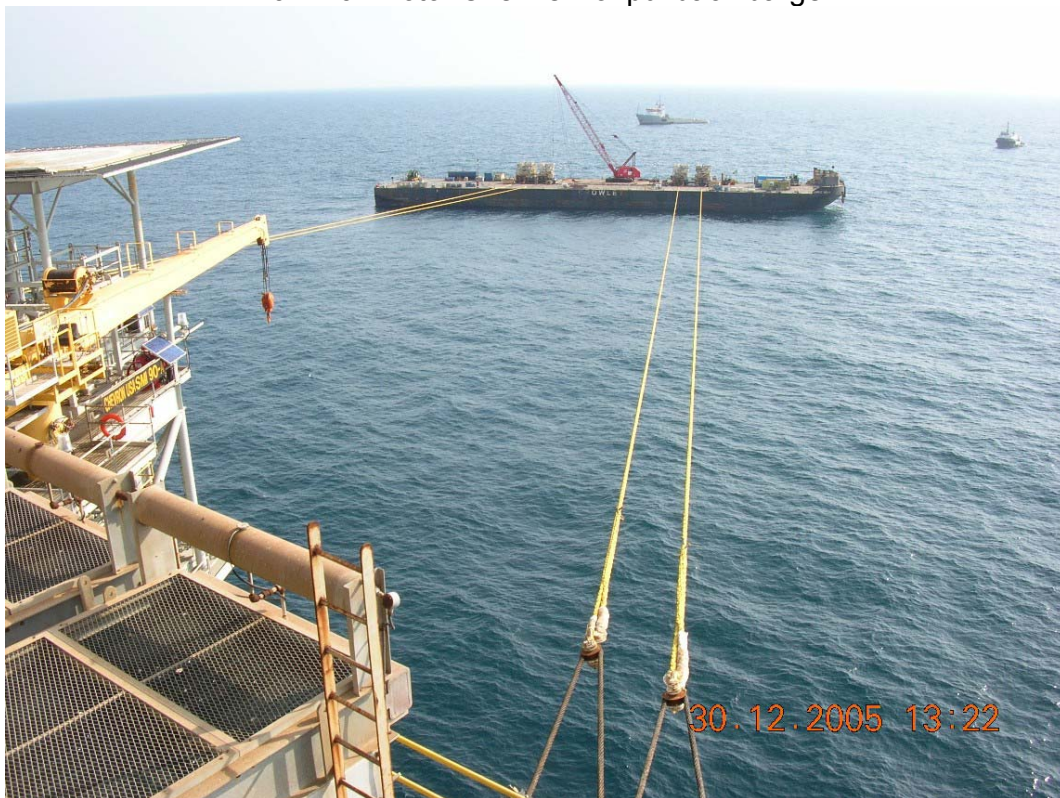
9.17.10 Photo: Pull back barge: photo taken from jack-up

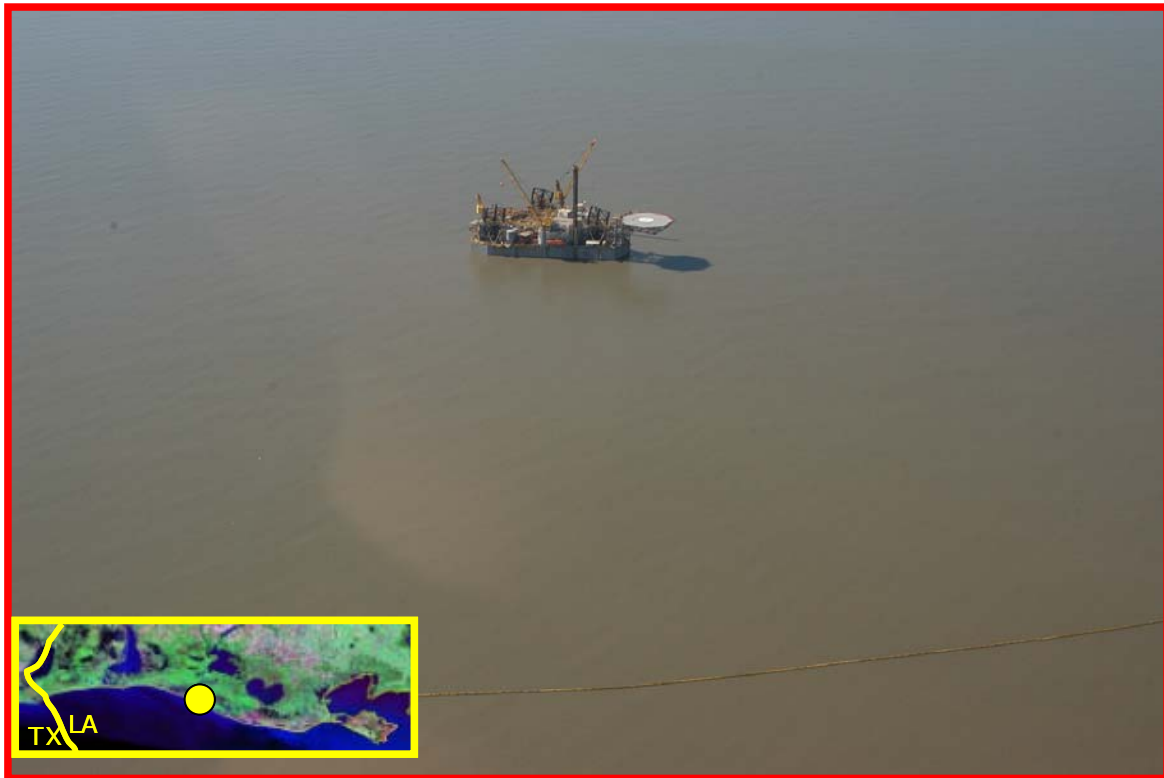
The GSF High Island III was working for Badger Oil in South Marsh Island 107 at the time of Hurricane Rita. The legs collapsed and the rig floated off location. It was severely damaged and drifted approximately 108 mi and grounded off East Cameron 4. It was reported that there was extensive damage to the drilling tower. The pontoon, with the remaining leg protruded from the leg wells, was sitting aground in a self created trench on the sea bottom.

Photo 9.18.2: GSF High Island III off East Cameron

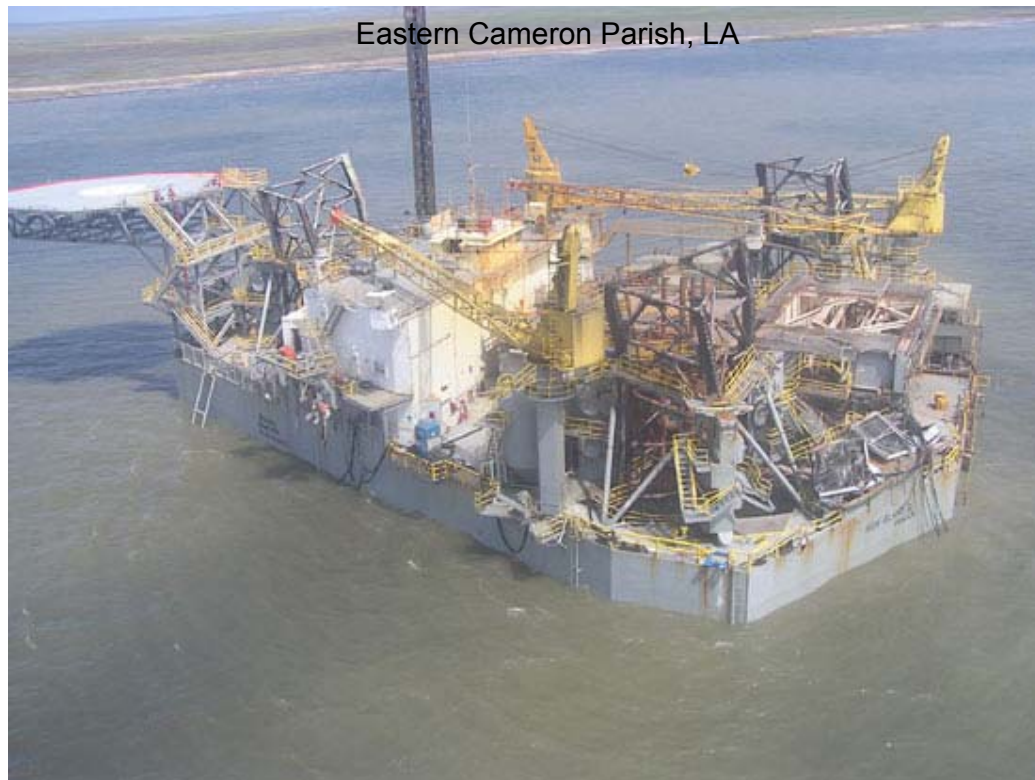
Photo 9.18.3 : High Island III grounded after Hurricane Rita

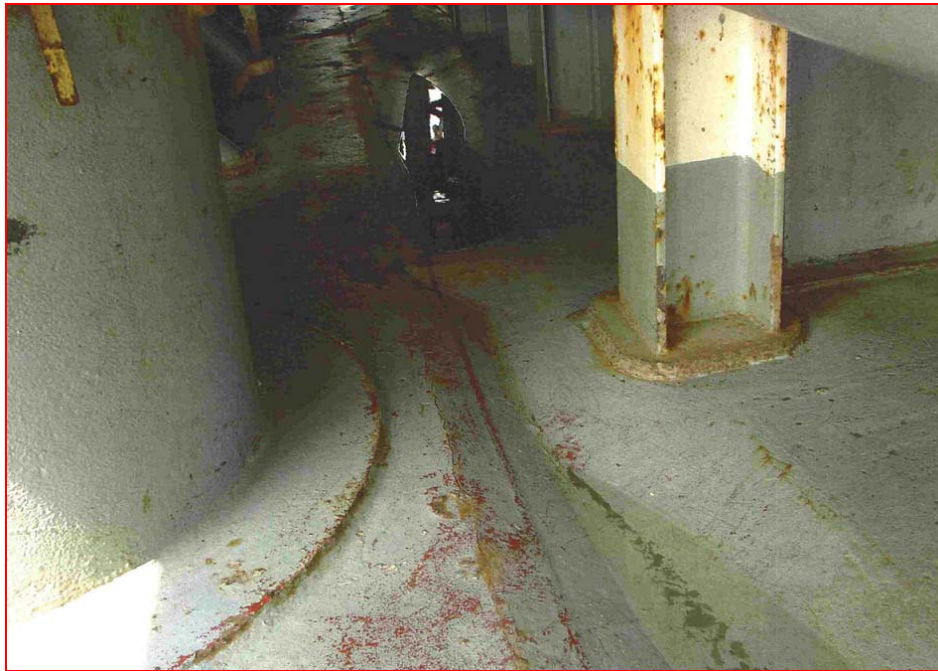
Photo 9.18.4: Hull Structural Inspections: Near the jacking tower some buckling of the main deck appeared to occur. One centerline tank was reported flooded.

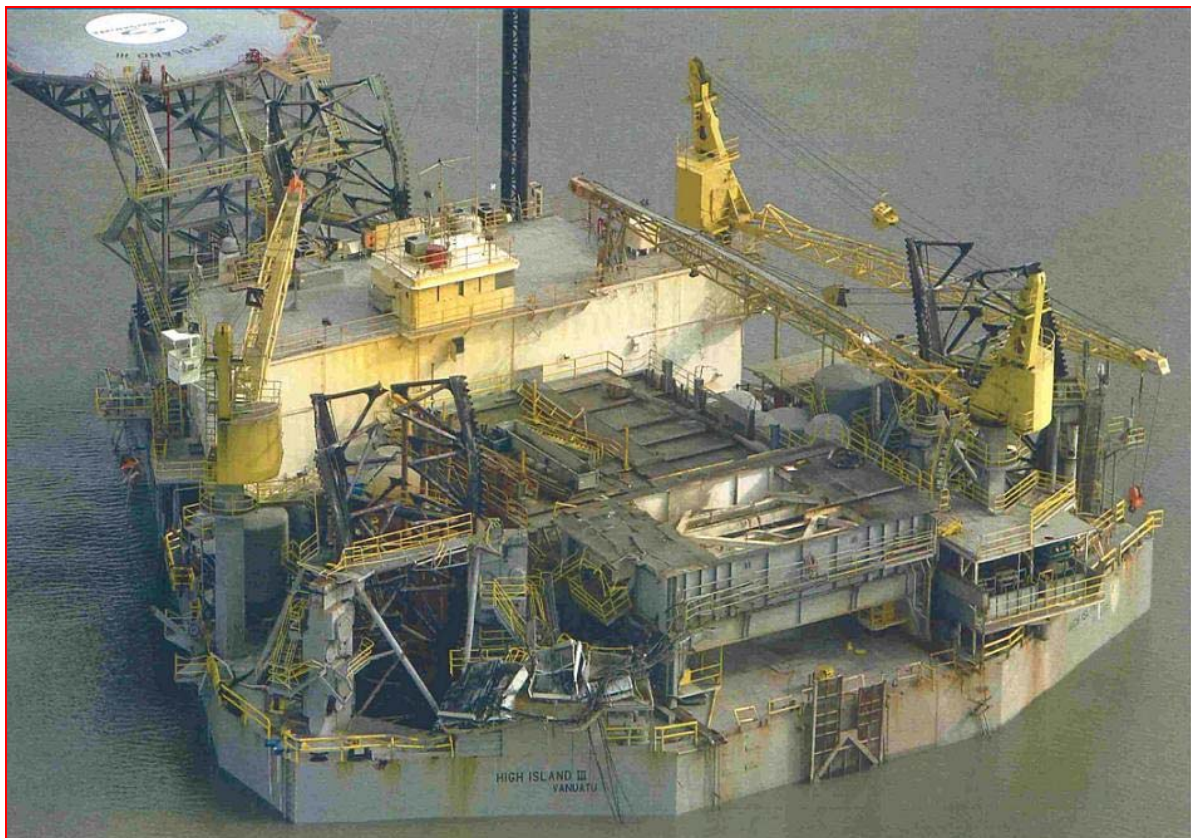
Photo 9.18.5: GSF III after the storm

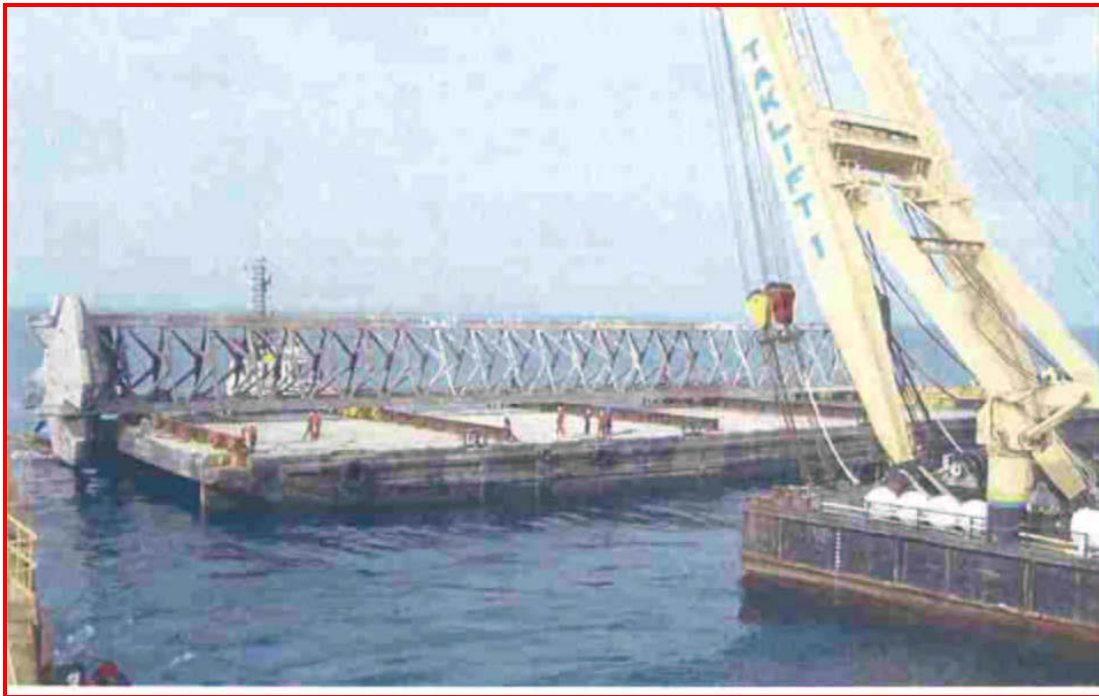
Photo 9.18.10: First of the High Island 3 legs (bow) on deck (Courtesy Smit website)

In October 2006 the legs of the GSF High Island III were removed.

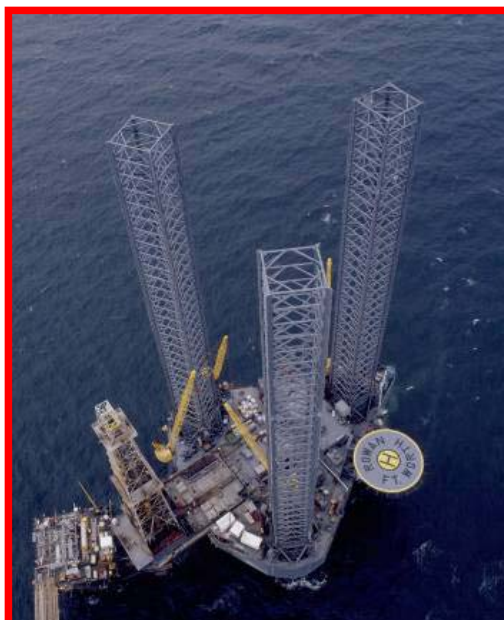
Airgap (C.E. + Surge + 2 ft tide)	Actual Air Gap (ft)	API 95 J Recommended Airgap	Computed Clearance to the Crest (ft) <6ft	East or West of Storm	Distance from Hurricane Track (n.mi)	REGION	Ori-entation (deg)	Leg Length (ft)	Penetration (ft)	Additional Penetration (ft)	Comments (Estimated Approximate Capability)
53.3	73	0	19.7	E	25.4	WC	360	477	78	Afloat	All 3 legs failed and the rig floated off location and sank. (100 kts wind, 40 ft waves, 1 kt current)

“The Rowan Fort Worth and the Rowan Halifax were subjected to conditions that challenged their ultimate strength and in addition the soil conditions were such that significant additional settlement was possible if the preload vertical reaction was exceeded. Its failure was probably initiated by failure of the leg structure or elevating system with additional settlement of the legs” (Ref 28).

“The loading on the rig would have been predominantly from the starboard side toward port for wind, wave, and current based on the bow-northerly orientation at this location. The soil conditions, would have withstood the preload-designed loads, below the 78 ft penetration, the soil shear strength increases only very modestly with depth. Thus once the preload value had been exceeded it would be anticipated that there would be an increase in penetration and as indicated in the table above the vertical reaction was calculated to be 1.7 times that used to site the rig. Additionally the calculated overturning moment is very large.”

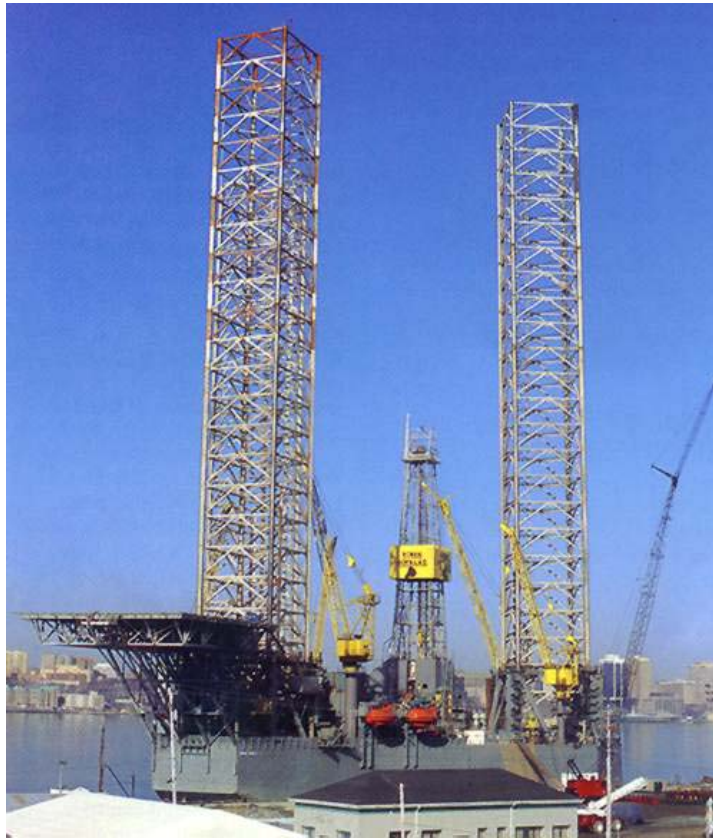
Photo 9.33.1: Rowan Gorilla II in Halifax Harbor (Ref 29)

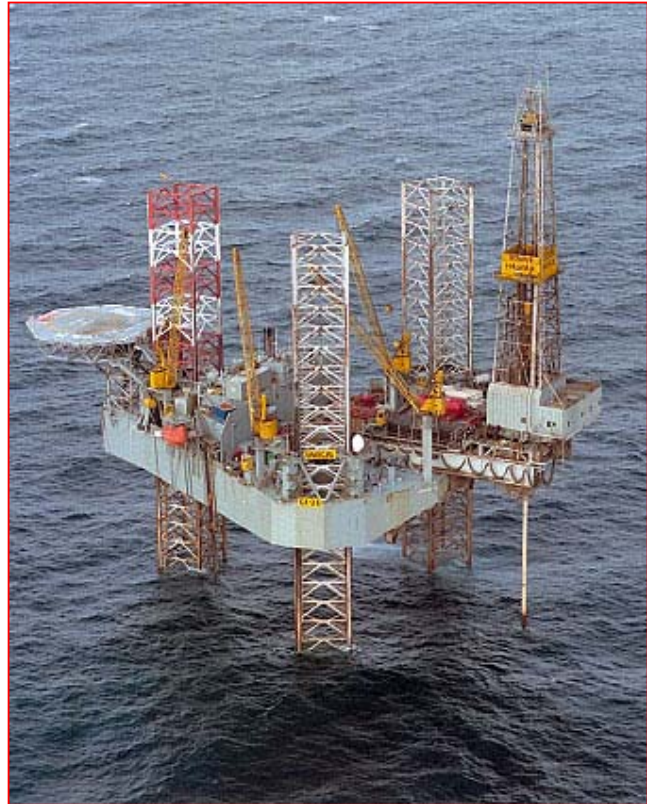
Airgap (C.E. + Surge + 2 ft tide)	Actual Air Gap (ft)	API 95 J Recommended Airgap	Computed Clearance to the Crest (ft) <6ft	East or West of Storm	Distance from Hurricane Track (n.mi)	REGION	Ori-entation (deg)	Leg Length (ft)	Penetration (ft)	Additional Penetration (ft)	Comments (Estimated Approximate Capability)
48.7	70	62	21.3	W	9.1	WC	335	477	42 ft bow; 44 ft stern	Afloat	All 3 legs failed and the rig floated off location and sank. Total Loss (100 kts wind, 48 ft waves, 0 kt current)

“The Rowan Fort Worth and the Rowan Halifax were subjected to conditions that challenged their ultimate strength and in addition the soil conditions were such that significant additional settlement was possible if the preload vertical reaction was exceeded. Its failure was probably initiated by failure of the leg structure or elevating system with additional settlement of the legs” (Ref 28).

In the environmental conditions that the Rowan Halifax saw it would be classified as an expected failure as show in the Table 10.1. The overload was calculated to be approximately 3 times more than the design capability.

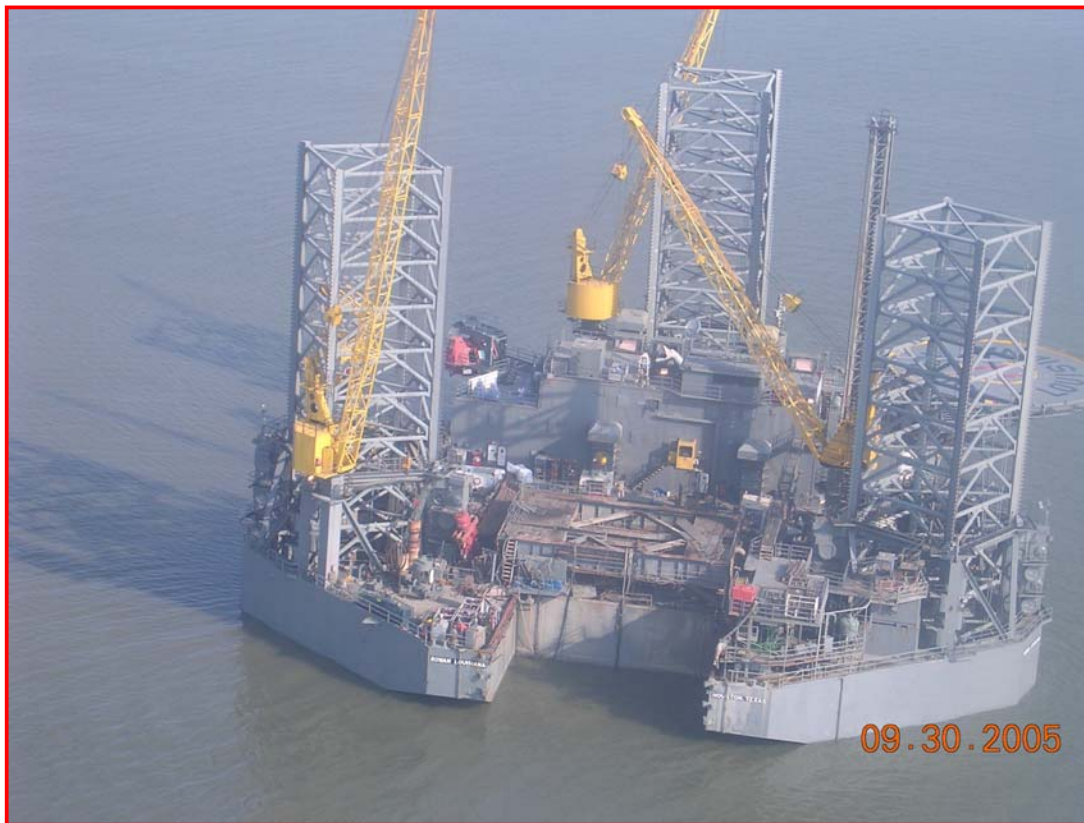
The Rowan Louisiana was found 103 mi NW of its original location near Cameron Louisiana. The drift direction can be seen on the Figures 9.3 and 9.4.

Photo 9.38.1 Rowan Louisiana as located after the storm

Based on comparing the rig's design values to what it saw in the storm it was overload to about 3.2 times its "design capability" as reported in Table 10.1 and thus is an expected failure. It is also likely that the hull was impinged on by the storm since based on calculation the jack-up would have had negative airgap. The combination of overload and additional wave forces, if any, on the hull, would have made this an expected failure.

"The Rowan Louisiana was subjected to conditions that challenged its ultimate strength and showed high unity check for the leg chords even under the assumption of full initial fixity without degradation. In addition, it is likely to have been subjected to wave impingement on the deck. Its failure was probably initiated by failure of the leg chords near lower guides. APPEAR TO BE CONFIRMED AFTER RECOVERY OF HULL" (Ref 28).

The Rowan Louisiana was salvaged by specialists Bisso Marine and floated to R&R Marine Fabrication and Drydock in Port Arthur, Texas. By 2007 the vessel was repaired and crews were drilling in the Gulf of Mexico.

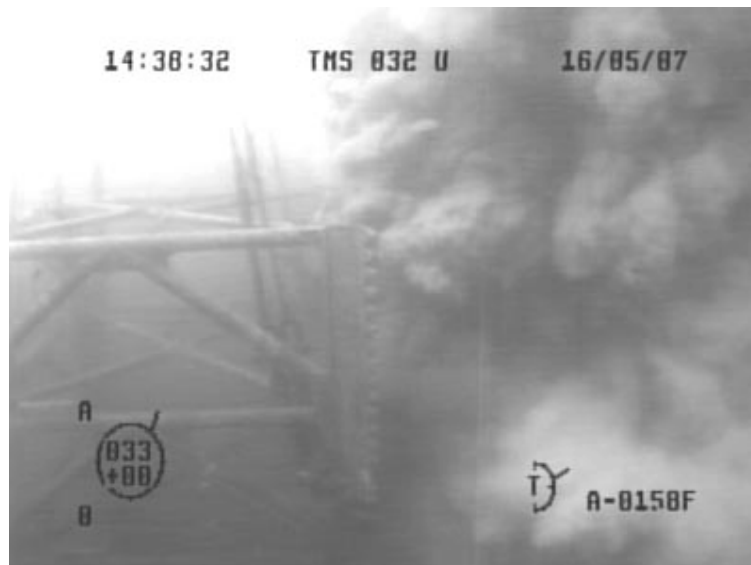
“With 1,600 tons of force, BARGE 415 supported by the D/B BOAZ together were able to successfully stand the first 30’ x 30’ square 84 Class leg section from an angle of approximately 45 degrees to a completely vertical position. Once vertical, the BARGE 415 applied a force of between 2,000 and 2,500 tons, depending on the sea state, until the leg and the 46’ diameter can were suspended in the water column clear of the sea floor. To assist the pulling efforts of the BARGE 415, the D/B BOAZ conducted airlifting and jetting operations using high volume/high pressure air compressors. The operation took seven days of pulling, airlifting and jetting to stand the Leg and Can to a vertical position and to extract. The first 130’ section was transported to a temporary wet storage location in the immediate vicinity until the other two sections are extracted at which time all three will be transported to a permanent reefing location.

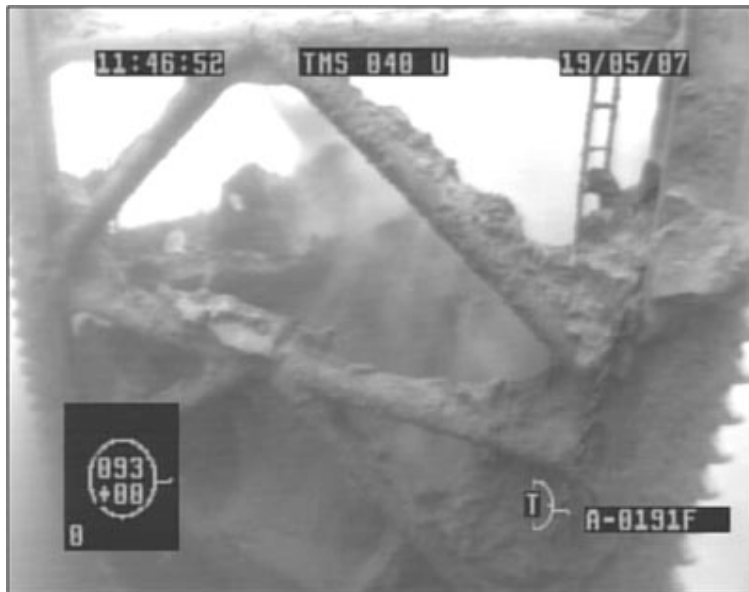
“BISSO MARINE has also mobilized several of its custom designed 10 x 6, 4 stage, “Super Jet Pumps” to the salvage location to assist in the extrication process. Each of the BISSO MARINE “Super Jet Pumps” is a self-contained, crash caged, skid mounted

portable unit capable of delivering 2,800 GPM at 1,150 PSI at the nozzle tip. The “Super Jet Pumps” are each powered by 1,600 HP Cummins KTA50.

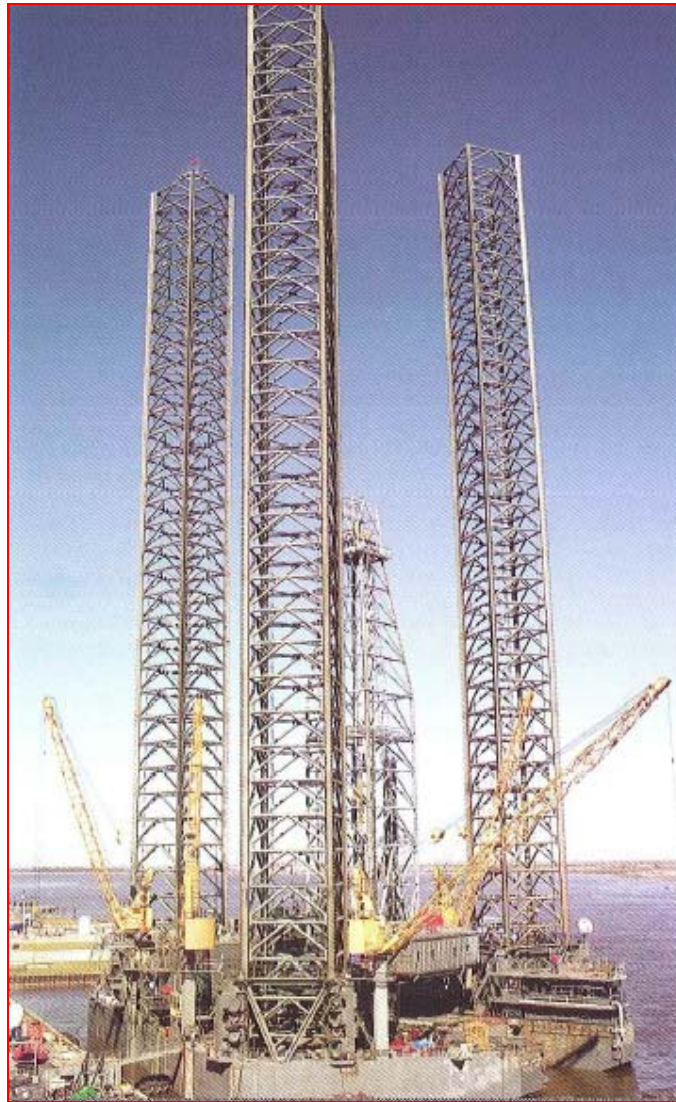
Photo 9.38.3: “Prior to working once more in the Gulf of Mexico, crews finish refurbishing the LOUISIANA at the Sabine Pass, Texas yard.”

The Rowan Louisiana was refurbished. “ In addition to a full restoration, some improvements were made in the rig, including increasing hook load capacity to 1.5 million pounds and upping power by 1,100 HP. The rig’s hull has been strengthened, while capacities, and load capabilities have been increased” (Ref 41).

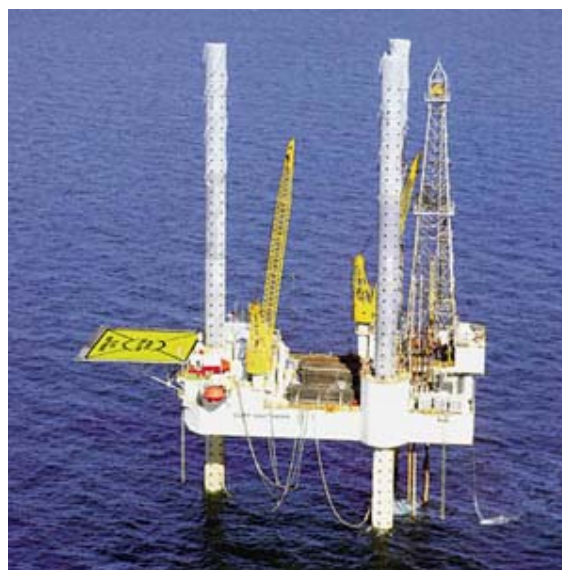
#	Rig of Interest	Design	Location & Block No.	Water Depth (ft)	Max 1 min mean (kt)	Surge Ht at time of max wave (ft)	Max Surge Ht (ft)	Maximum Current Speed (kts)	Max Wave Ht (ft)	Max Crest Ht (ft)	Oil Company
9.50	Pride Wyoming	JU250-MC	East Cameron 194	98	90.9	4.2	4.5	4.0	56.3	37.8	Fairways

Airgap (C.E. + Surge + 2 ft tide)	Actual Air Gap (ft)	API 95 J Recommended Airgap	Computed Clearance to the Crest (ft) <6ft	East or West of Storm	Distance from Hurricane Track (n.mi)	REGION	Orientation (deg)	Leg Length (ft)	Comments (Estimated Approximate Capability)
44.4	55	62	10.6	E	9.6	WC		312	Jack-up slid off location

It was reported that the rig moved off location 137 ft. The bow heading changed 2 degrees. Drive pipe and BOPs were not visible upon return to the location. The rig had skidded in 15 ft. The deep well pump on the Texas deck was lost and there were a few broken windows and lights. An underwater inspection revealed only a small hole in a flooded tank due to collision with a BOP wing valve.

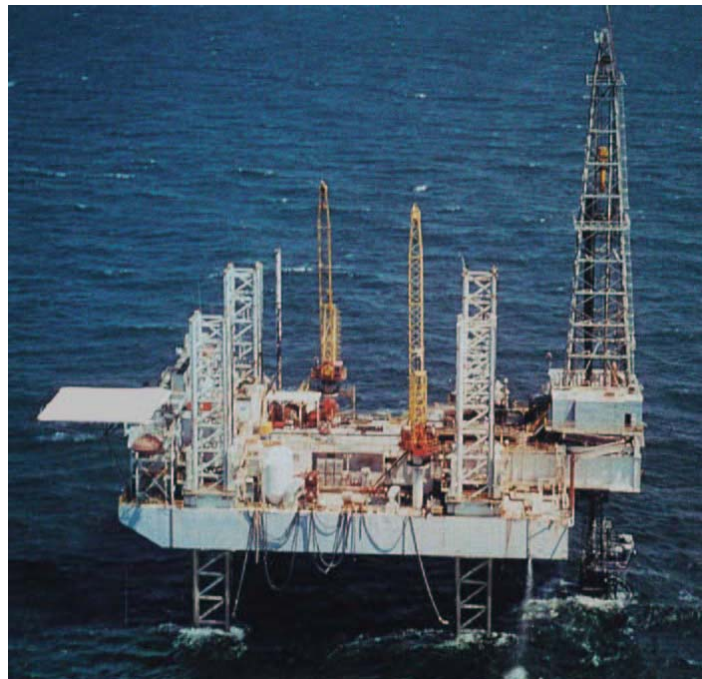
#	Rig of Interest	Design	Location & Block No.	Water Depth (ft)	Max 1 min mean (kt)	Surge Ht at time of max wave (ft)	Max Surge Ht (ft)	Maximum Current Speed (kts)	Max Wave Ht (ft)	Max Crest Ht (ft)
9.54	Hercules 21	Delong	Main Pass 21		44.5	3.4	3.4	0.2	9.6	6.5

Following Hurricane Katrina the Hercules 21 at pre-storm location in Main Pass 41/59 sustained mat damage. It planned to go in mid 10/05 for mat repairs. (Platou Report November 2005).

Following Hurricane Rita the Hercules 21 was reported as “moved from mat repairs area to neighbouring block Main Pass 21 – listing precariously. Only minor damage

from Rita. Moved to Signal Shipyards, Pascagoula, for damage repairs from Hurricanes Katrina and Rita". (Platou Report November 2005).

In the Table 10.1 this was classified as an "Other Expected Issue" in that mat jack-ups do often move in hurricanes, when severe storms hit, depending on the foundations at the particular site.

Offshore Mag. June 2006 "Hercules mat supported jack-up rig was repaired in Signal's yard, with major steel replacement along with some upgrades." "Signal also salvaged 100 ft of steel from each leg of the Hercules Rig 25. The rest of the Katrina-damaged rig will be scrapped."

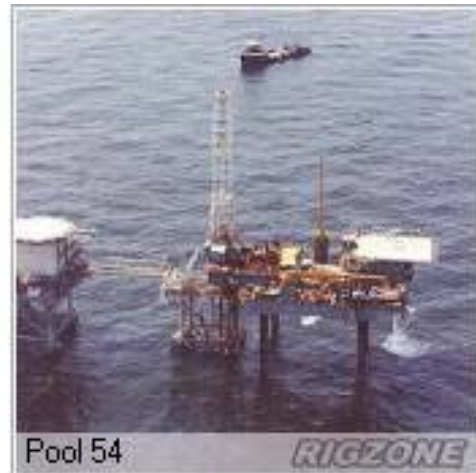
Derrick blown over (Ref 42: Platou Report November 2005).

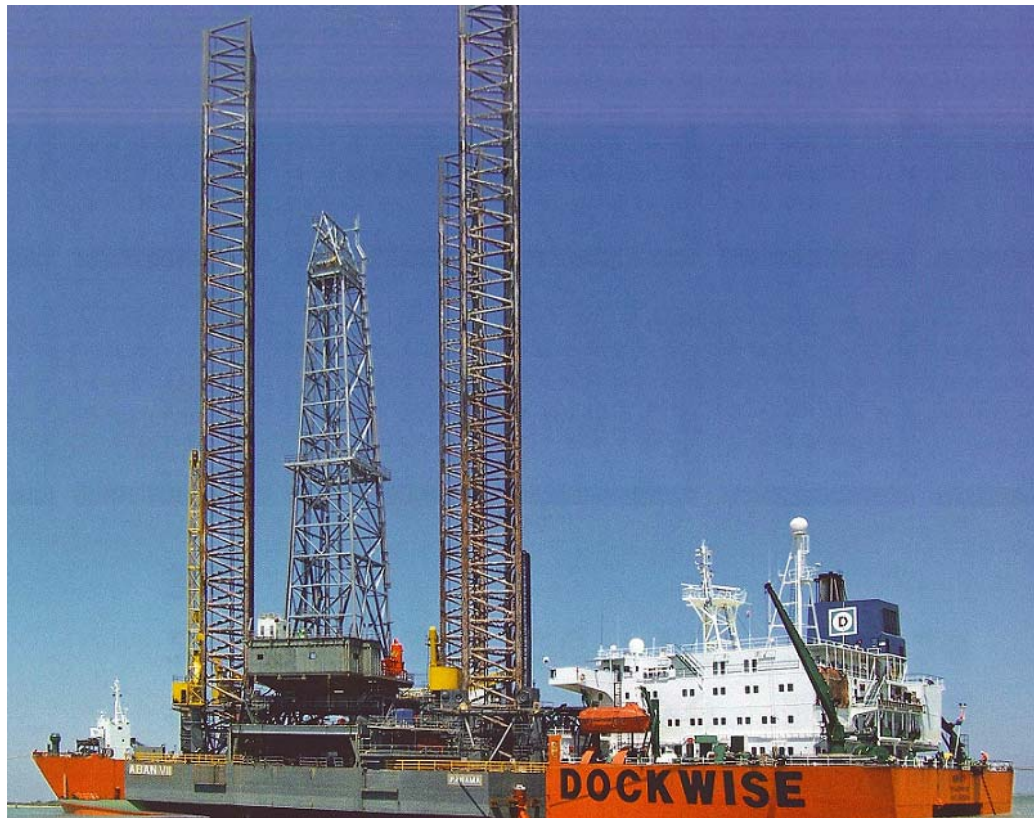
The Aban VII, (former Rowan Texas), was reported to have lost a drilling package while stacked in Sabine Pass, undergoing repairs at the yard. The rig had been bought and was being prepared for a transport to India when the hurricane Struck. Lack of tiedown was blamed on the incident. The photo below shows the Aban VII prepared for transport after the event. Reference to the sale just prior to the hurricane was reported as follows:

The following photograph shows the vessel after the hurricane having been loaded for transport.
