Damage and Critical Analysis of Accidents to Assist in Avoiding Accidents on Offshore Wind Farms on the OCS

May 2010

Project No. 633, Contract M09PC00015

This document is the Report on Damage and Critical Review of Accidents: documentation of significant damages relevant to wind farms for which appropriate information is available together with analyses of the causes when available.

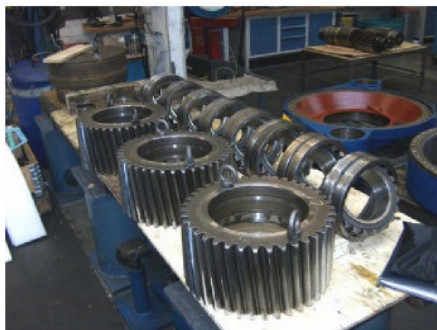
The three wheels and the 6 bearings from the planetary stage of a typical gearbox

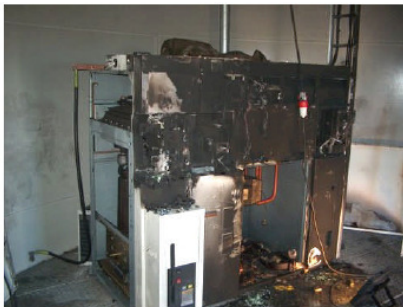
Short circuit in a power panel. Root cause was a bad connection on a high power cable.

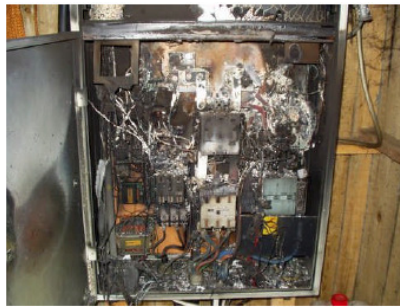
Short circuit in a power panel. Root cause was lightning.

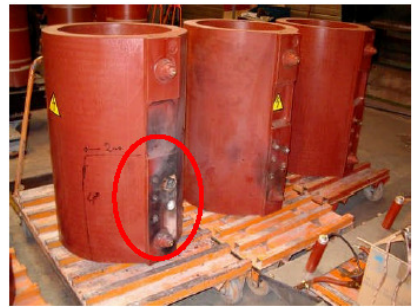
Short circuit in the transformer. Root cause was probably high temperature due to insufficient cooling.

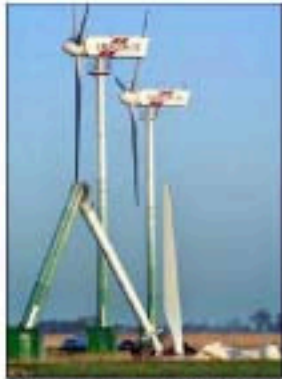
20000210.1.bmp

February 10, 2000: Tower
Collapse
Enercon E 32, 300 kW
Year of construction: 1992

Location: Aseel in the district
of Wittmund / Lower Saxony

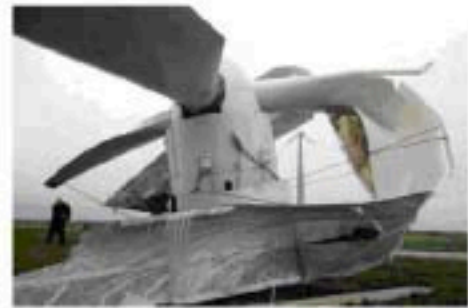
20000210.2.bmp

Fig. 18: Structural collapse of a wind turbine in 2002 in a storm. Source: Der Spiegel, DPA.

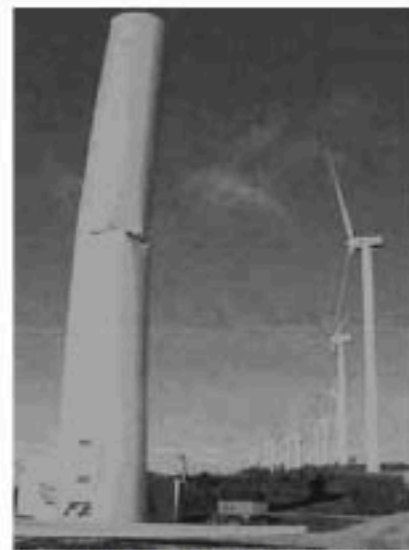
99999999.51.bmp

Figure 5. The loss of the turbine due to rotor bearing flaws
