2005 Hurricane Preparedness

Shell's Experience with Hurricane Ivan

API – 2005 Hurricane Readiness and Recovery Conference

Virgo Platform (Viosca Knoll 823) Hurricane Ivan Impact & Recovery

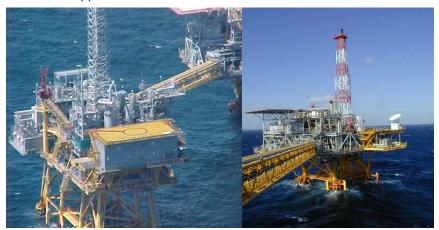
Damage Assessments – MP 252

- ➤ Evidence of Green Water in the deck, 50 feet above the water line. Platform was near the eye of the storm.
- ➤ Estimated wave height 65 70 ft which corresponds to the maximum design wave of 72 feet.
- ➤ Platform damaged consisted of:
 - Missing Grating and Handrails (100 % at boatlanding to 20 % on lower deck)
 - Facilities equipment, cable tray and mostly support utilities

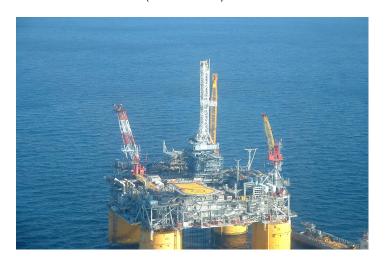
Damage Assessments – VK 956

- ➤ Evidence of Green Water in the deck, 90 feet above the water line. Platform near the eye of the storm.
- ➤ Estimated wave height at this location is around 100 ft. Design wave was around 87 ft.
- ➤ Platform damaged consisted of:
 - Drilling rig moved off location
 - ❖FGC 2 exhaust
 - Missing Grating and Handrails (100 % at boatlanding to 20 % on lower deck)
 - ❖Facilities equipment, cable tray and mostly support utilities

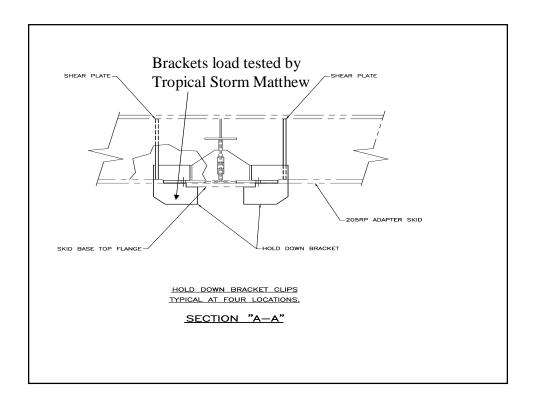
VK 956 A – Drilling Rig Recovery

- ➤ Rig was located in potentially unstable position.
- ➤ Rig had to be secured to prevent further damage.
- ➤ 2500 ton rig to be a) lifted vertically then slid back into position or b) disassembled and then reassembled.
- ➤ Option a) was selected

- -Strategy
 - ➤ Secure rig using hold down brackets.
 - ➤ Hold down brackets designed for additional hurricane force conditions.
 - ➤ Use a system of strategically placed jacks, cylinders and grippers to recover rig.

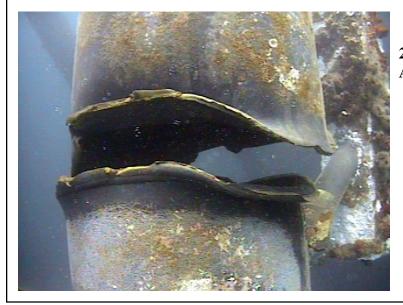
Jacket Diagonal

26 x 0.500" A-572 Gr 50

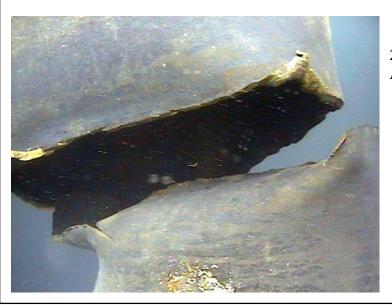
Jacket Diagonal

26 x 0.500" A-572 Gr 50

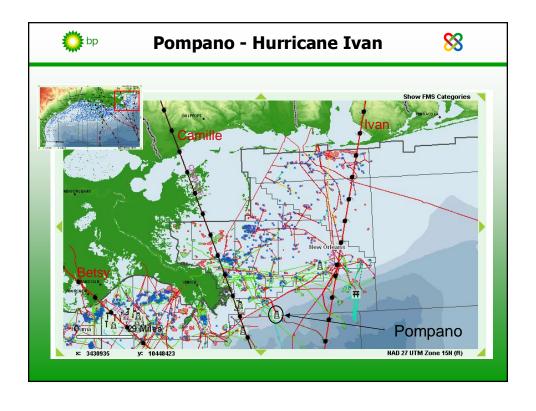
Hurricane Damage: -

- Hurricane Ivan Damage to Pompano: -
 - Top of jacket handrails majority missing
 - Cable trays & panels damaged on sub-cellar deck
 - Piping and equipment damaged on sub-cellar deck
 - Damaged & missing grating
 - Damage to lights

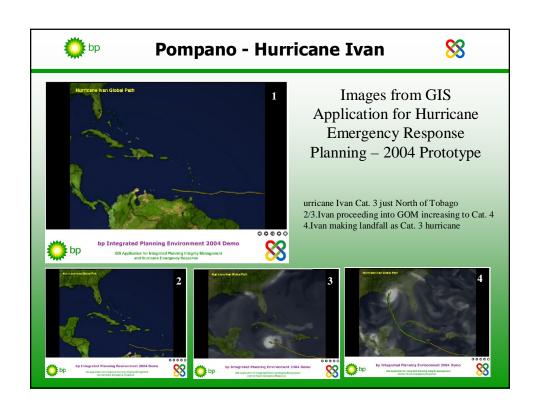
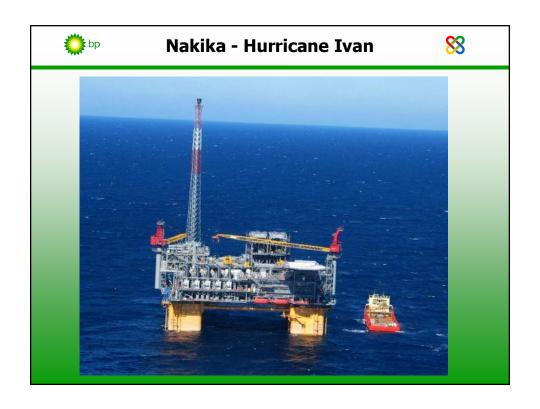
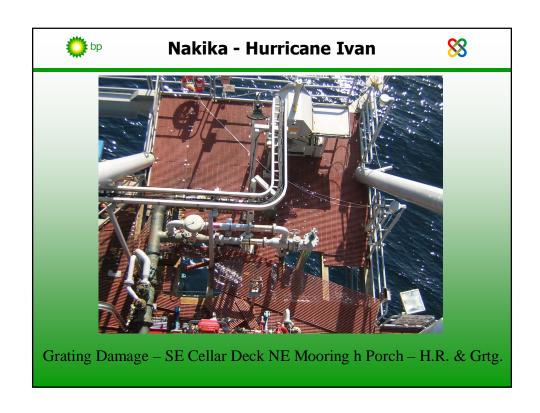
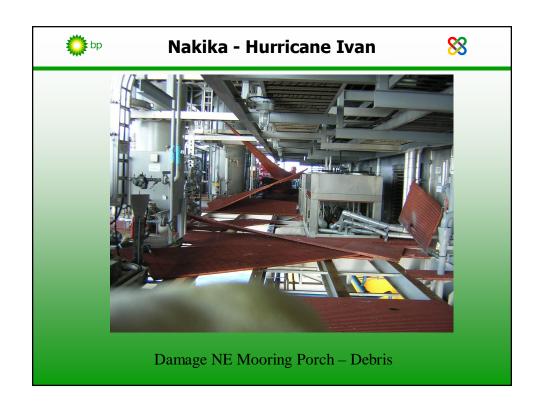
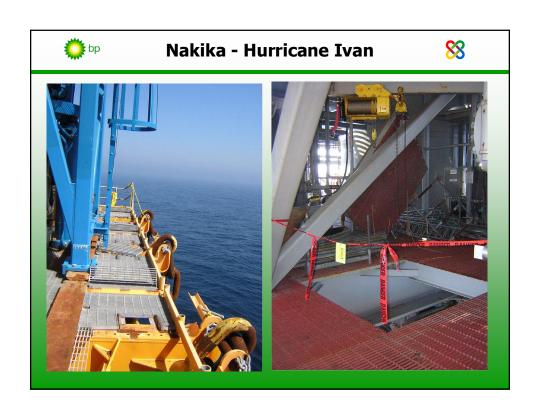
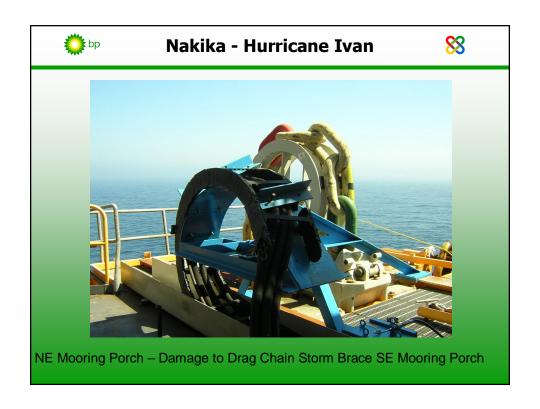
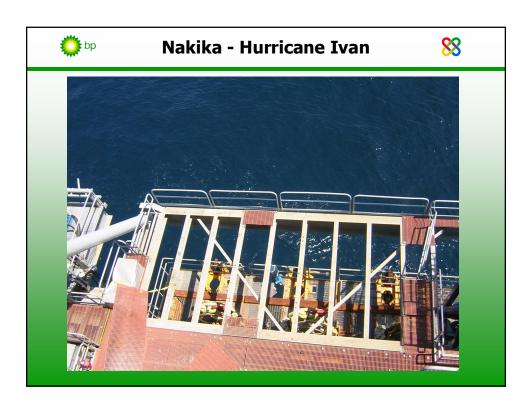
Hurricane Ivan

- Observed damage to cable trays at EL (+) 63 ft.
- 3rd order stream function, 55% of wave above MSL
- Estimated wave height = 105 ft assuming 6ft tide & surge.
- Ultimate strength analyses correlate to Pompano surviving event.

- Observed damage to cable trays at EL (+) 70 ft.
- 3rd order stream function, 55% of wave above MSL
- Estimated wave height = 116 ft assuming 6ft tide & surge.
