Fire Boom Testing at Ohmsett in 2000

Ian Buist, James McCourt,
 Jake Morrison
 SL Ross Environmental Research
 Ottawa, ON
Ian@slross.com

Abstract

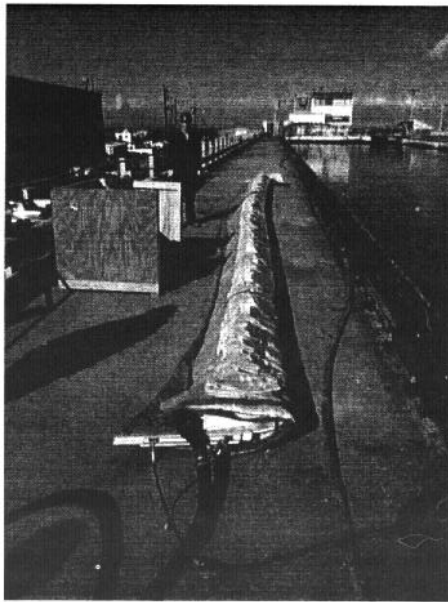
Figure 8 - Oil Stop, Inc. Auto Boom Fire Model on deck.

This fire boom was designed to be deployed from a reel and inflated with a low-pressure blower. The version tested was an older model (estimated by the manufacturer to be about three generations old). The boom tested (Figure 8) consisted of a fire-resistant insulating cover (comprised of a sandwich of stainless steel screen containing a refractory felt mat wrapped with a polyethylene film) over a coated glass fabric flotation chamber and skirt membrane. A chain in a pocket in the bottom of the skirt functioned as both ballast and tension member. The boom was inflated at one end, with air communication between all flotation chambers in one section.

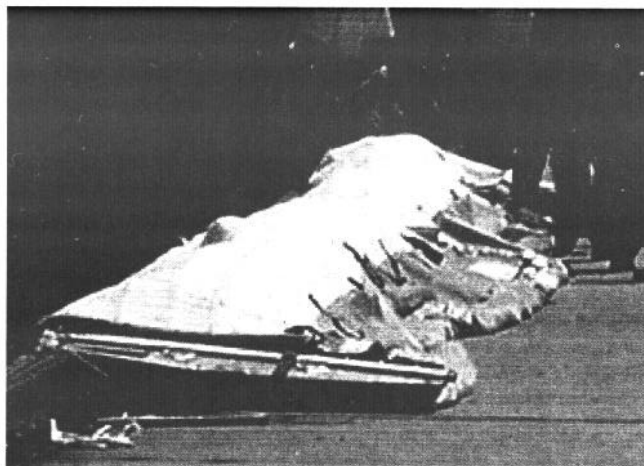
Figure 9 - Elastec/American Marine water-cooled fire blanket installed on the USS-42B boom.

Detailed descriptions of the water-cooled blankets may be found in Stahovec et al. 1999. Figure 9 shows the Elastec/American Marine water-cooled fire blanket installed on the USS-42B boom laying on the deck of the tank. The connection for adjacent blankets involved zipping the two ends together. The blanket was constructed to seal around the bottom of the boom, restricting the access of propane to the underside of the blanket. It should be noted that the fabric used in the blanket produced for these tests is much lighter than normally used in the Elastec/American Marine Hydro-Fire Boom.

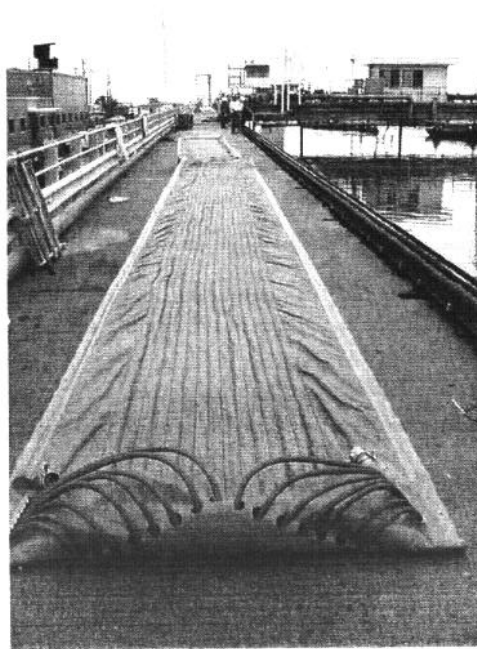
Figure 10 - Oil Stop, Inc. water-cooled fire blanket laid out on the deck prior to its installation on the USS-42B boom

Figure 10 shows the Oil Stop, Inc. water-cooled fire blanket laid out on the deck prior to its installation on the USS-42B boom. Note that this blanket was not constructed to seal around the bottom of the boom thus allowing the propane bubbles

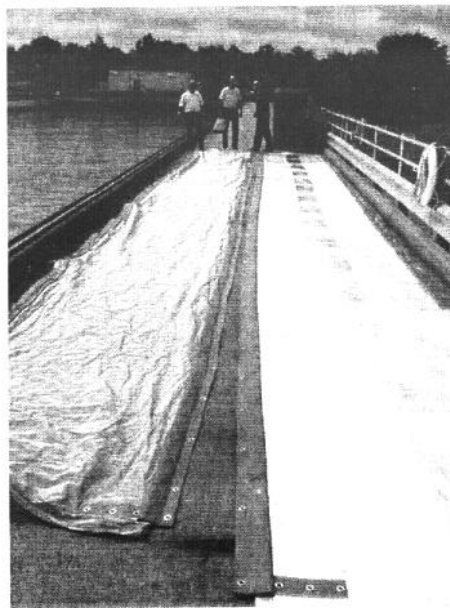
Figure 11 - AFTI cover # 1 (on the right).and cover #2 on the tank deck.

Three different prototype reflective, insulating blankets produced by AFTI were exposed to different levels of radiant heat from the air-enhanced propane fire. For the purposes of this paper these are denoted as #1, #2 and #3. AFTI prototype #1 consisted of an aluminized Zetex[®] cover over a Tuftemp[®] stitched felt insulating blanket attached to a Flotemp[®] mesh. AFTI prototype #2 comprised a fine stainless steel mesh covering an aluminized ceramic paper attached to the Flotemp[®] mesh and prototype #3 was aluminized Zetex[®] covering the Flotemp[®] mesh. Figure 11 shows cover # 1 (on the right) and cover #2 on the tank deck prior to their installation. The covers were draped over the flotation of the USS-42B boom and attached to clips mounted along the skirt of the boom.

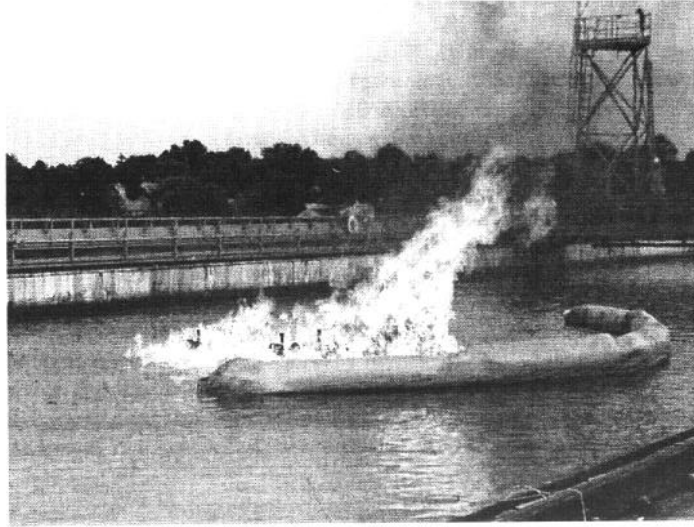
Figure 18 – AFTI cover #3 deployed in semi-circle beside fire.

Three different prototype reflective, insulating covers produced by AFTI were exposed to different levels of radiant heat from the air-enhanced propane fire. Since these covers were intended to provide temporary, short-term protection to the underlying boom the test for these was modified from the standard fire boom protocol. The test sections (50') were deployed beside the fire (Figure 18) and exposed to the radiant heat for ten minutes, or until the inside temperatures exceeded the maximum permitted for the USS-42B boom fabric (280°F). Three thermocouples were attached to each boom/cover combination. One was located outside the cover and two were between the cover and the USS-42B boom, at different heights above the waterline. All the tests were conducted in calm conditions.
