***MMS TA&R PROJECT 650
OFFSHORE WIND TURBINE INSPECTION
REFINEMENTS
FINAL REPORT***

**Subject: MMS TA&R Project 650 –Offshore Wind Turbine Inspection Refinements
– Final Report**

The following is our Final Report documenting the development of the refinements to the Offshore Wind Turbine Inspection Guidelines. The report describes the steps taken, the personnel involved, and the logic behind these refinements to the guidelines with respect to blades and tower inclination.

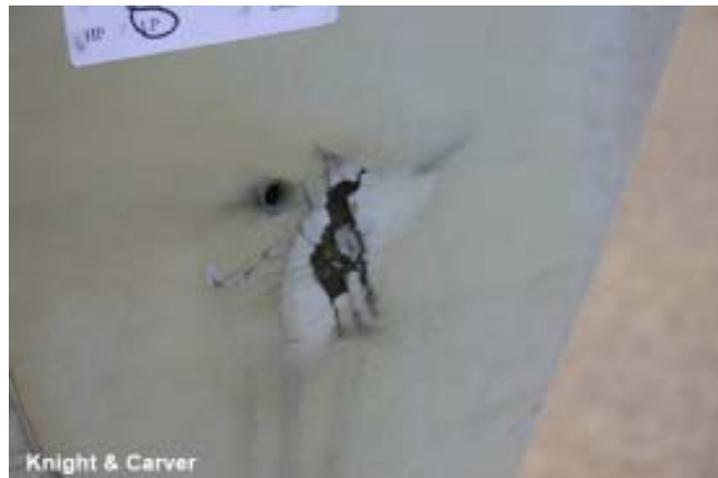
Figure 2.1 – Lightning Damage to Blades

Generally responses from subject matter experts have indicated that lightning and erosion (particularly along the leading edge of the blade) are the most commonly detected in-service degradations (see Figures 2.1 and 2.2). Underlying structural issues such as delamination, cracks at details of the geometry and bond failures are typically manufacture related and generally identified within a short period after installation (e.g., within six months of installation); either through poor blade performance or because of problems with the same or similar blades made by the manufacturer (see Figures 2.3 and 2.4).

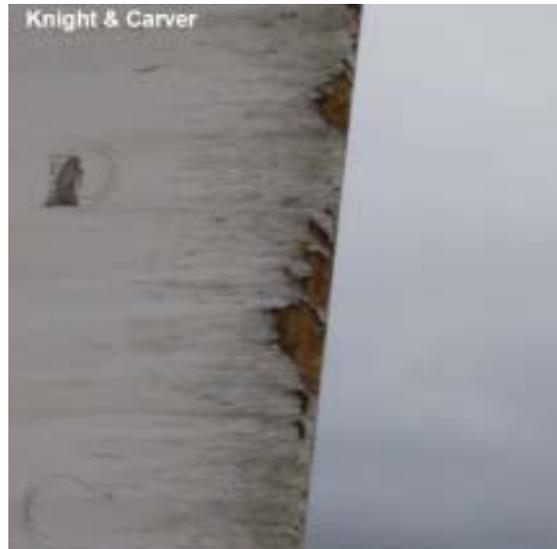
Figure 2.2 – Leading Edge Erosion

Erosion, particularly leading edge, is highly dependent on the local conditions. Some installations see virtually no erosion over many years of service while others can be significantly eroded and require repair within a few years. Airborne particulates, rain, snow, sleet, etc. are drivers of this. Inspection guidelines should emphasize the variable nature of these effects so operators can highlight the evaluation of this effect on their blades.

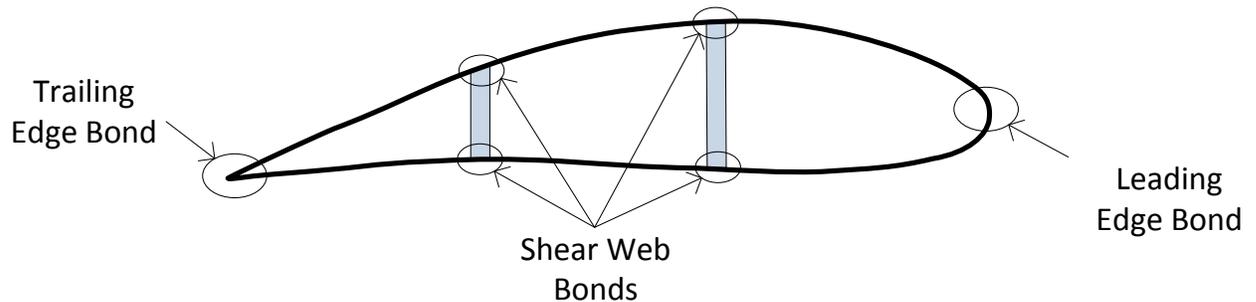
Figure 2.3 – Prevalent Structural Failure Locations

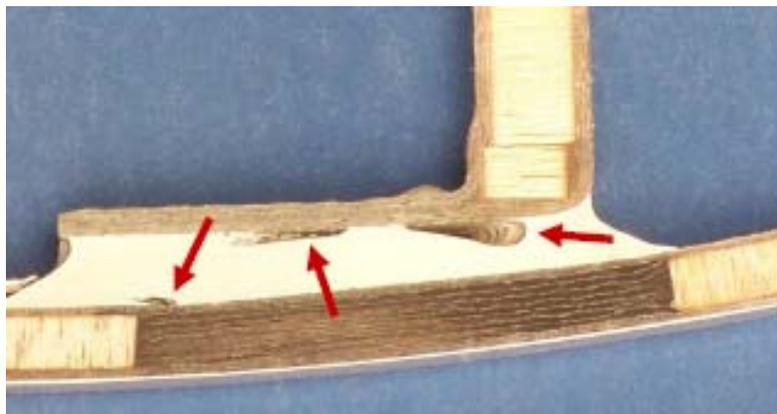
Figure 2.4 – Bond Voids

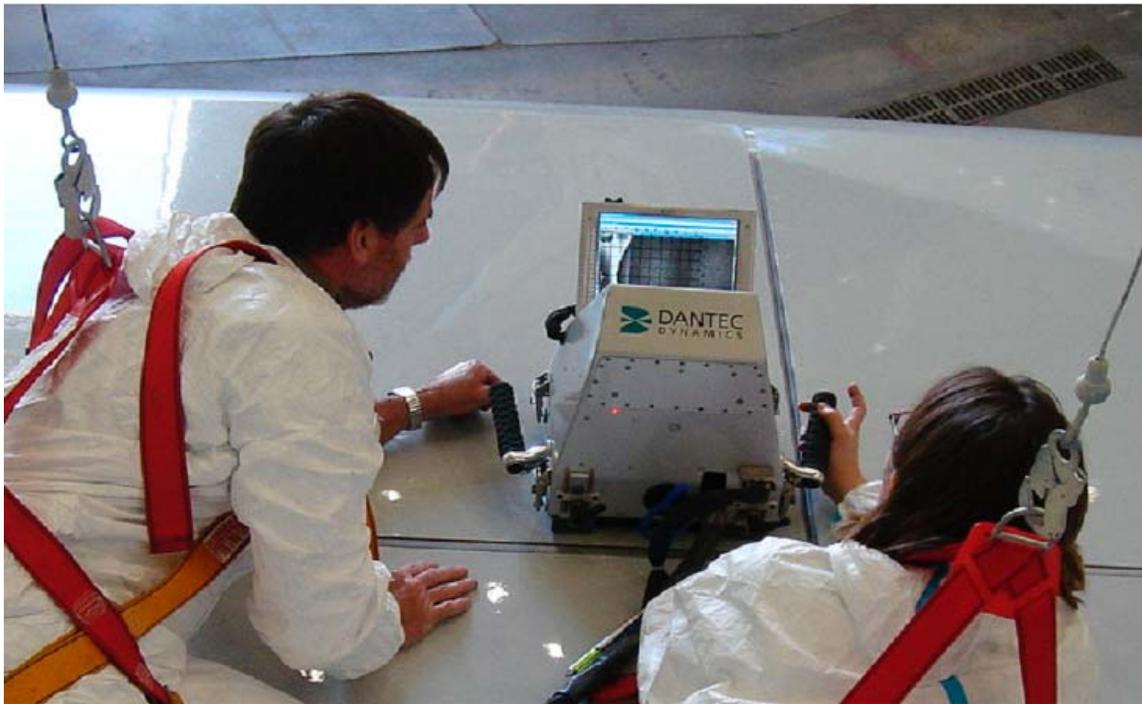
Figure 2.5 – Dantec Q-810[®] Portable Shearography System

The more equipment-intensive methods are generally more suited to testing in the manufacturing plant rather than in-service though their effectiveness is greatly enhanced if suspended platforms are available. Input from industry experts indicates that UT and thermography are techniques that are used on blades in situ depending on the goal of the inspection and the type of blade being inspected. There are also portable shearography units that are near to being implemented in the field and “up-tower”, notably from Dantec Dynamics (see Figure 2.5).

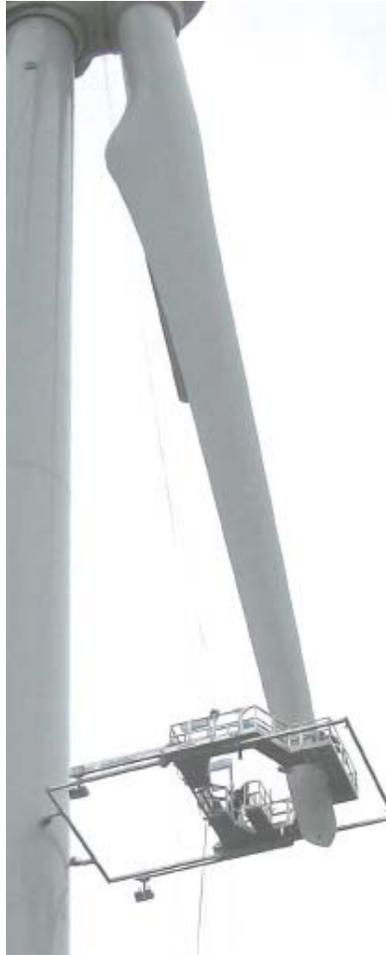
Figure 2.6 – Asmus® Suspended Platform

The first option is to use rope access since this is the quickest and cheapest of the access options. For areas that cannot be accessed safely using rope access, or to improve inspection efficiency, the next option is to use a suspended platform system (see Figure 2.6 for a typical blade access platform system). These systems are common and can be suspended from existing parts of the nacelle or purpose-built supports can be included in the nacelle design. There are a variety of manufacturers and vendors providing robust access platform solutions for wind turbine inspections including the blades including Safway, Sky Climber, Spider and Kaeufer.

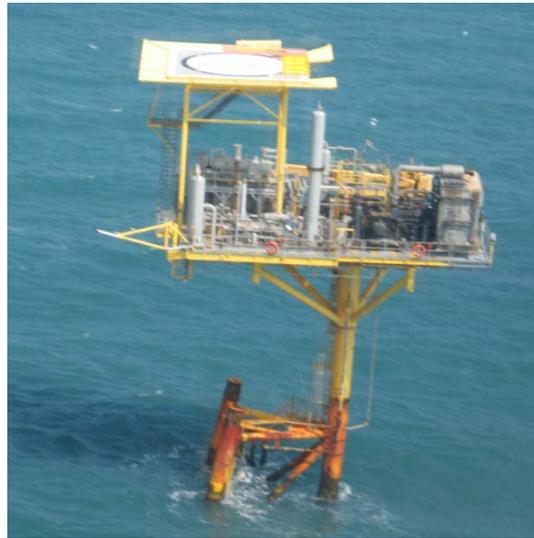
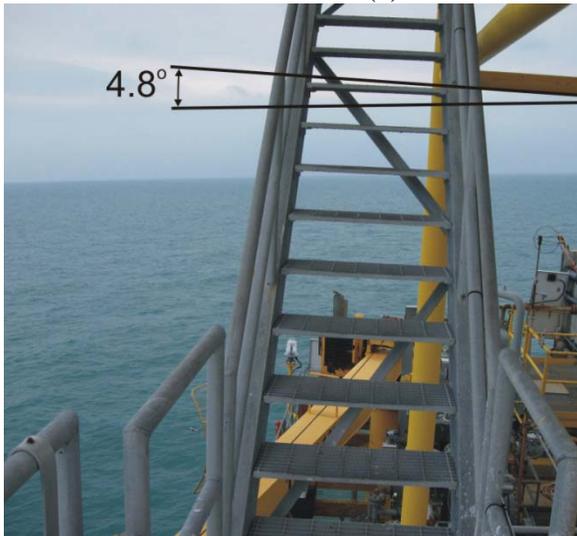
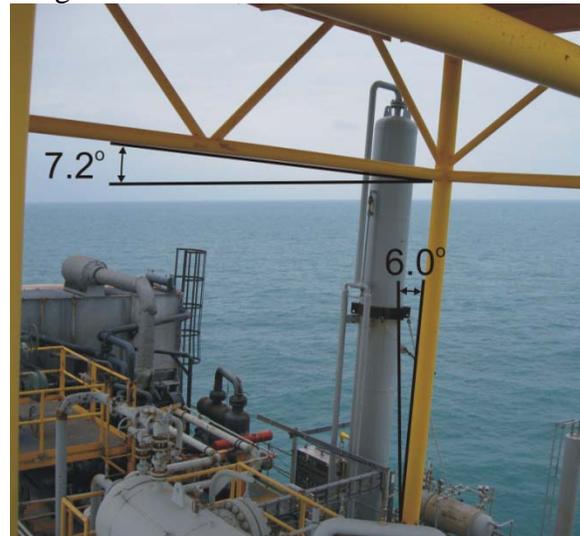
(a) WC 426 following Hurricane Ike

(a) WC 426 structure showing inclination

(b) WC 426 structure showing inclination

Figure 3.1. Inclined Oil Platform (WC 426) following Hurricane Ike

Examples of structural deformation that causes an overall inclination are numerous for offshore oil platforms. One case of an inclined platform following Hurricane Ike is shown in Figure 3.1 with an example from Katrina/Rita in Figure 3.2. These images highlight some of the challenges in determining the inclination angle, namely photographic determination based on local observations of structural members requires a non-trivial effort to properly assess the inclination angle.

For the example in Figure 3.1, multiple inclination angles ranging from 4.8 to 7.2 degrees could be predicted based on member orientation relative to the horizon. Similar difficulty is present in predicting the inclination of Figure 3.2. In actuality, it is highly likely that the true facility inclinations are not captured by any of the simplified estimates presented. This can be attributed to issues such as the photographs not showing the true orientation of structural members (projecting three-dimensional members in two dimensions) or photographic effects such as keystoning (parallel lines appear to be converging when photographed with a camera not parallel to the plane of the lines) and barreling/pincushion (image magnification varies with distance from optical axis).

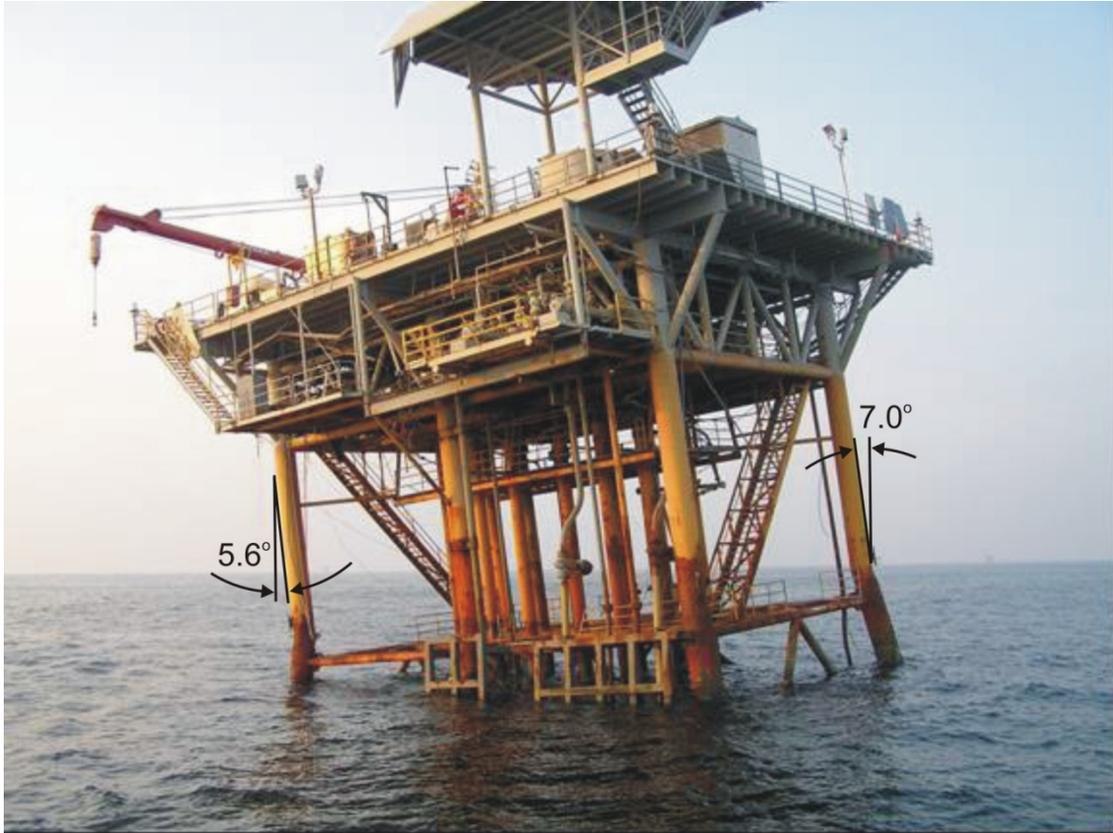
Figure 3.2. Example of Platform Destroyed during Hurricane Katrina/Rita

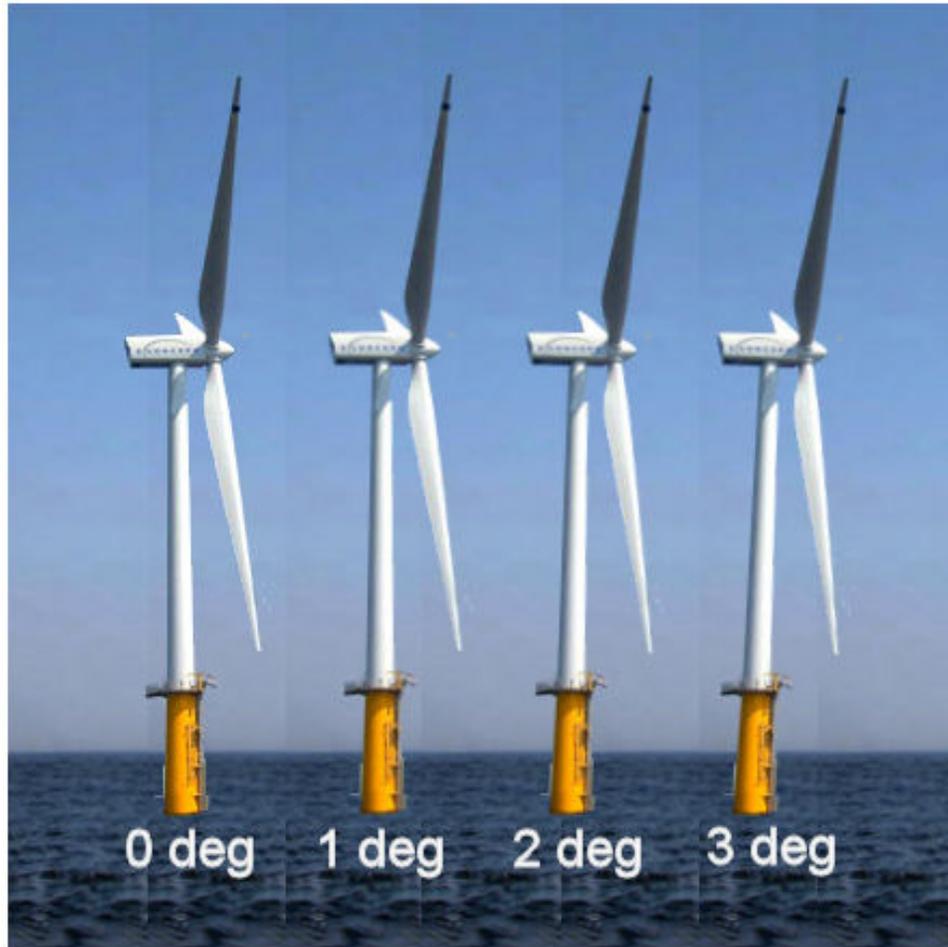
Figure 3.3. Sample Offshore Wind Turbine Showing Facility Inclination (Turbine taken from Princess Amalia Wind Farm, hub height 59m above waterline)

Figure 3.3 shows an example of how an offshore wind turbine inclination may appear. In this case, the inclination was varied from as installed (0 degree) to a 3-degree inclination. Note that a rather minor inclination can produce a readily observable variation when considering the height of the turbine. Unlike the jacket structures presented in Figures 3.1 and 3.2, the inclination of a wind turbine facility resting on a caisson could be reasonably predicted provided that a full 360-degree view could be obtained. While this will define the lean, the images may not define the reason for the lean if it is below the waterline. It should be noted that there is often a taper in the tower structure or the caisson substructure that should be considered when evaluating a lean using photographs.

One key inspection quantity to understand is the resolution of the measurement to determine the inclination magnitude. The simplest system is to consider the structure in Figure 3.3 as a rigid body where the facility rotation is governed solely by a rotation of the caisson at the mudline. Given this, the resulting lateral deflection at different elevations can be readily determined as shown in Figure 3.4. In this case, the lateral deflection at the waterline ranges from 1.22 to 3.66 ft for inclinations of 1 to 3 degrees. If attempting to characterize the inclination below water, the measurement technique would be required to resolve a deflection of less than this.

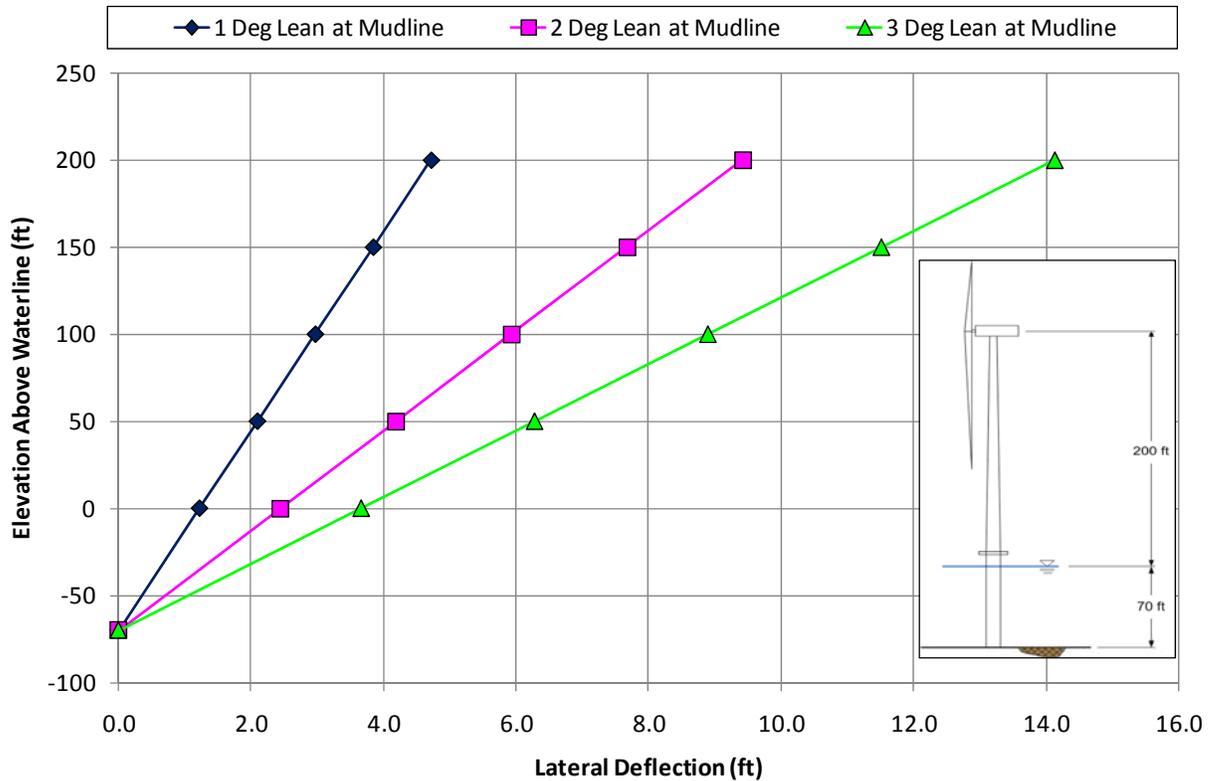
Figure 3.4. Lateral Deflection of Simplified Rigid Wind Turbine Facility Subjected to Rotation at Mudline
