4subsea investigates used risers

Flexible risers - Norwegian Continental Shelf

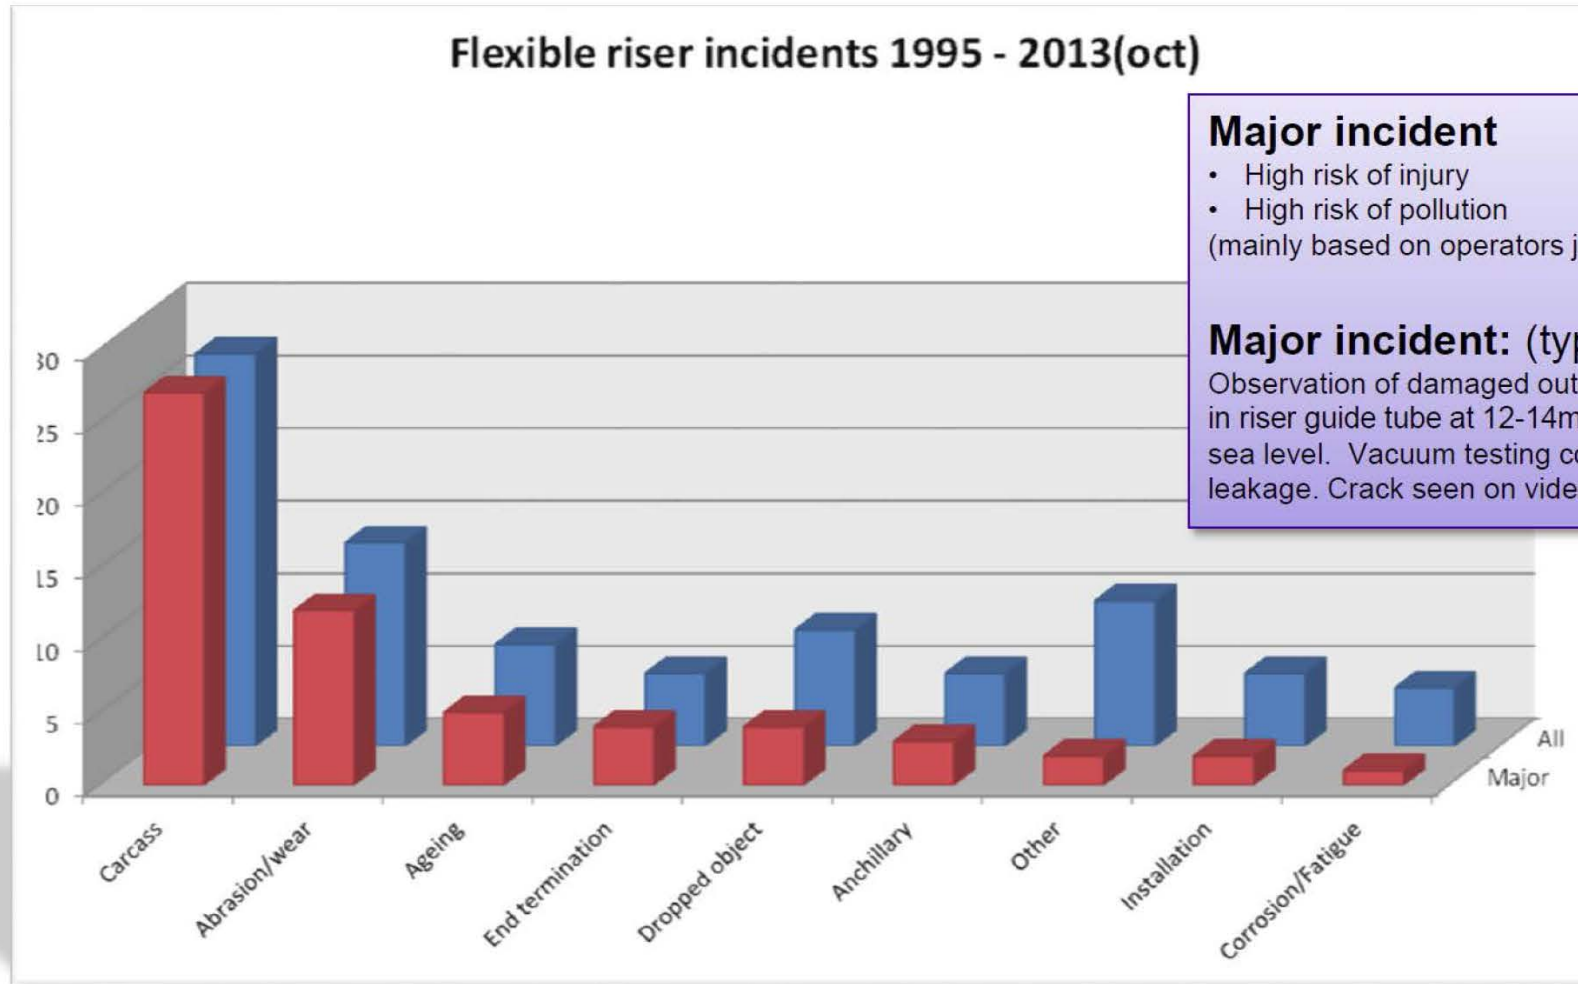
Flexible riser incidents reported to PSA

Major incident

- High risk of injury
 - High risk of pollution
- (mainly based on operators judgement)

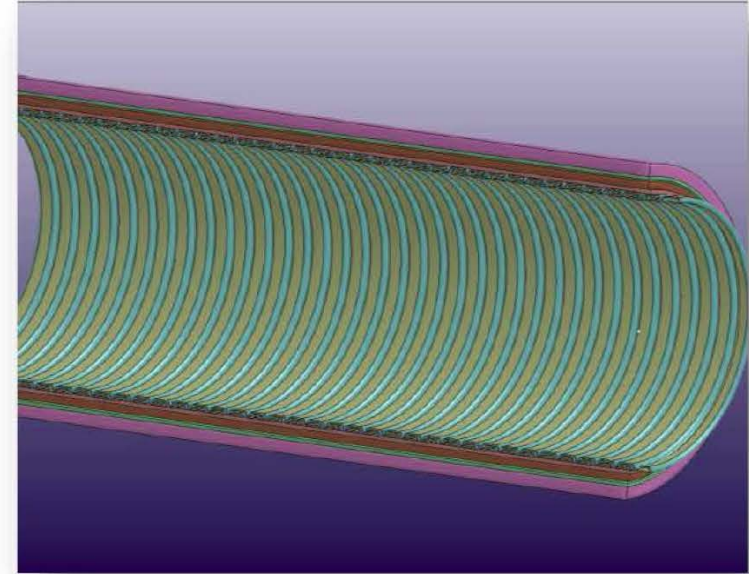
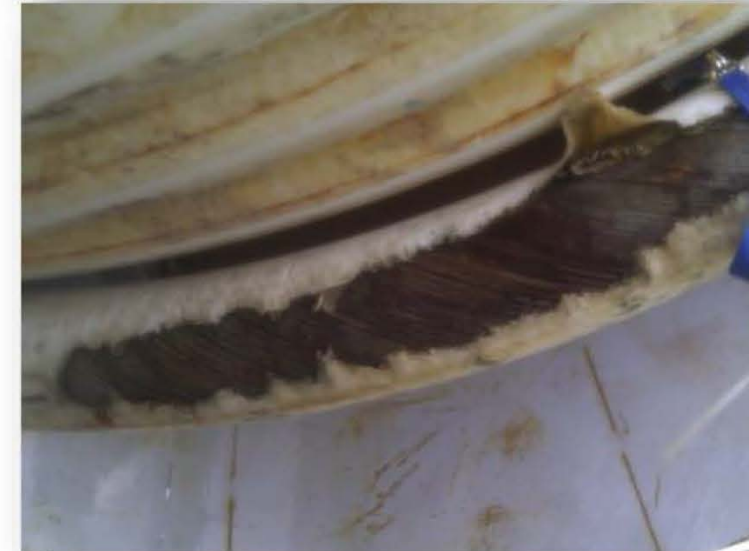
Most frequent riser incidents in Norway

Carcass incidents

- Collapse
- Pull-out – PVDF interaction
- Axial failure - hydrate blocking
- Sand Erosion
- Fatigue

Abrasion / Wear

- Bell Mouth / Guide Tube
- Interfacing Structures / Ancillaries
- Seabed At Riser Touch Down
- Internal Wear

Ageing

- Hydrolysis (External Sheath, Tape Layers, Pressure Sheath)
- High temperature (shielding/insulation)

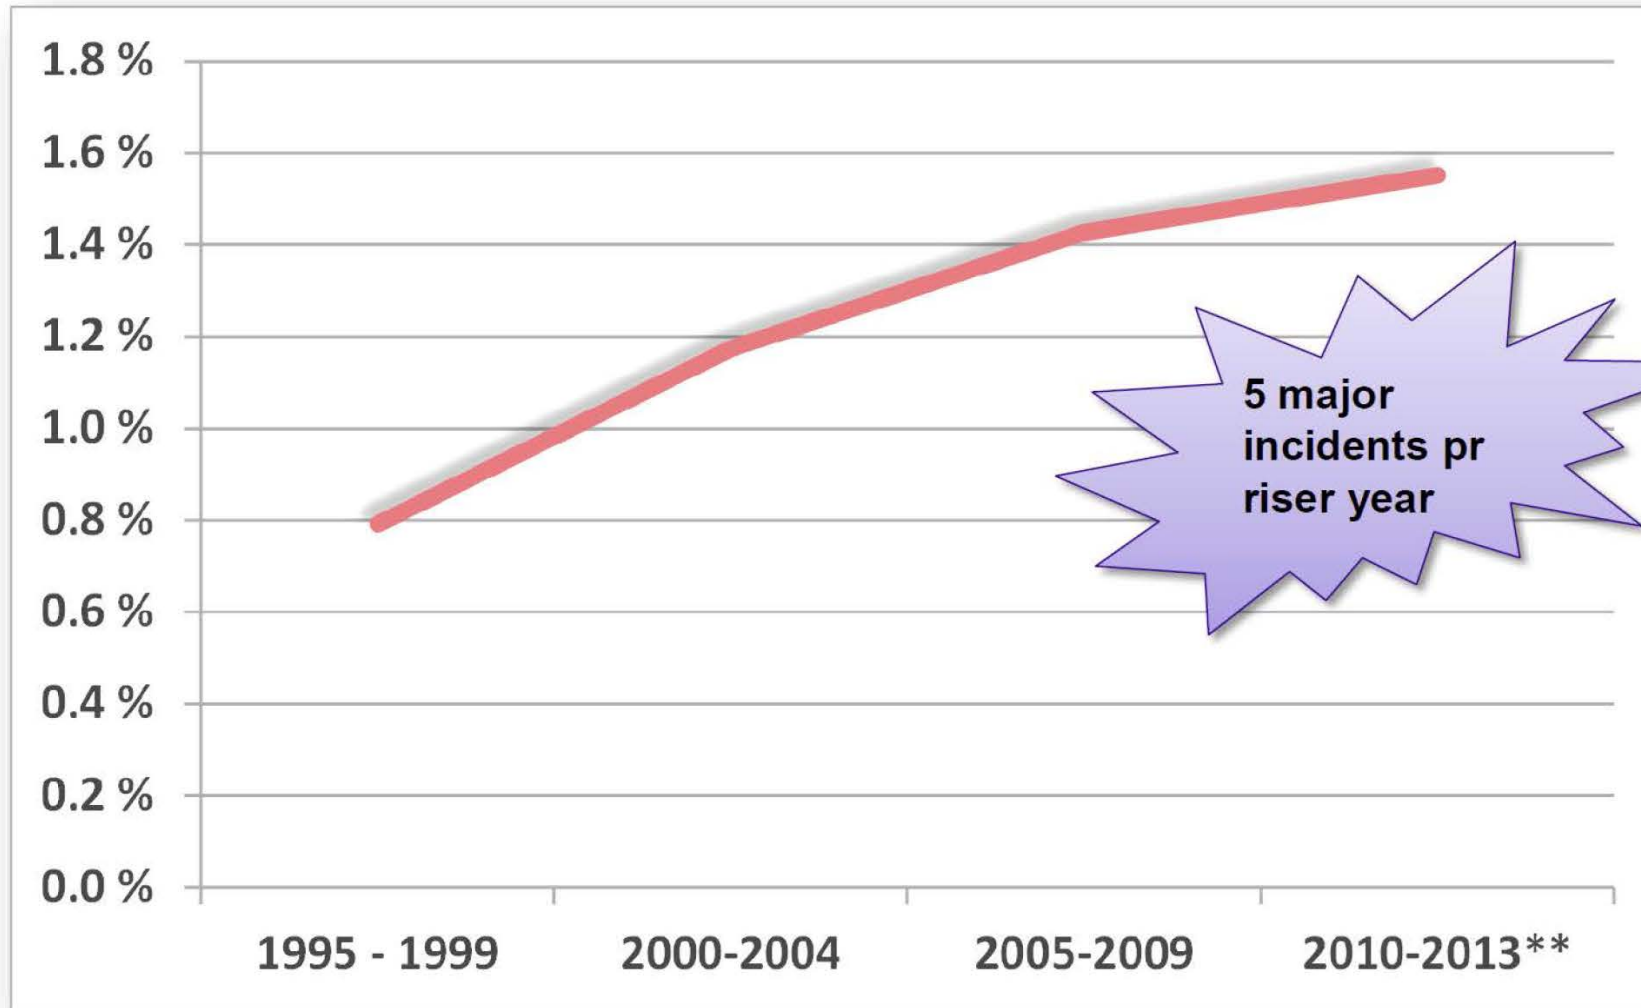
Incident rate development

** data to Oct 2013

- In total 80-100 risers replaced
 - 30-50 risers replaced due to risk assessment
 - 25-30% of the 324 risers in operation have been replaced or re-terminated
- 60 reported major incidents in CODAM (1995-2013)
 - 49 risers reported to be replaced
 - 11 risers repaired (later replaced?)
- Other replacements (flexibles)
 - Flowlines
 - Topside jumpers
