**UNITED STATES DEPARTMENT OF THE INTERIOR
BUREAU OF SAFETY AND ENVIRONMENTAL ENFORCEMENT
GULF OF AMERICA OCS REGION**

NTL No. 2026-G01

NOTICE TO LESSEES AND OPERATORS OF FEDERAL OIL AND GAS LEASES
AND PIPELINE RIGHT-OF-WAY HOLDERS ON THE OUTER CONTINENTAL
SHELF, GULF OF AMERICA OCS REGION

Post-Hurricane Inspection and Reporting

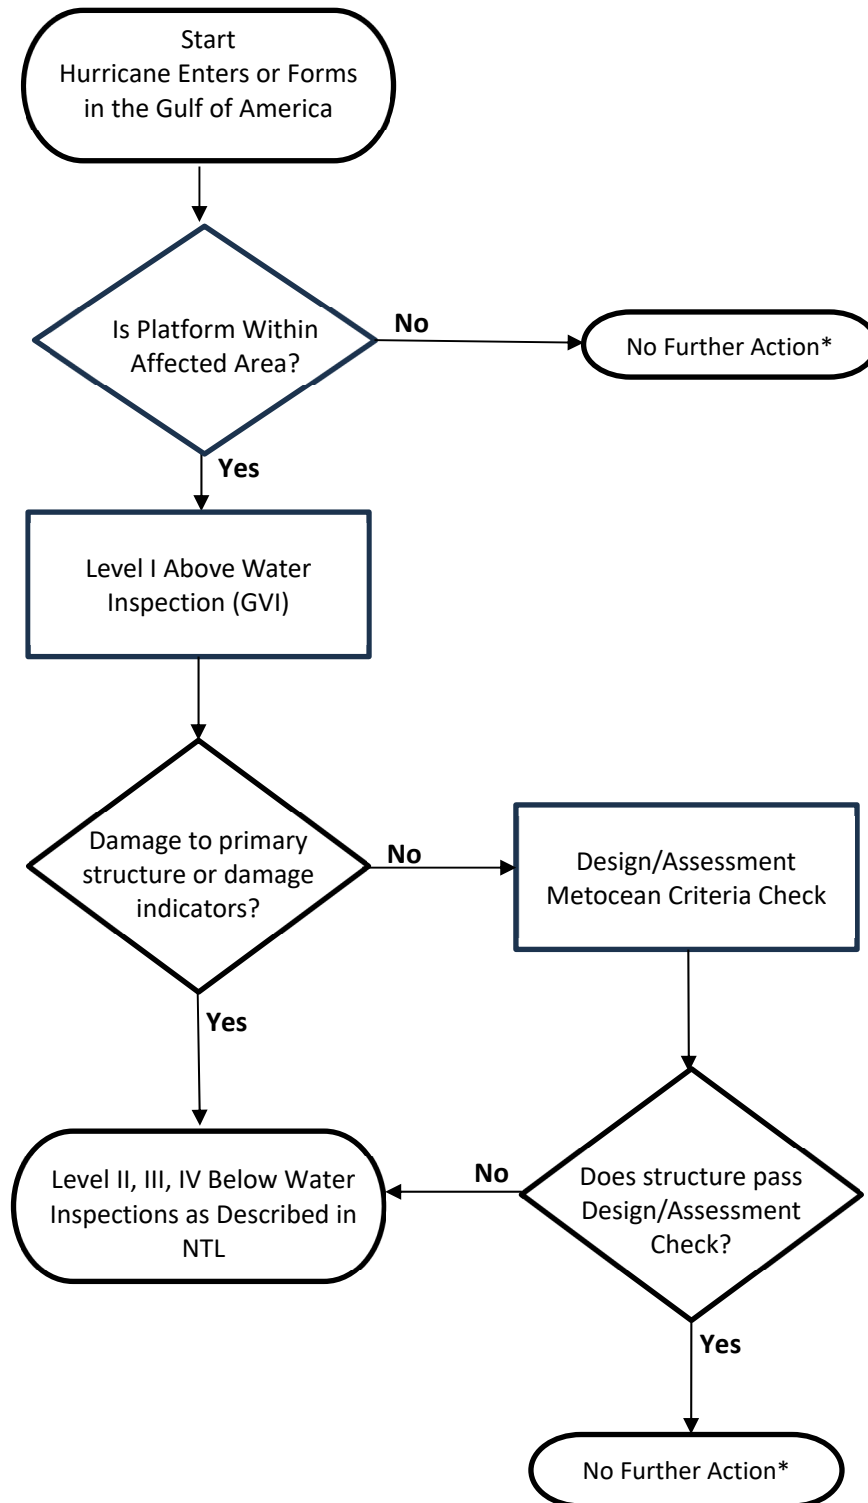
Attachment No. 1

*Unless structure specific inspections required by owner or regulator.

1. A list of affected structures;
2. A timetable for conducting the surveys described in Section 14.4.3 of API RP 2A-WSD; and
3. An inspection plan for each structure that describes the work you will perform to determine the condition of the structure.
