The National Academies has posted a prepublication copy of a report entitled "High-Performance Bolting Technology for Offshore Oil and Natural Gas Operations." The American Petroleum Institute (API) has reviewed the report and provides the following technical corrections for consideration.

API Technical Corrections to the NA Prepublication Copy of High-Performance Bolting Technology for Offshore Oil and Natural Gas Operations"

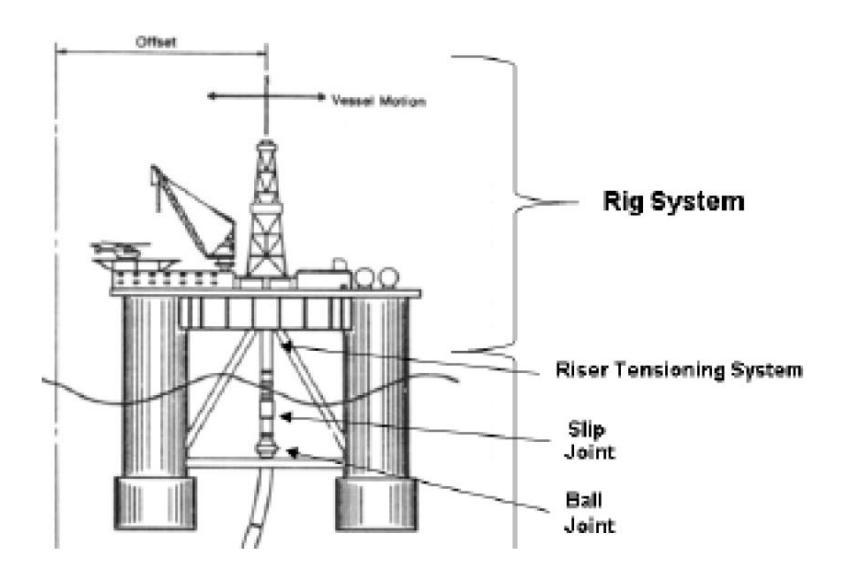
Figures I.1, I.10, & I.11

COMMENT: Slip joint is located below the upper ball / flex joint. Move or remove slip joint label, or include a new figure like this:
